Heritage Impact Assessment

Land west of Sunningdale Road,
Crosland Moor, Huddersfield

H764

Kirklees Council

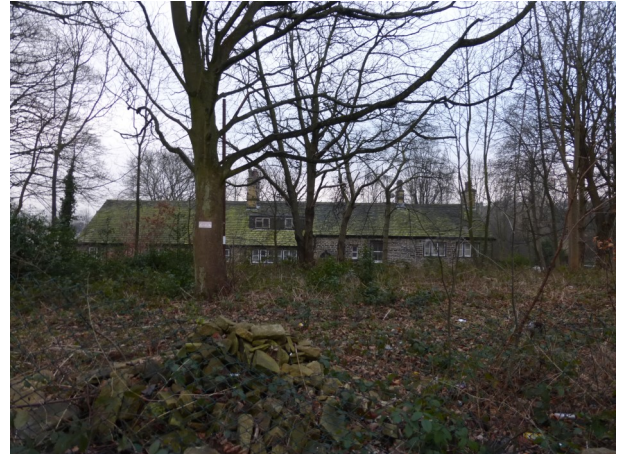
Figure 2 - View of the asset from the footpath

4.1 One can assume that at the time of listing in 1973 the asset was operating as a hotel but this does not appear to have been the case since at least 2008 when an application was made to convert the existing dwelling into 2 dwellings (listed building application no 2008/65/94382/W1). A second application was made in 2013 to convert and extend the adjoining barn into a third dwelling. As such, due to the private nature of the property it was not possible to undertake a detailed visual inspection of the building other than from the public footpath running to the north of the asset.

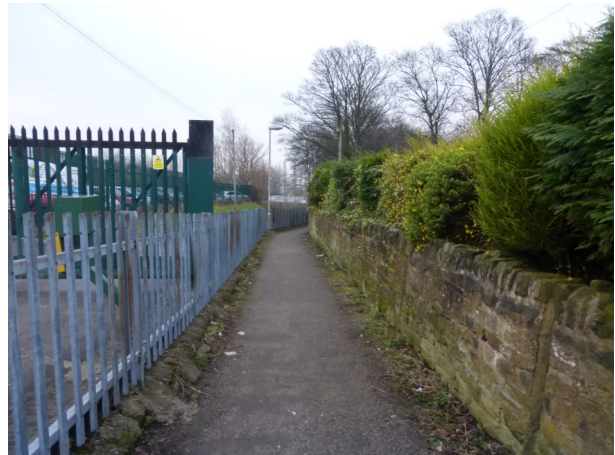
Figure 3 - View of the footpath adjacent to the historic asset

4.11 **Associative Historical Value** - There is associative historical value in the surrounding landscape to the south in particular in relation to the Dry Clough valley which has high value to the property. The stone boundary wall which exists along the northern boundary of the property have value as a historic field boundary. It is not apparent whether these walls continue along the east elevation.

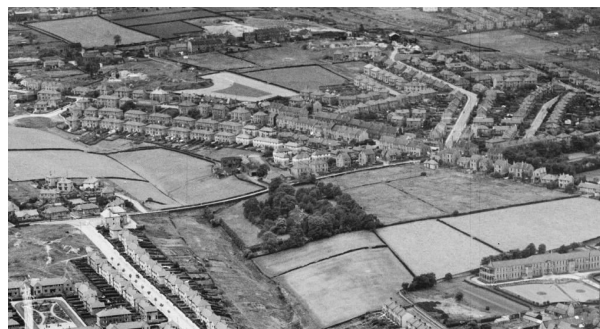
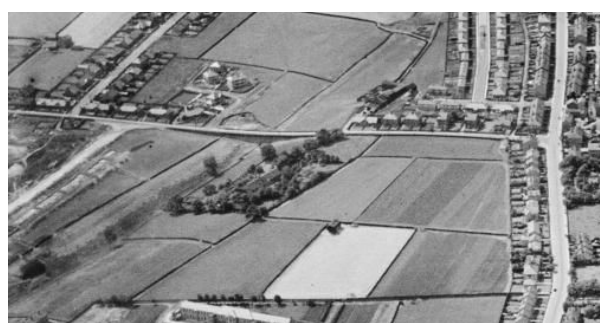
Figure 4 - View of the asset from 1937

5.03 At this point it would have been possible to discern the surrounding landscape was agricultural / rural in nature.

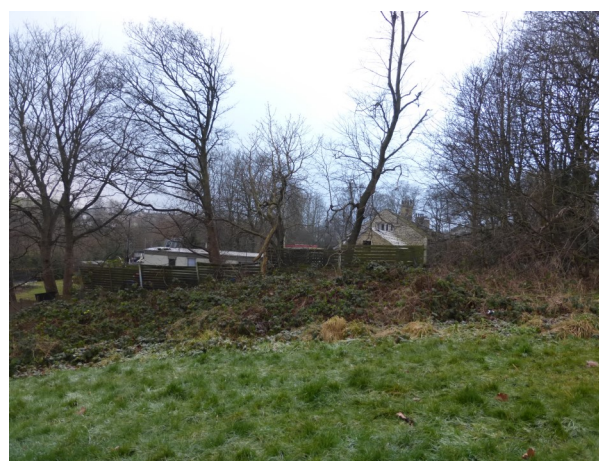
Figure 5 - View of the asset from the allocated site

5.04 **Views towards the heritage asset from the allocated site: Negligible Significance** - The belt of trees around the boundary of the asset has increased over the years and now acts as a barrier between the asset and the surrounding landscape. which has limited the available views of the asset. The listed building is almost completely obscured from Dry Clough Lane and has limited views from the allocated site due to the tree belt and the gradient of the land.
