# Heritage Impact Assessment

Land adjacent to Whitechapel  
Road, Cleckheaton

H508

**Kirklees Council**

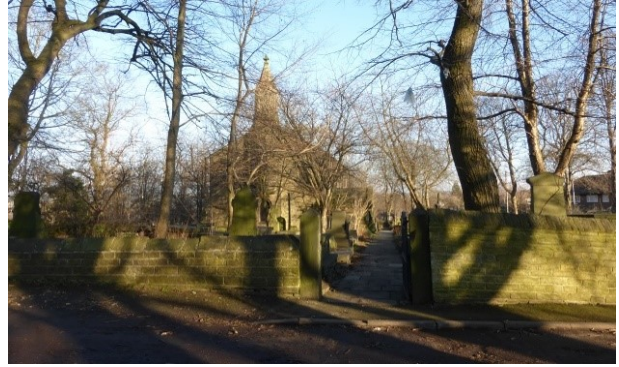
Figure 3 - Recent photograph showing the west entrance

- 4.10 **Historical Value** - There is a great deal of historical value in the immediate setting. The graveyard itself provides key information on the people who lived and died in the area with some gravestones dating back to the beginning of the 18th century. The walls surrounding the church also give more information about the historical setting of the church. The fact that the entrance is located in the west wall gives an indication of the orientation of the church. On the first edition OS map dated 1854 we can see that the road coming from Scholes to the west leads directly to the existing

entrance in the west wall and is aligned with the existing footpath running in front of the south elevation. According to this map there were stocks located at this junction and a Public House to the north which still exists, and may have been used not only for entertainment but also for public meetings. As the current Church pre-dates the churches in the nearby Scholes and Cleckheaton it is safe to assume that this church served both communities in addition to others in the area. This would account for its somewhat remote setting. The road then turned south and then east following the current boundary of the church. This layout to the west has now been lost which has caused harm to the setting of the church. The relationship with the former public house (now vacant) contributes positively to the setting of the church.

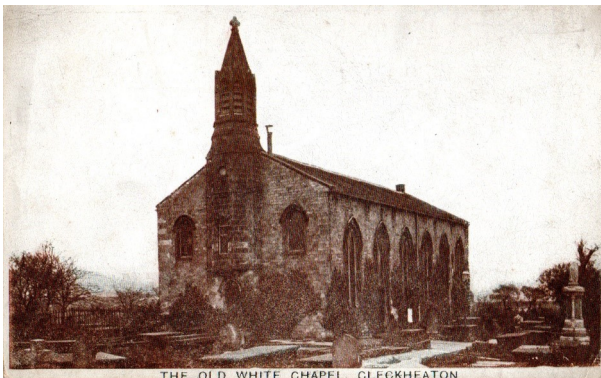
Figure 5 - Photograph taken in the early 20<sup>th</sup> Century showing the open nature of the immediate setting

4.11 **Aesthetic Value** - The immediate setting of the Church is currently heavily treed, but this would, historically, have been much more open to allow greater visibility of the building, particularly as the congregation were coming from further afield which meant that the building needed a strong presence in the landscape. Despite the introduction of these trees the immediate setting of the Church up to the boundary wall has aesthetic value as church grounds.

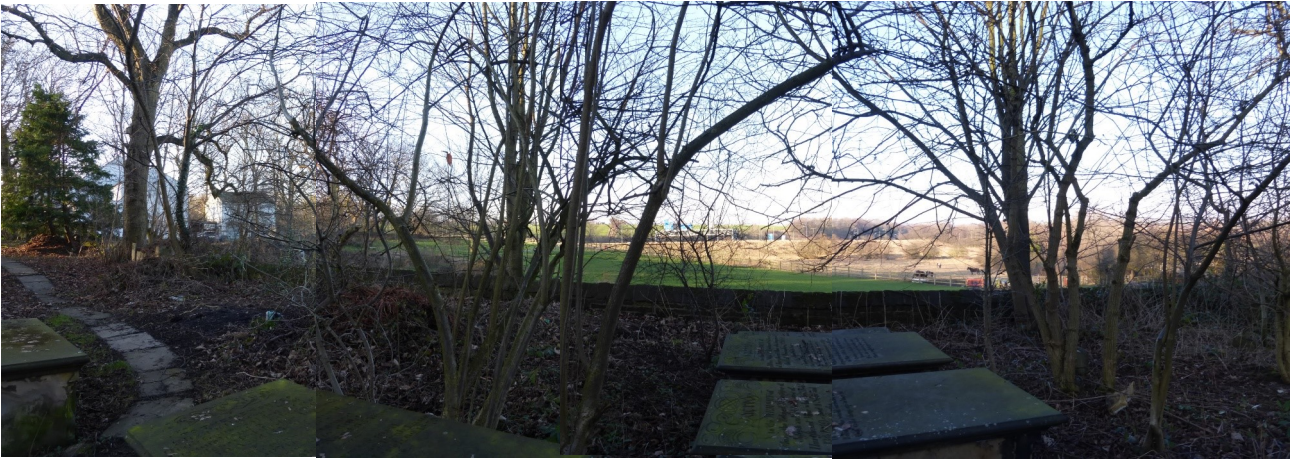
Figure 6 - Photograph showing the view of the allocated site from the church graveyard

4.15 **Aesthetic Value** - There is little aesthetic value in the extended setting, the only area that provides some value is the area to the north but this is limited due to the construction of the M62.
