**PUBLICATION DRAFT KIRKLEES LOCAL PLAN (NOV 2016)  
SITE H591 LAND TO THE WEST OF CLIFFE MOUNT, FERRAND  
LANE, GOMERSAL**

For KCS Development Ltd

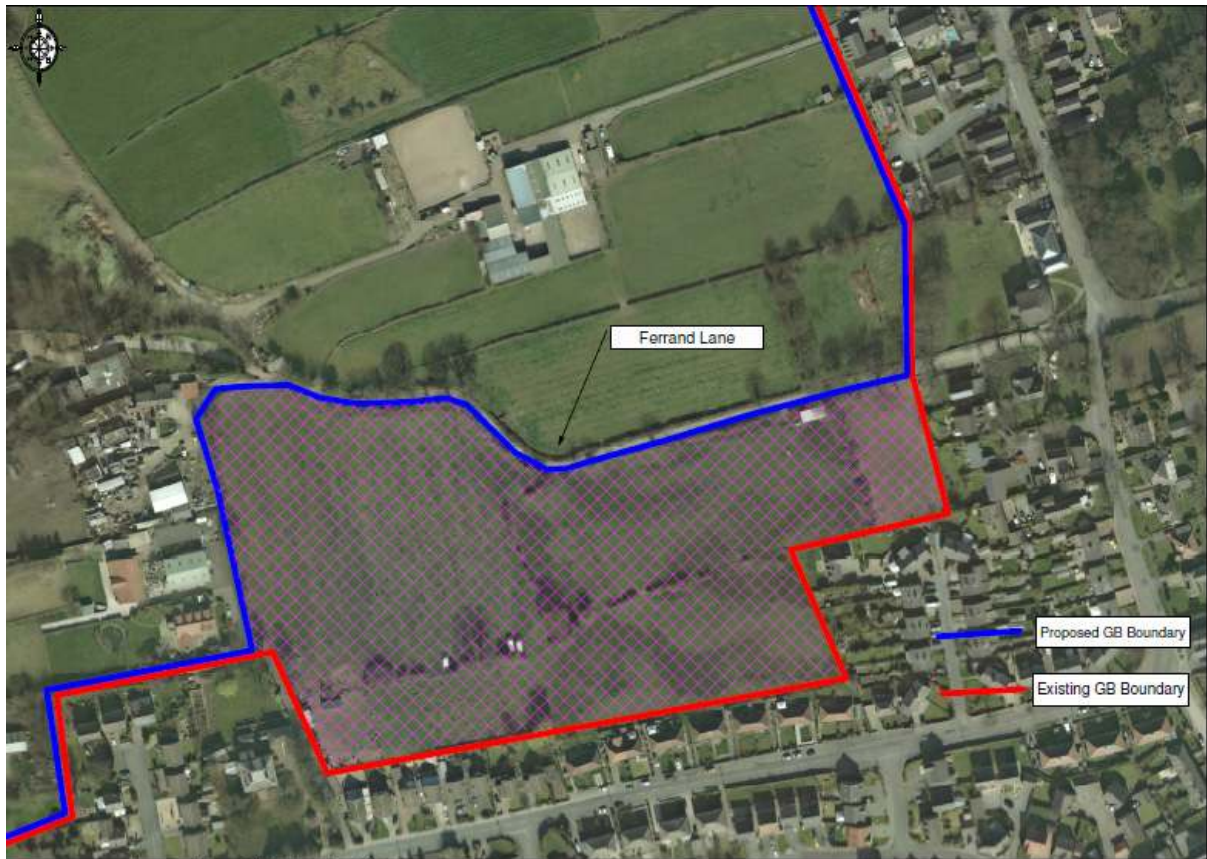
Figure 1 – Aerial Photograph showing the existing and proposed Green Belt boundary

- 3.1 On the northwestern edge of Gomersal, the current Green Belt boundary established in the Kirklees Unitary Development Plan (UDP) (1999) runs along the back of the properties on Latham Lane, Thatchers Way, Cliffe Mount, and Cliffe Lane. We have attached an aerial photograph of the site below showing the line of the existing Green Belt boundary as well as the line which we consider better reflects the realities on the ground and Green Belt policy.

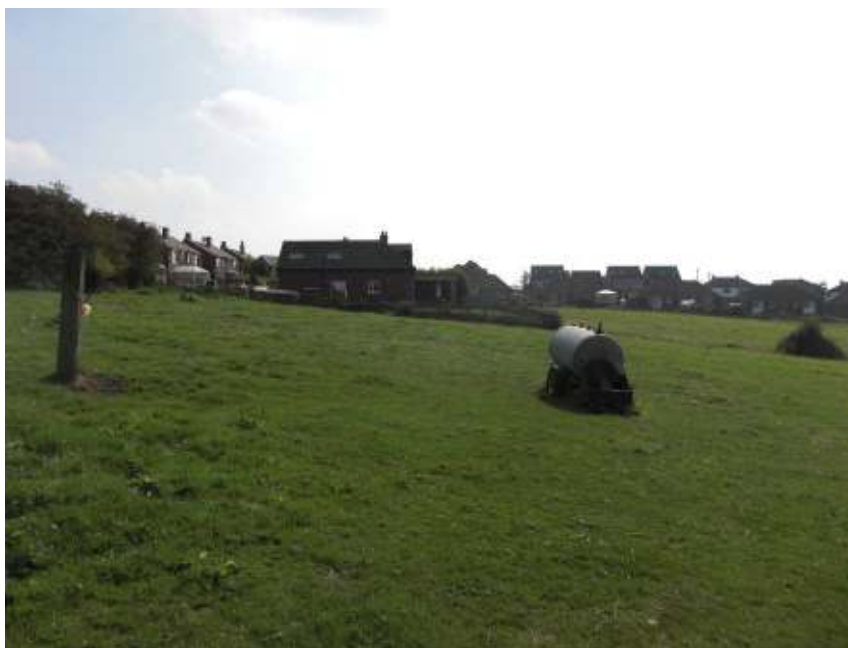
**Photograph 1 of the north eastern edge of the site. The lack of a defensible Green Belt boundary has lead to the incursion of a number of properties into the Green Belt in this location.**

3.11 The site comprises of a number of small fields, which are enclosed by development on three sides. The site is bordered on to directly by residential properties, which provides an untidy and hard edge to the settlement. We have attached below a number of photographs, which show the existing Green Belt boundary:

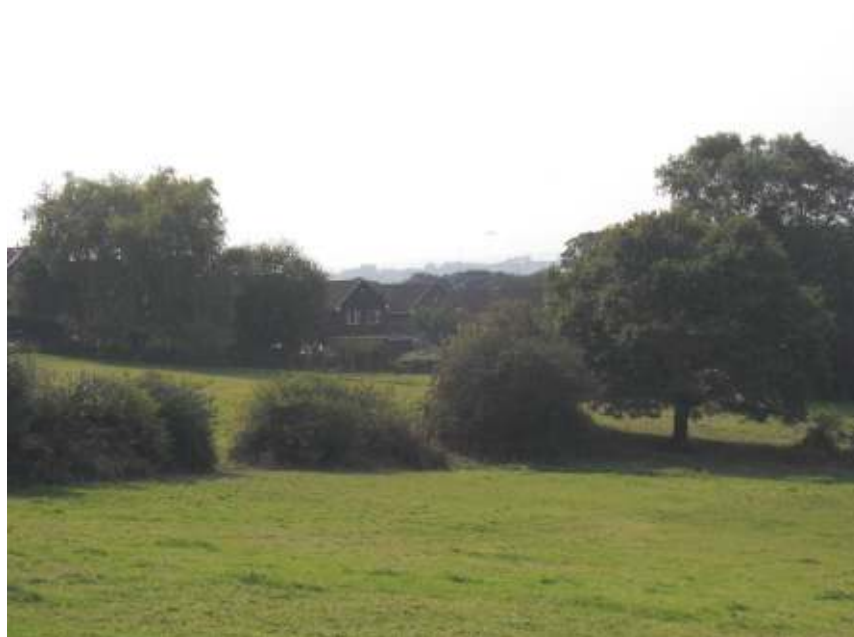
**Photograph 2 – the northern edge of the site**

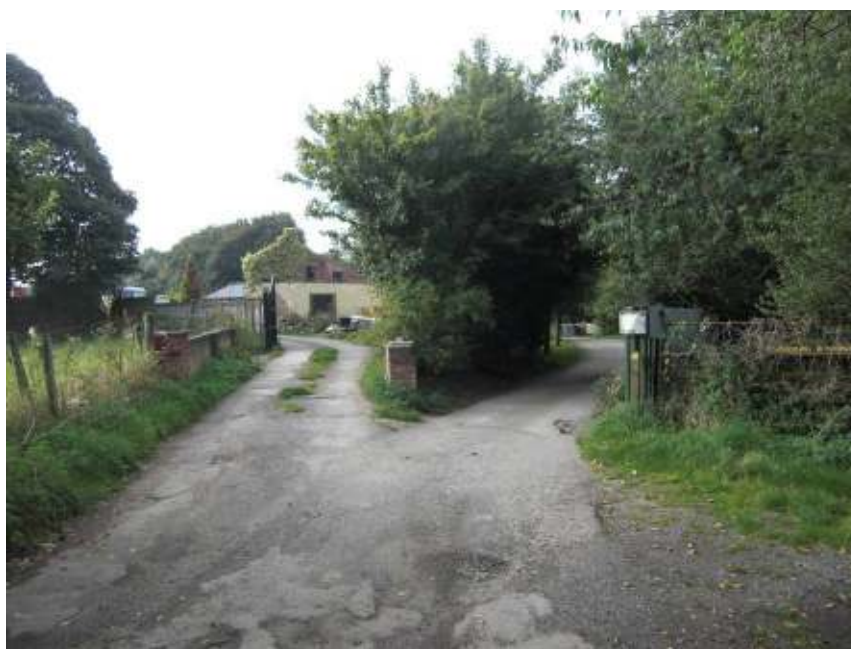
**Photograph 3 of the entrance to Thostle Nest Farm and the Boy Scouts Centre**

- 3.12 There is an extensive area of built development to the west of the site, which is currently in the Green Belt. There is Spen Valley Boy Scouts Centre, Throstle Nest Farm, and a property called Holmfield located along the western boundary of the site. The developments on the adjoining sites are semi-industrial in character and appearance and currently detract from the openness and visual amenities of the Green Belt. We have attached photographs showing the extent of the development bordering the site, which clearly demonstrates that the site is bounded by development on three sides.

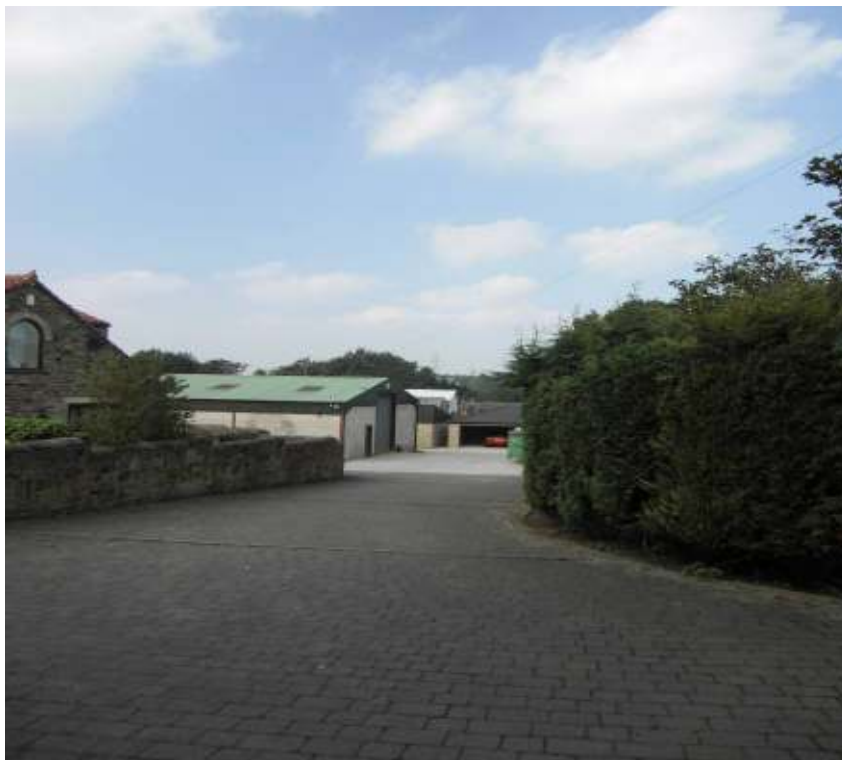
**Photograph 6 showing the extent of development at Holmfield**

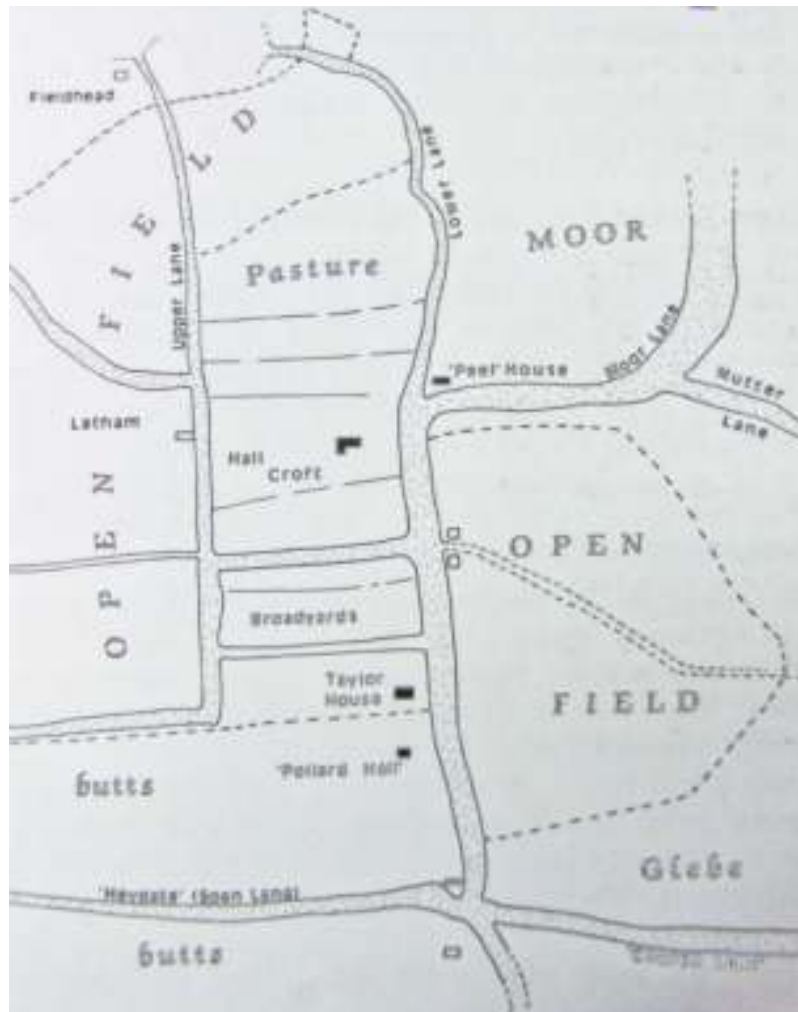
Suggested layout of mediaeval village (Cookson) showing major houses **Fig 2**

- 3.6 The 18th century Red House Museum on Oxford Road (formerly the residence of the prominent Taylor family, see **Fig 2**) is noted as featuring in Charlotte Bronte's novel '*Shirley*', which drew material from the Luddite riots.

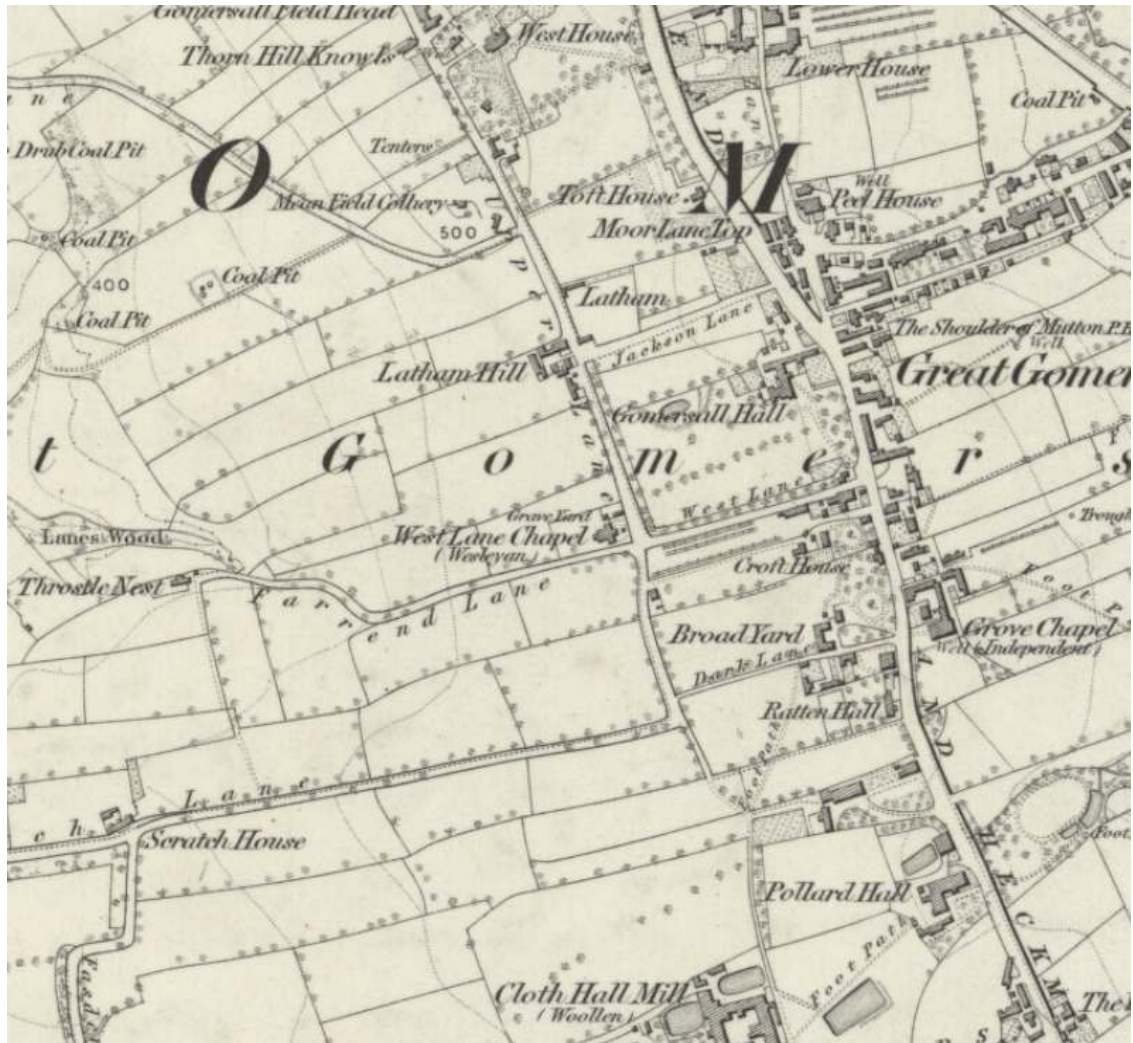
Ordnance Survey Map 1854 **Fig 3**

- 3.8 The earliest detailed map of the area (- the Ordnance Survey map of 1854, see **Fig 3** -) shows the northern part of Gomersal relevant to this assessment. Evidence of the cottage woollen and weaving industry is evident in the tenter frames in the surrounding fields: at the same time it is evident that the area was undergoing much more radical industrialisation, with large woollen mills, coal pits, stone quarries, brick works and rope works taking over the fields, with their associated catchment ponds and reservoirs.

- 3.9 The map shows buildings (- mostly houses -) scattered rather randomly along the north-south highway, with smaller houses on the east side and larger detached houses in substantial grounds on the west side: they may have housed the mill owners or other industrialists. Farrend Lane already exists, serving Throstle's Nest farm, with open fields either side. By this time the non-conformist churches had taken root in the village, taking advantage of the lack of a Protestant church in the vicinity, with a Wesleyan (now Methodist) chapel built at the end of West Lane and a Congregational (now United Reformed) chapel on Oxford Road, both built in the 1820's. A fine Public Institute of classical design was built on Oxford Road in 1860.

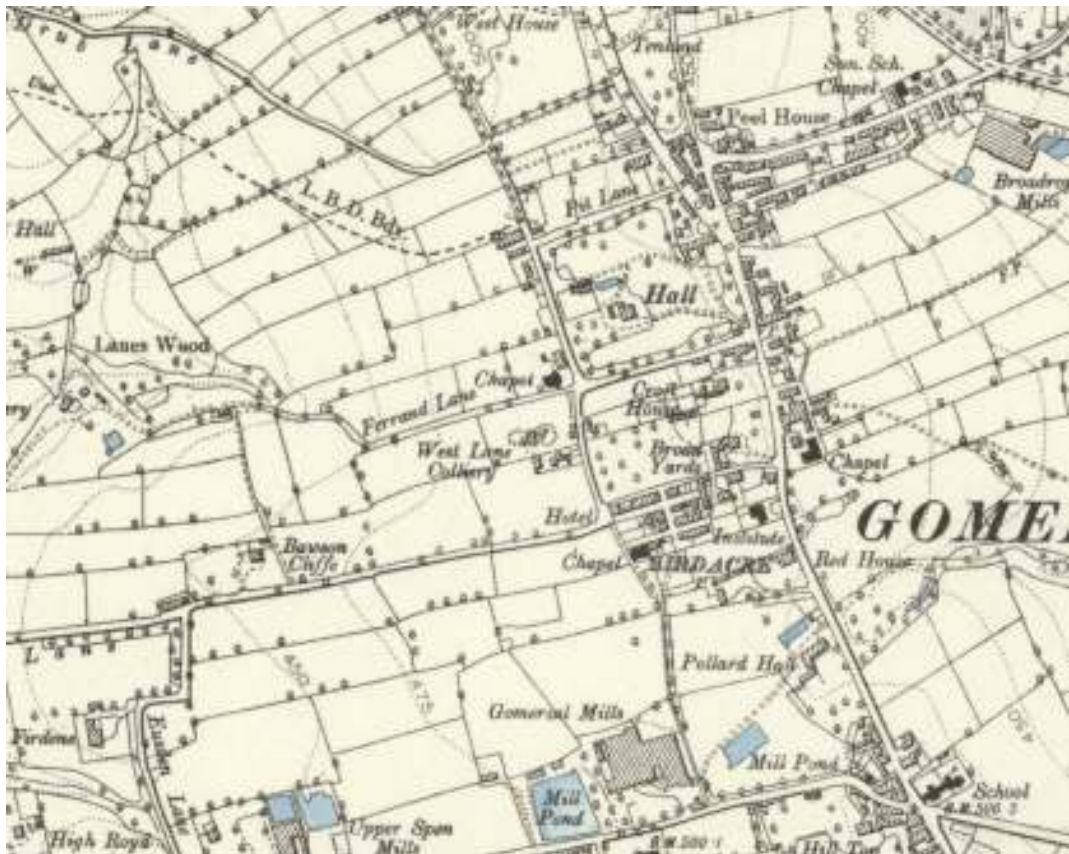
Ordnance Survey Map of 1894 Fig 4

- 3.10 The Ordnance Survey map of 1894 (see **Fig 4**) shows relatively little change. The previous industrial activities appear to have diminished, with fewer coal pits, quarries and brick fields etc. Gomersal was unable to keep pace with the industrialisation of the area due to its elevated position, the mills etc tending to migrate to the valley bottoms where there was a better supply of water: the village therefore avoided the damaging new developments found in many other east Pennine villages.

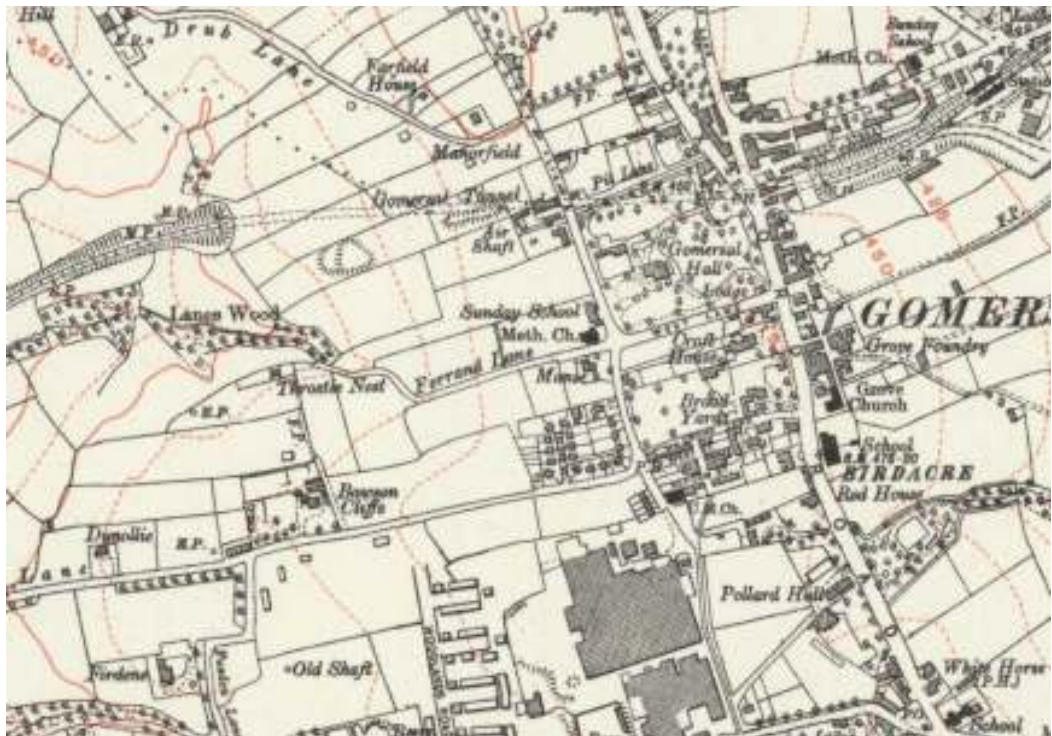
Ordnance Survey Map of 1944 Fig 5

- 3.11 The last major development to affect the village was the construction of the LNWR Heaton Lodge and Wortley failway line from Leeds to Heckmondwyke, built at around the turn of the 19th century: however, its impact was limited as the line was tunnelled under Gomersall from a point north of Ferrand Lane to the north end of the village, emerging next to what is now Queen Street (see **Fig 5**).

- 3.12 The Ordnance Survey map of 1944 (see **Fig 5**) still shows relatively little change apart from the expansion of the Gomersal Mill on Spen Lane, and the impression is one of a settled residential area liberally interspersed with mature trees. The Methodist chapel had by now (prior to or around 1900) expanded along Ferrand Lane by acquiring an adjoining plot, no doubt intended to serve the Sunday School which had been added at that time.

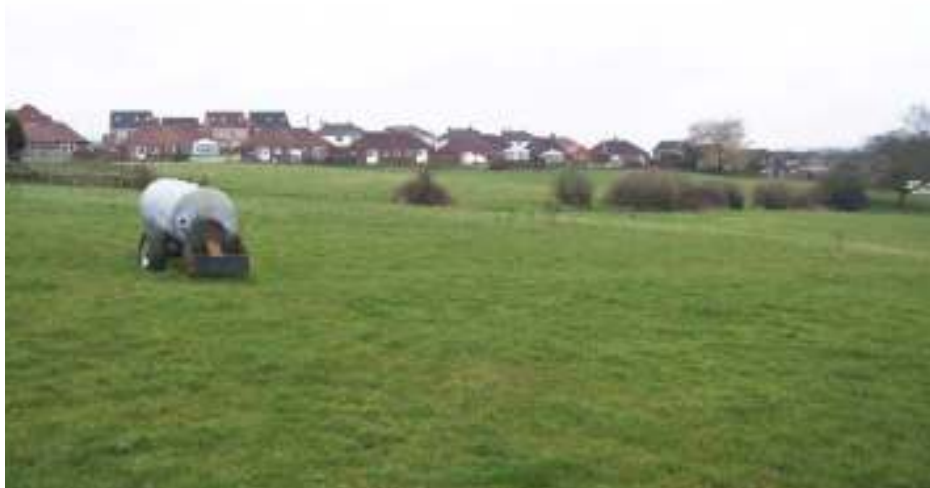
View from Ferrand Lane across proposed development site **Fig 14**

- 4.10 At this point the conservation area stops and the character of the area changes dramatically. Having crossed the ridge Ferrand Lane narrows and descends steeply between fields and wide views now open up to the north and west. To the south side of the lane the steeply sloping fields descending from the modern housing on the skyline are the location of the proposed housing development (see **Fig 14**).

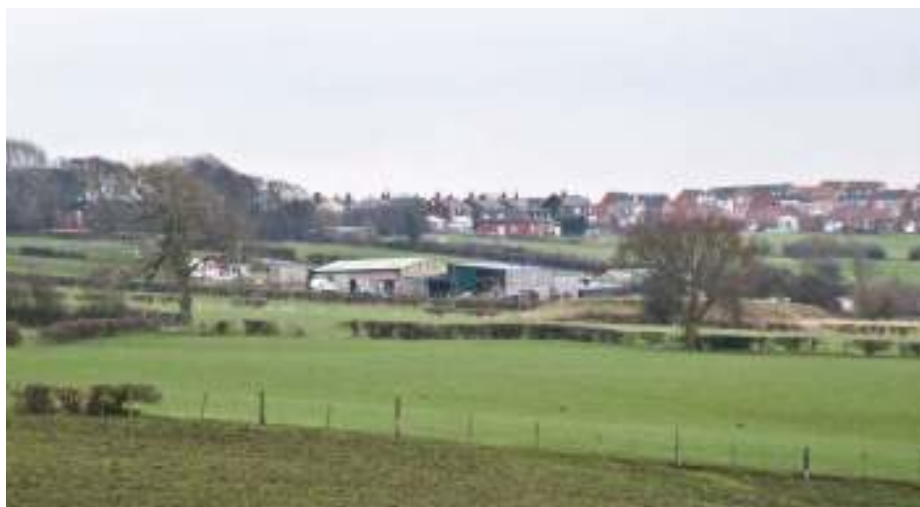
View south-eastwards from Drub Lane, Ferrand Lane in centre **Fig 15**

- 6.8 The impact on long distance views of the conservation area has been considered but these are limited to views from Drub Lane to the north east (see **Fig 15**). However, the chapel is screened by trees and the new housing would sit below a skyline already lined with modern housing, with no detriment to the chapel or conservation area.

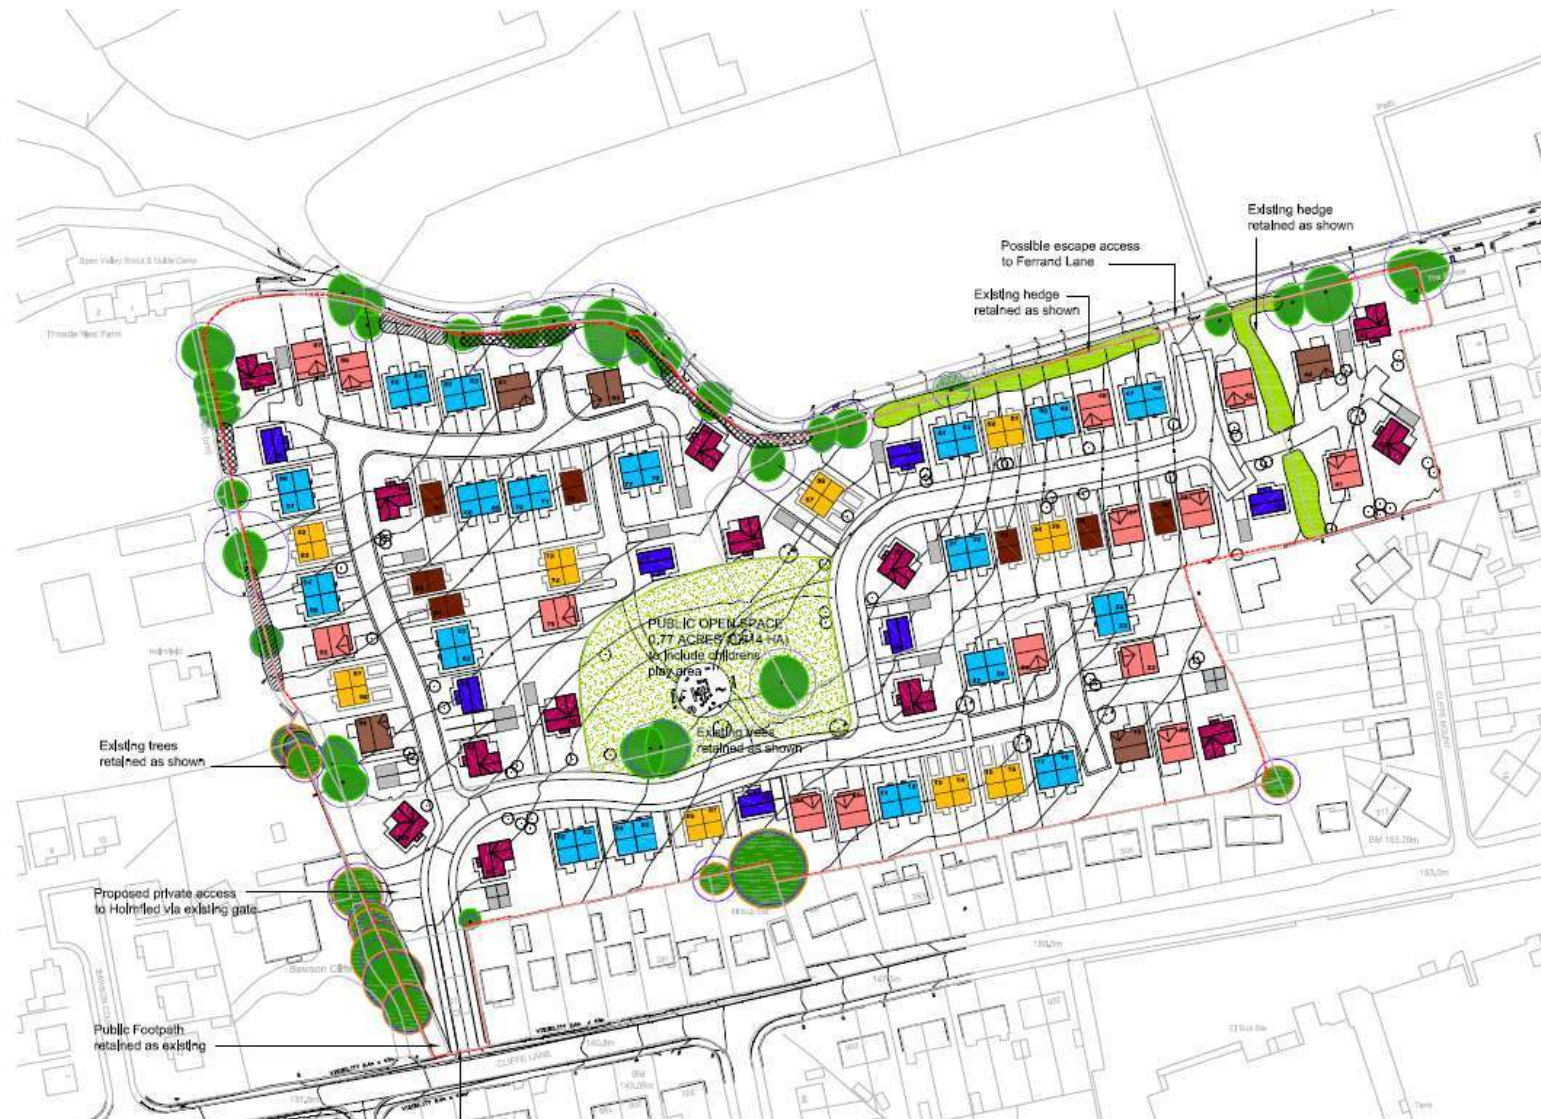
Proposed housing site -indicative layout Fig 16

The proposed development site is physically and visually remote from the majority of the conservation area, particularly due to the presence of the intervening ridge and modern housing, and even where the two areas come into close proximity the impact will be negligible. The conclusion of this analysis is therefore that development of the proposed site for housing will have no detrimental impact on the conservation area, or on any of the Listed buildings within the area.

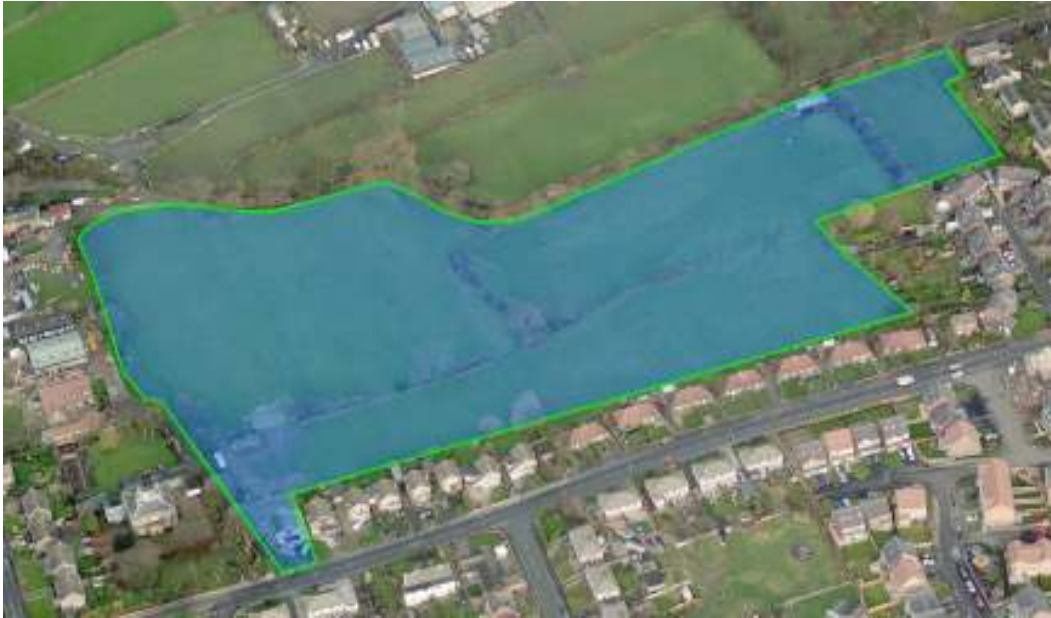
**Figure 1:** Area Surveyed Highlighted

- 2.1 The area surveyed is located to the south of Ferrand Lane, Gommersal. Figure 1 shows the extent of the area.

- 2.2 The area is comprised of a number of agricultural fields currently used for grazing. Some outbuildings used for housing poultry are located to the rear number 271 Cliffe Lane which was also included within the survey area.

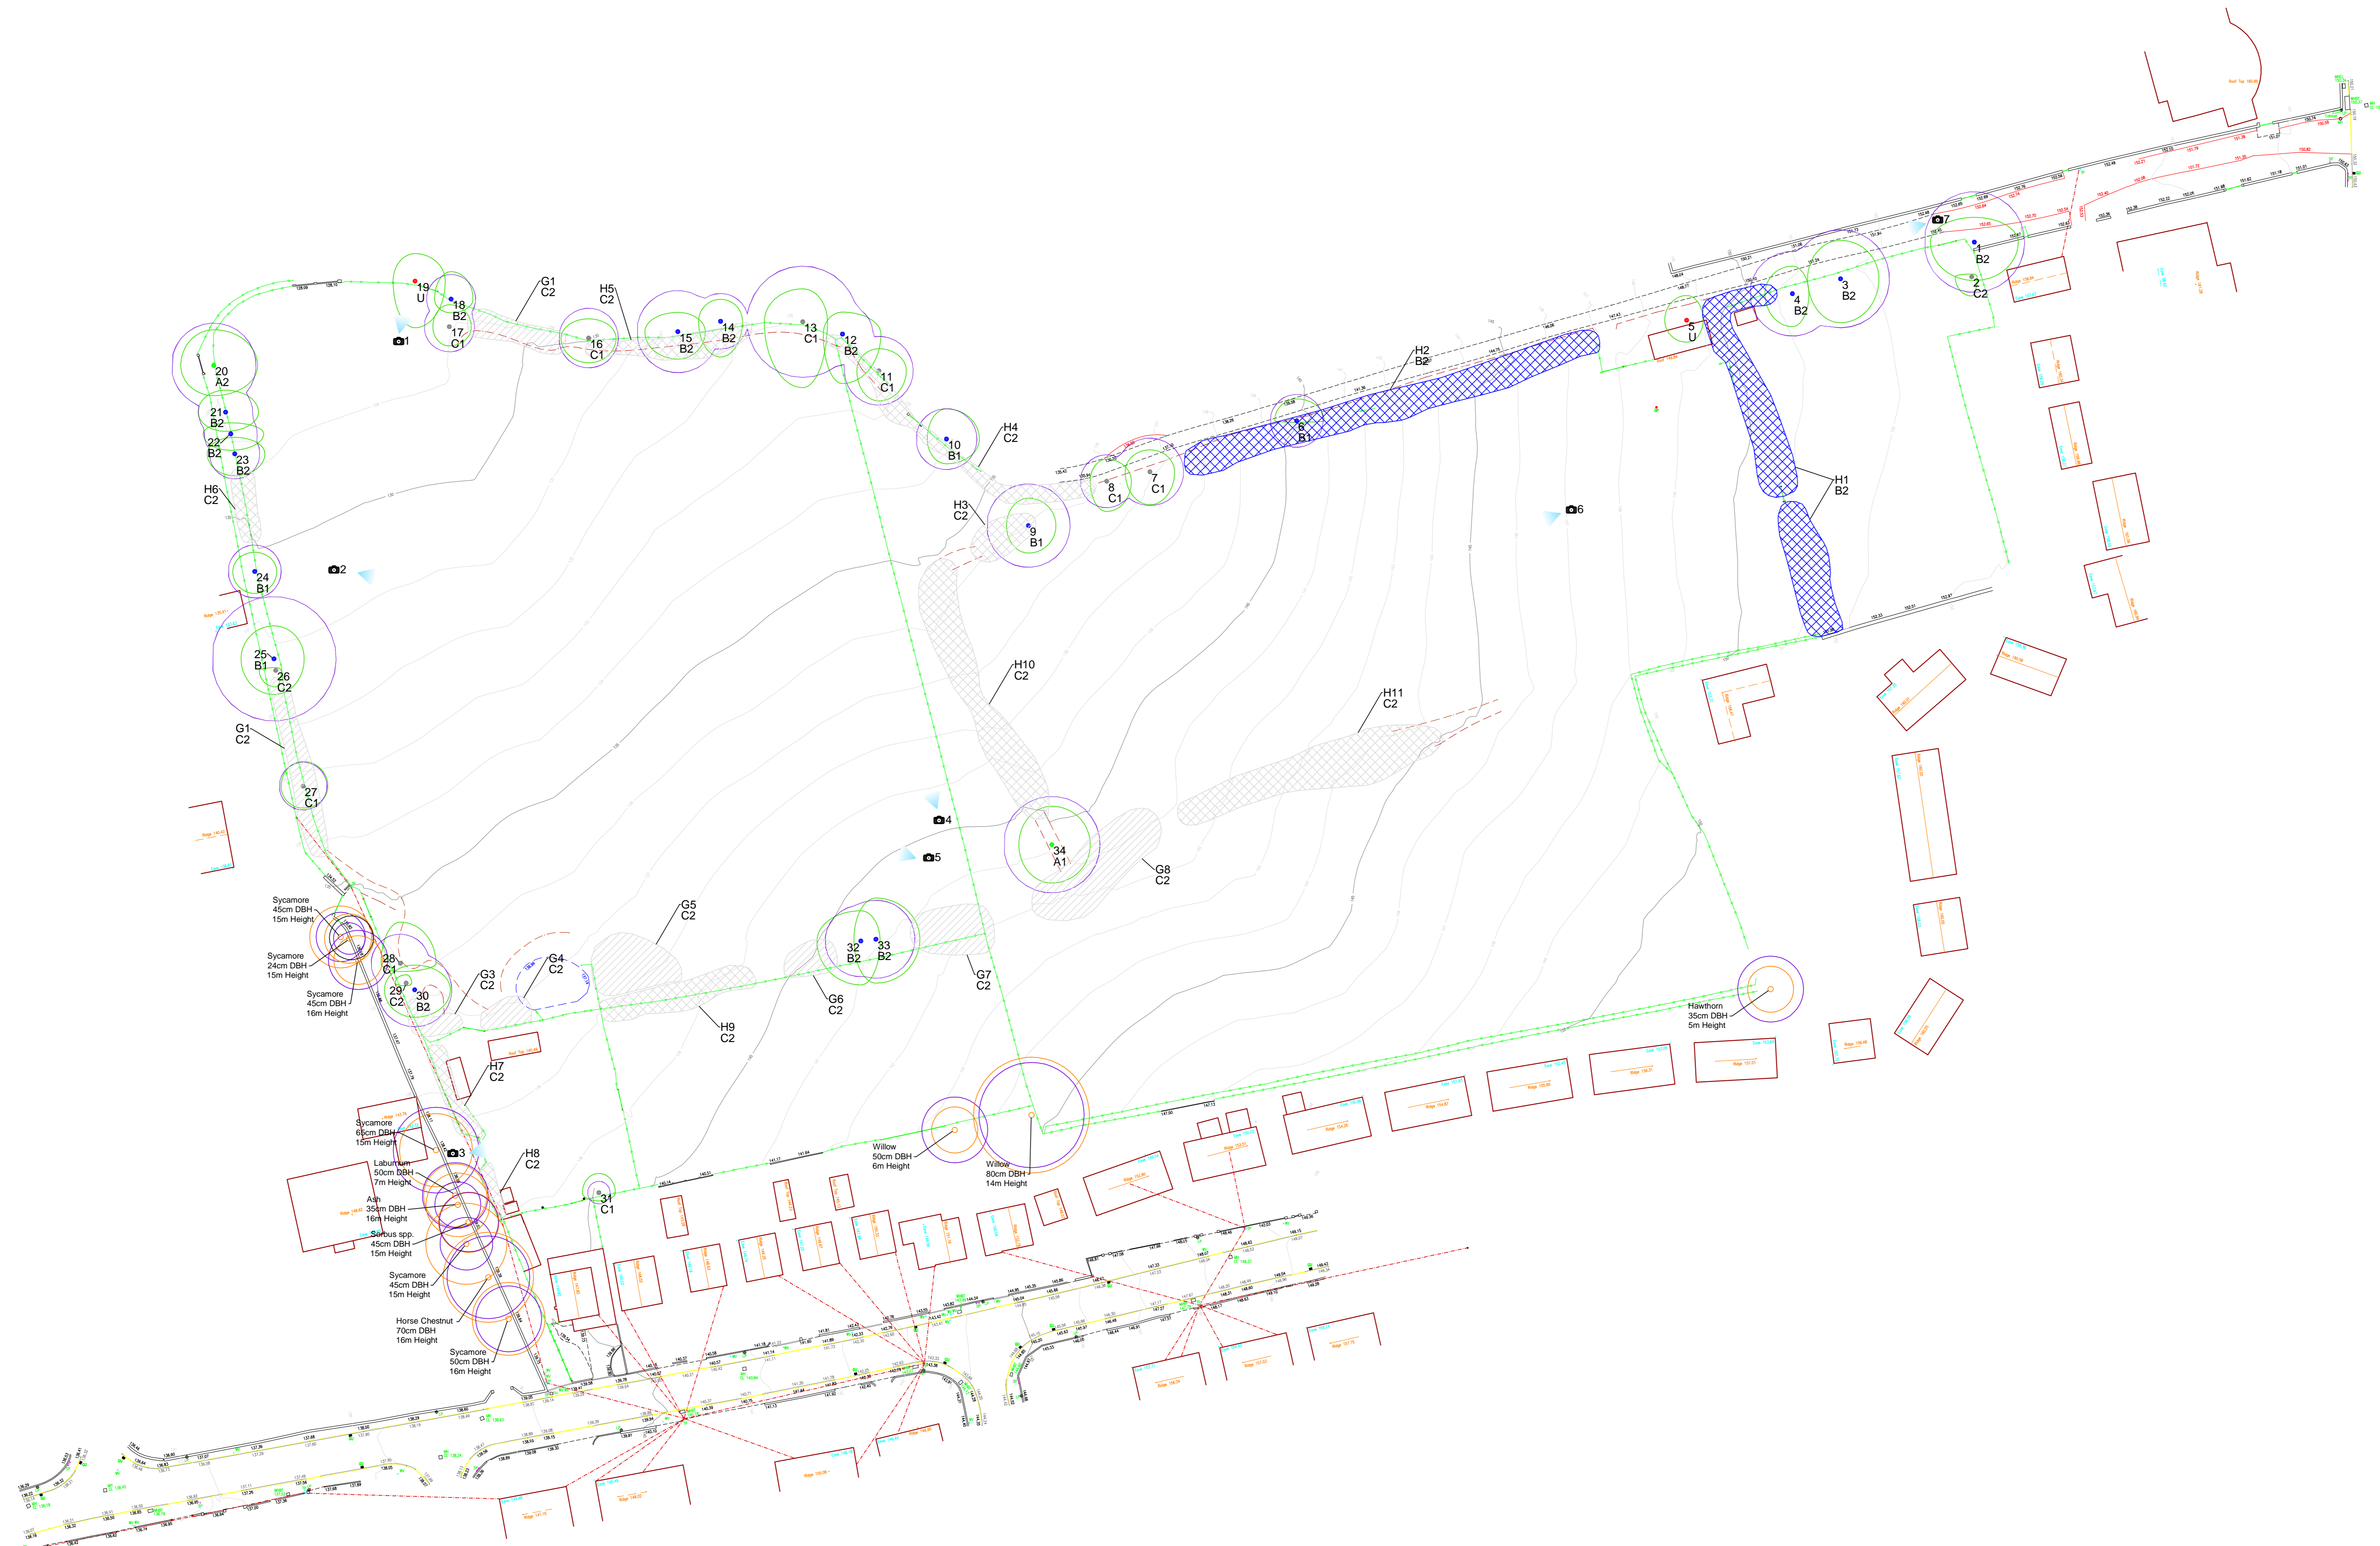
Drawing Title: Tree Constraints Plan  
 Project: Ferrand Lane, Gomersal  
 Drawing Number: ARB/CP/1224/TCP  
 Date: November 2015  
 Scale: 1:500 @ A1  
 Client:

- 2.3 The trees are predominantly located within field boundary hedgerows that surround and crisscross the area. A small number of trees located within adjacent properties were recorded where they could have an influence within the site. Their details are annotated upon the Tree Constraints Plan, Appendix 2.

- Tree Position Showing Crown Extents and BS5837 Category A
- Tree Position Showing Crown Extents and BS5837 Category B
- Tree Position Showing Crown Extents and BS5837 Category C
- Tree Position Showing Crown Extents and BS5837 Category U
- Root Protection Area - to remain free from disturbance (merged where over-lapping)
- Position of Tree Upon Adjacent Property Showing Extent of Crown Overhanging the Site & Root Protection Area Estimate
- Group Position Showing Crown & Root Protection Area Extents, and BS5837 Category C
- Hedgerow Position Showing Crown & Root Protection Area Extents, and BS5837 Category B
- Hedgerow Position Showing Crown & Root Protection Area Extents, and BS5837 Category C
- Photo Number, Position and Aspect
- 1/G1 Tree/Group
- A1/B1/C1/U BS5837 Retention Category

3.2.1 **Category A** (coloured green) trees are those of high quality and value, and of a condition whereby they could make a substantial contribution to the site. The retention of Category A trees should be considered during the design phase and afforded adequate physical protection during the construction phase in accordance with BS 5837:2012 where retained. This means keeping proposed features and alterations to ground levels outside of root protection areas and crown spreads so as to ensure that the tree remains in an adequate condition post-development. Root protection areas and crown spreads are displayed upon the Tree Constraints Plan, Appendix 2. Two individual trees were classified as Category A; their numbers being Trees 20 and 34.

3.2.2 **Category B** (coloured blue) trees are those of moderate quality and value, and of a condition that they make a substantial contribution to the site. The retention of Category B trees should be considered during the design phase and afforded adequate physical protection during the construction phase in accordance with BS 5837:2012 where retained. Fifteen individual trees, and two hedgerows were classified as Category B; their numbers being Trees 1, 3, 4, 6, 9, 10, 12, 14, 15, 18, 21-25, 30, 32, 33 and Hedgerows 1 and 2.

3.2.4 **Category U** (coloured red) trees are of such a condition that any existing value would be lost within 10 years. As a result it is recommended that Category U trees are not considered a constraint for development and are removed prior to construction commencing. Two of the trees were classified as Category U. Tree 5 is a goat willow with poor form which is in contact with an out-building and Tree 19 is an oak which has been left unbalanced and with a stem crack following the loss of a co-dominant stem.

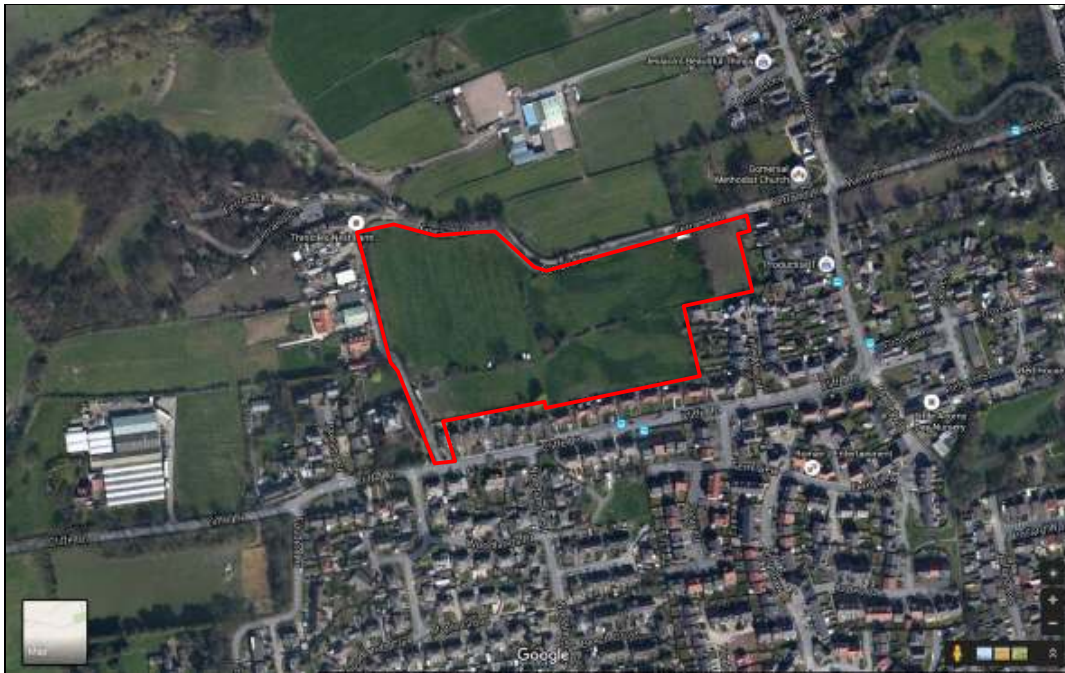
**Figure 01:** Aerial view / site location (red line denotes construction zone, blue line defines survey area).

The site is located on the outskirts of the village of Gomersal approximately 6.7km south of Bradford centre. It occupies an area of approximately 3.7 hectares and comprises improved pasture, hedgerows, trees, shrubs, nine buildings/structures and a pond, refer to *Figure 01* below.

The site is bound to the north by a fence and Ferrand Lane, beyond which lie fields of agricultural farmland; to the east by a fence and a hedgerow, beyond which lie a built up residential area; to the south by a fence and a hedgerow, beyond which lie a built up residential area; and, to the west by a fence and a hedgerow, beyond which lie residential homes and gardens and fields of agricultural farmland.

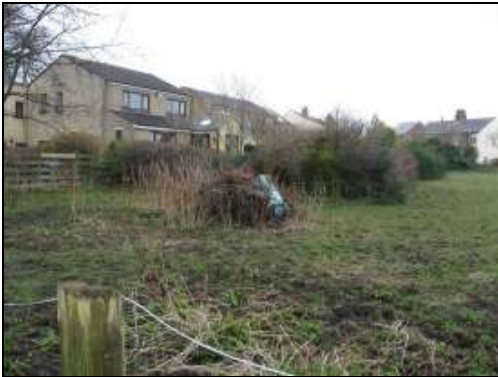
Hedgerow H1 and pile of debris (TN1)

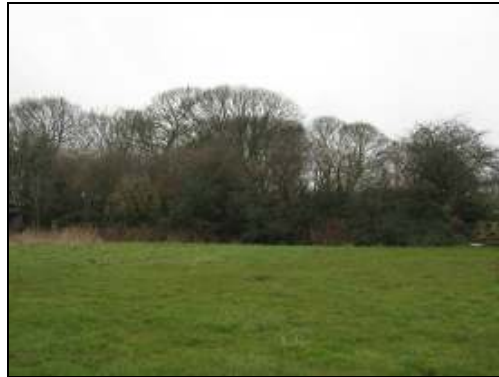
Hedgerow H2

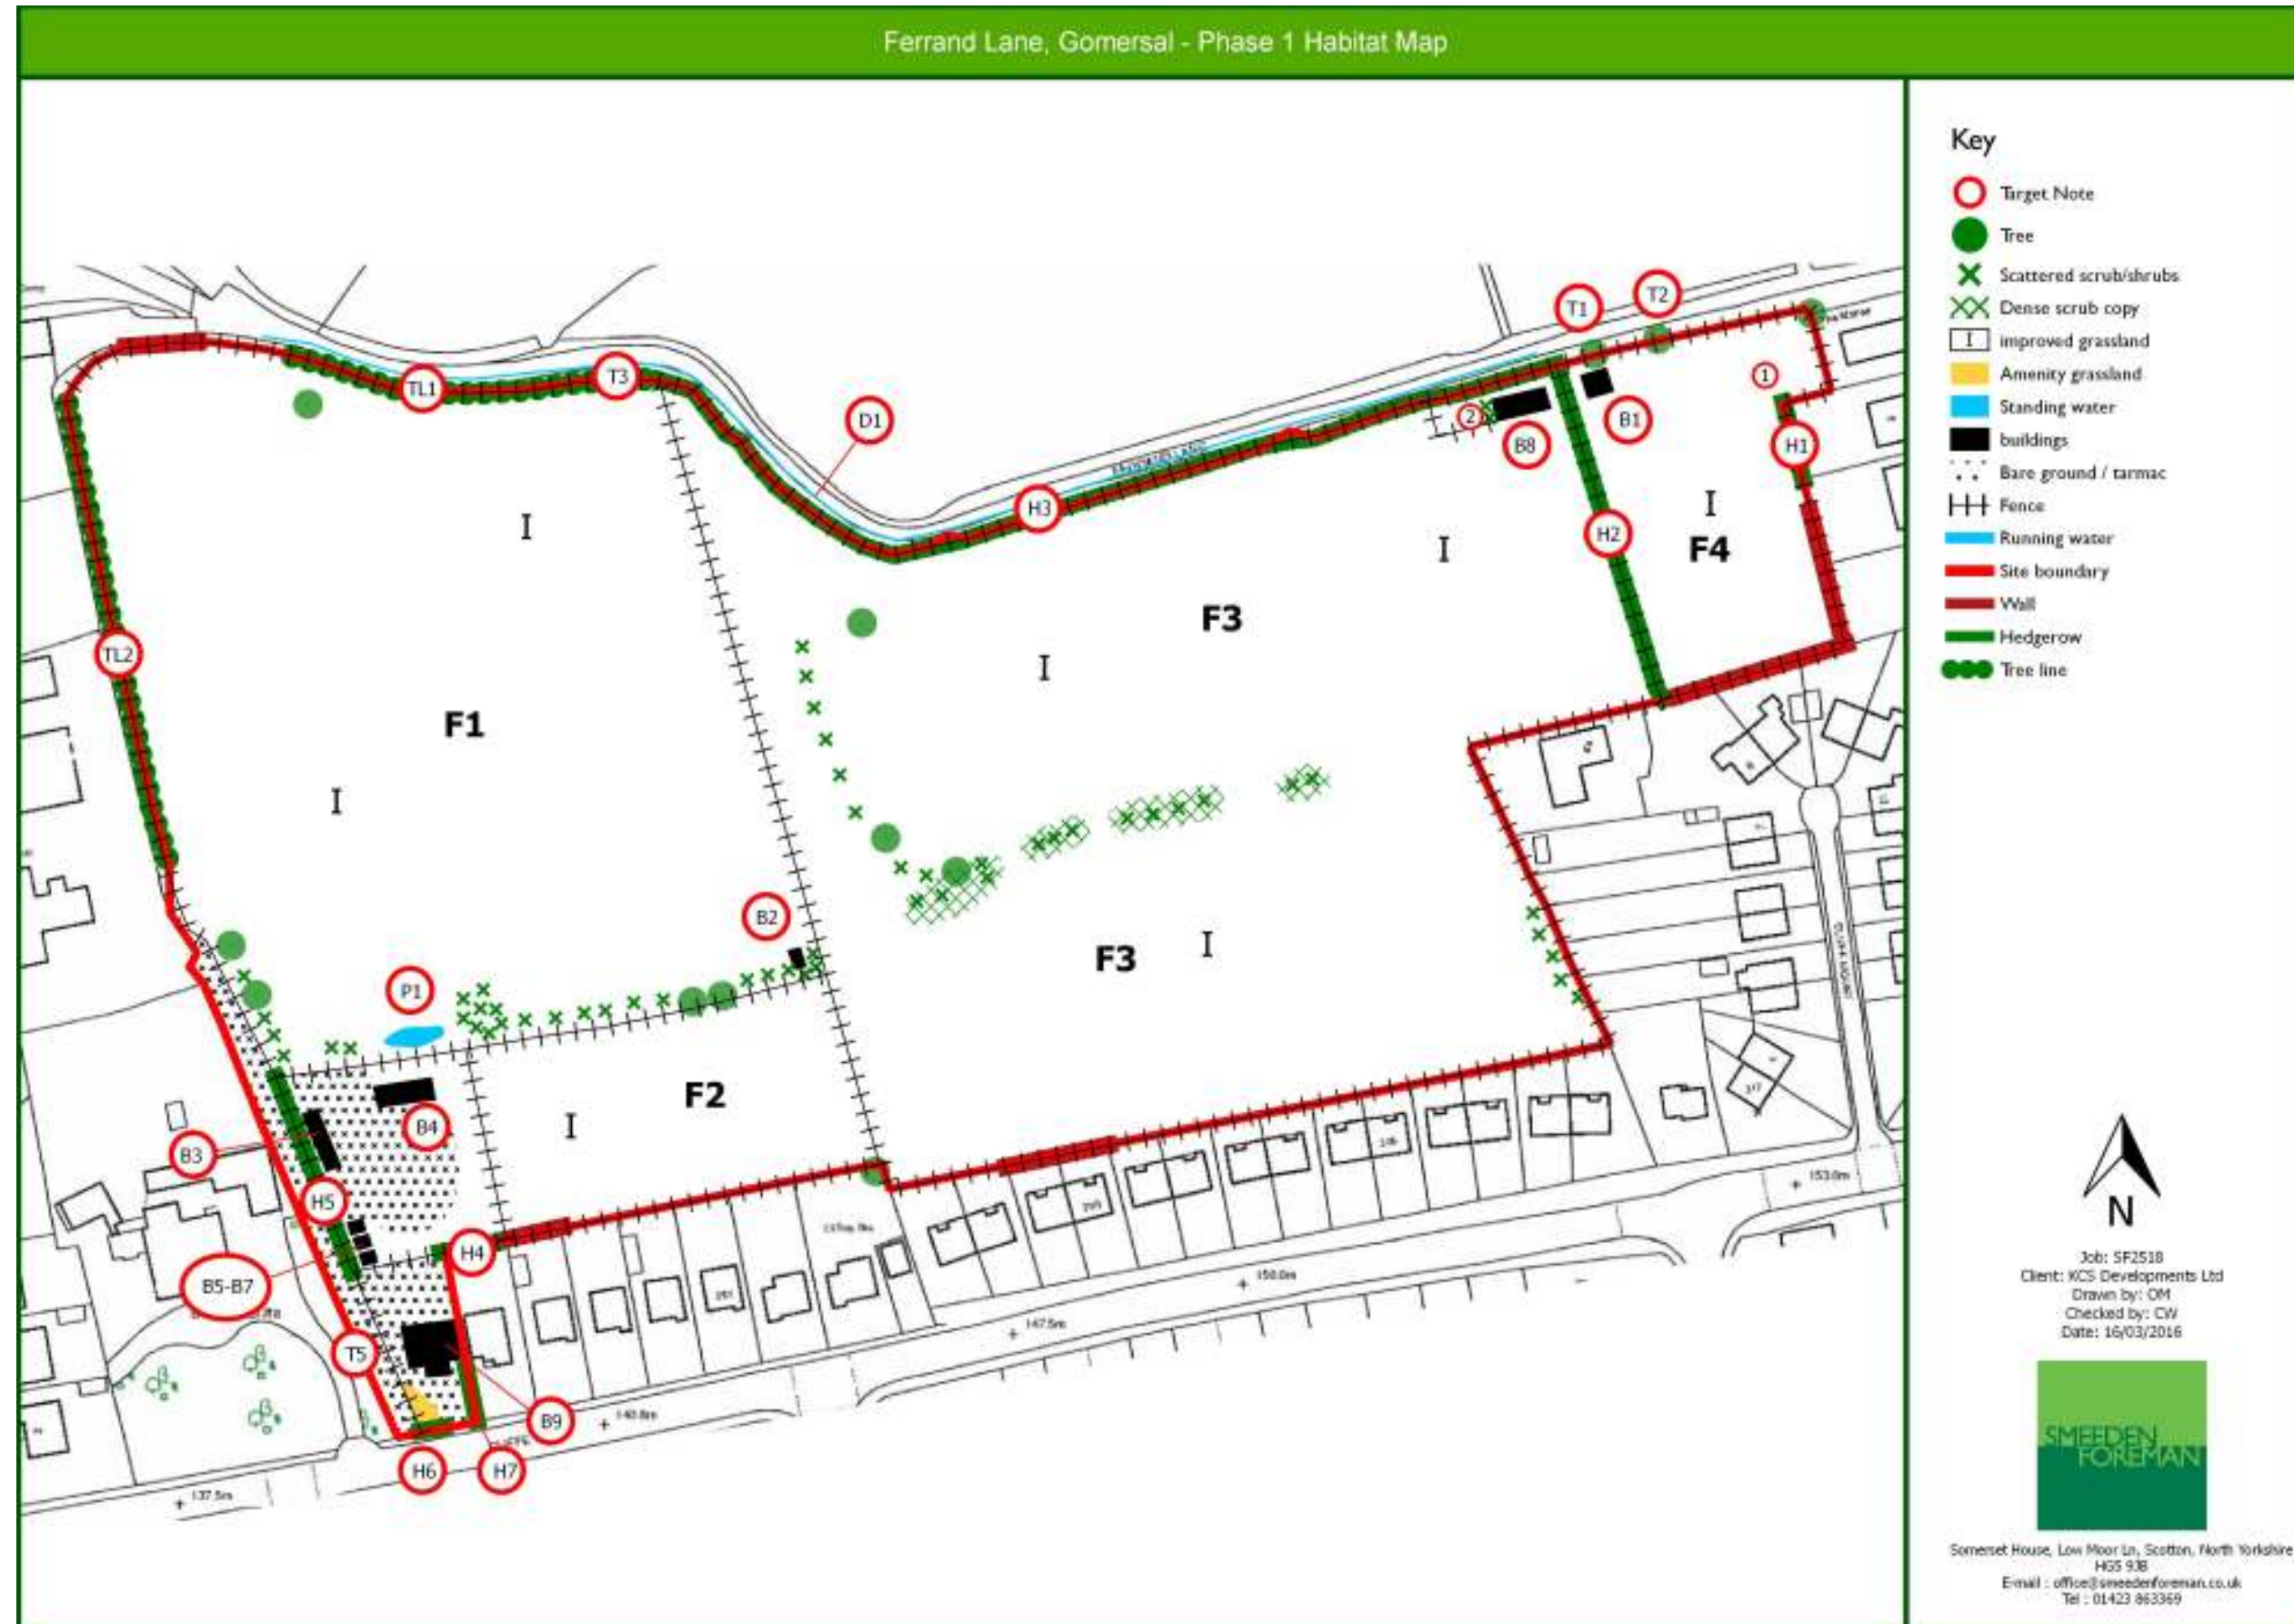
Figure 03: Phase I Habitat Map

A phase I habitat survey was undertaken on the 10/03/2016. Habitat types and key species were noted and are presented in the Phase I Habitat format based on the Joint Nature Conservation Committee methodology, 2010 (see *Figure 03: Phase I Habitat Survey* appended).

The survey at the site found it to be composed of improved pasture, hedgerows, trees, shrubs, nine buildings/structures and a pond, refer to *Figure 03* appended and *Section 3.4.8* for photographs.

During the walkover survey five trees (T1 to T5) were considered to have bat potential, refer to *Figure 03* appended for locations, and *Table 04* below for details.

There are nine buildings/structures present within the site (B1 to B9), refer to *Figure 03* appended for locations. An initial assessment of the buildings for evidence of, or potential to support, roosting bats or breeding birds was carried out during the walkover survey, refer to *Table 05* below for details.
