Land to the north and south of  
Leeds Road, Mirfield  
Landscape Character  
Assessment

Site ID: E1832

**KIRKLEES COUNCIL  
LANDSCAPE ARCHITECTS**

**SUMMER 2015**

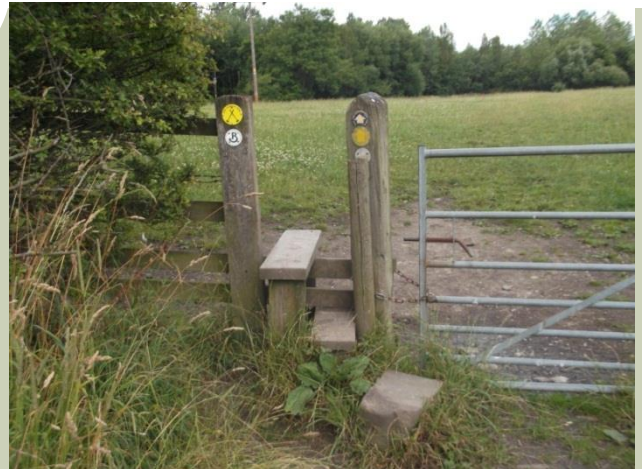
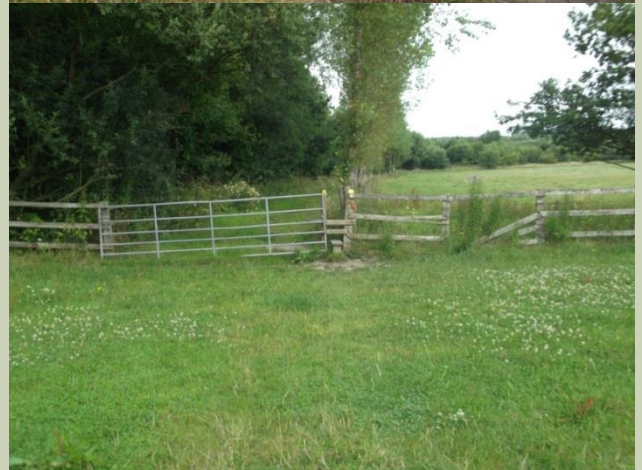
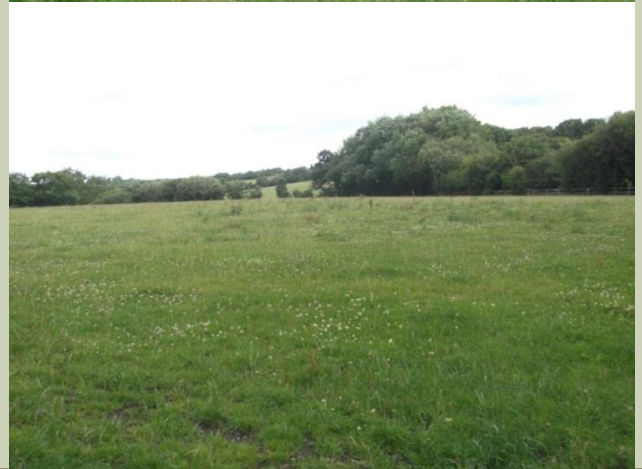
Typical images of landscape type 1

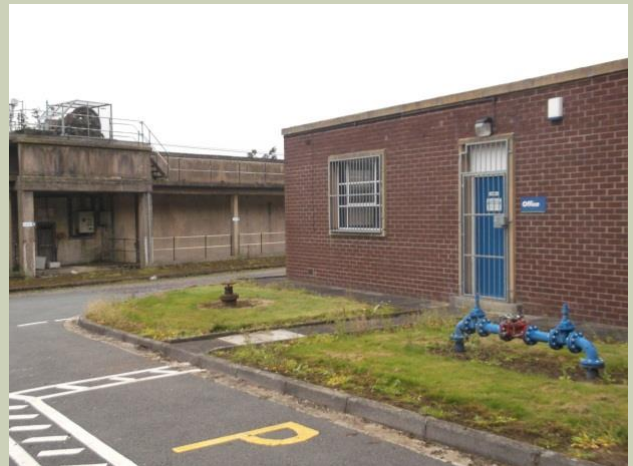
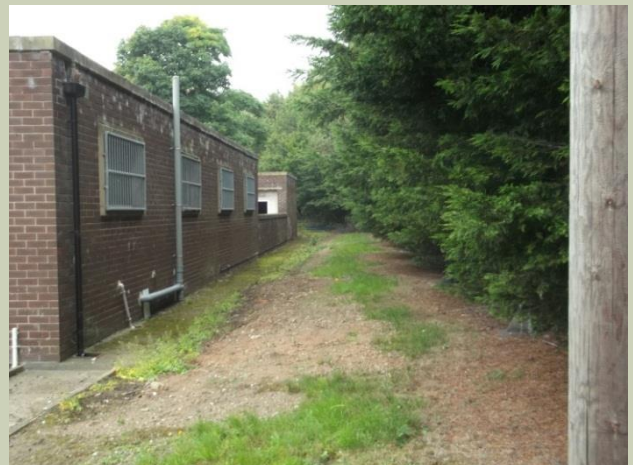
- **Landscape condition**

- The area is dominated by structures / works relating to the former water treatment plant. Within the site there are small pockets of grass and naturalised planting.
- The landscape condition is poor.

This local landscape character area is of weak landscape character and in poor condition. There is a case for development which could link more closely with the surrounding character of the area, drawing on the quality of the landscape and any such development should be sympathetic to this.

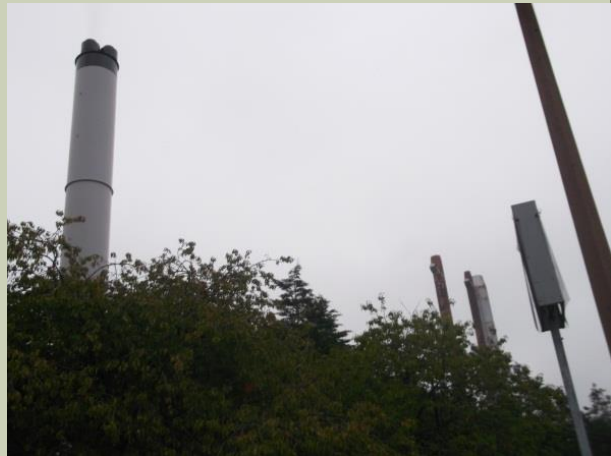
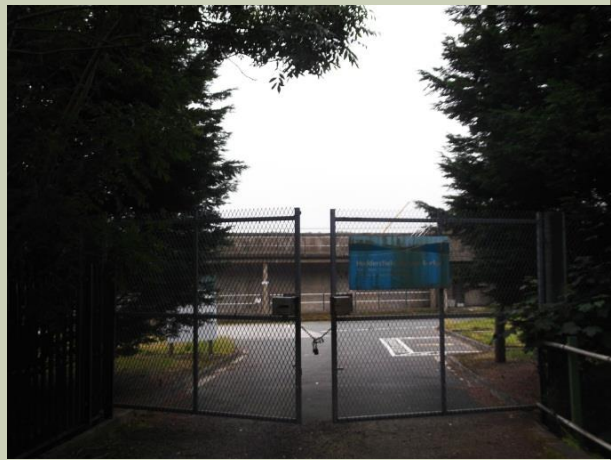
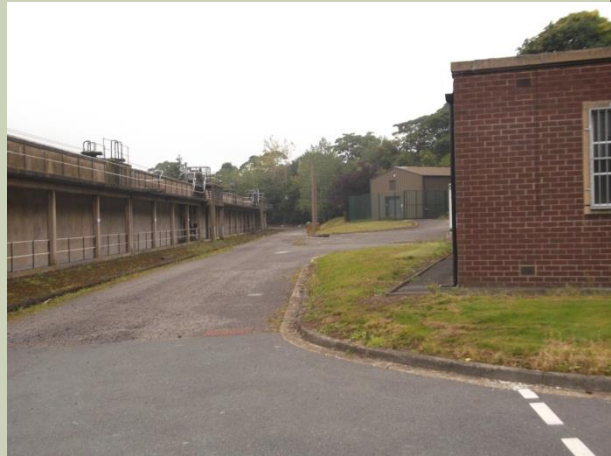
Typical images of landscape type 2
