ARBORICULTURAL ASSESSMENT REPORT

For:	**Client:**	Oriel Services Limited
	Insurer:	[redacted]
Site:	**Policyholder:**	[redacted]
	Risk Address:	1 Priestley Grove, Huddersfield, West Yorkshire, HD4 7RG
Refs:	**PRI Ref:**	115825
	Client Ref:	6917405
	Insurer Ref:	[redacted]

Property Risk Inspection
LIMITED

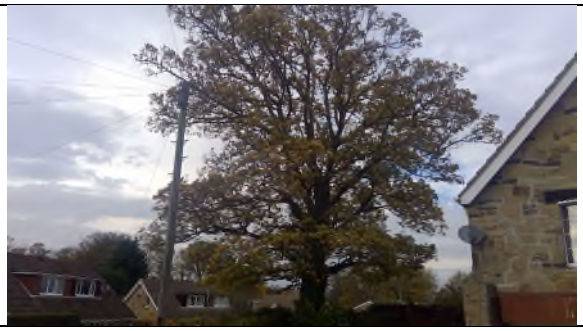
T1 - Maple	H1 - Cypress (Leyland)

Tree No	Common Name	Age Class	Condition	Height (m)	Crown Spread (m)	Stem diam. (mm)	Dist to bldg. (m)	Roots Implicated	Pruning history	Recommendation	Tree work constraints	Notes	Owner address	Owner
T1	Maple	Mature	Fair	16	16	720	7	Y	No significant past tree works.	Fell and treat stump	No parking restrictions.		1 Priestley Grove, Huddersfield, West Yorkshire, HD4 7RG	PH
H1	Cypress (Leyland)	Semi-Mature	Fair	1.5	1.0	20	8	N	Managed hedge	No work required	No parking restrictions.		1 Priestley Grove, Huddersfield, West Yorkshire HD4 7RG	PH

Tree No:	Species	Works Required
T1	Maple	Fell and treat stump
