5. BRICK STREET

Brick Street - Photographs

6. QUARRY ROAD

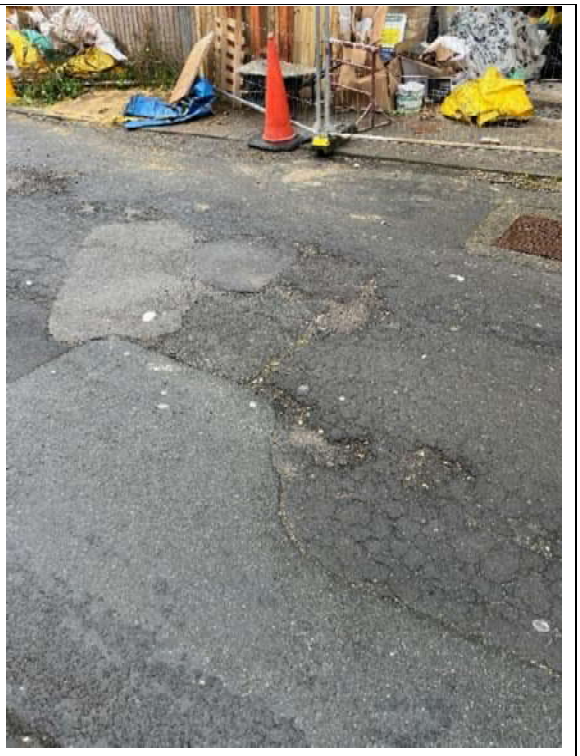
Photo 9 – Footway and carriageway severely fatigued along kerb line and visible trench scars in footway and carriageway.	Photo 10 – Carriageway has deteriorated severely

Photo 11 – Carriageway surfacing is fatigued and visible trench scars	Photo 12 – Ramp has been installed for access

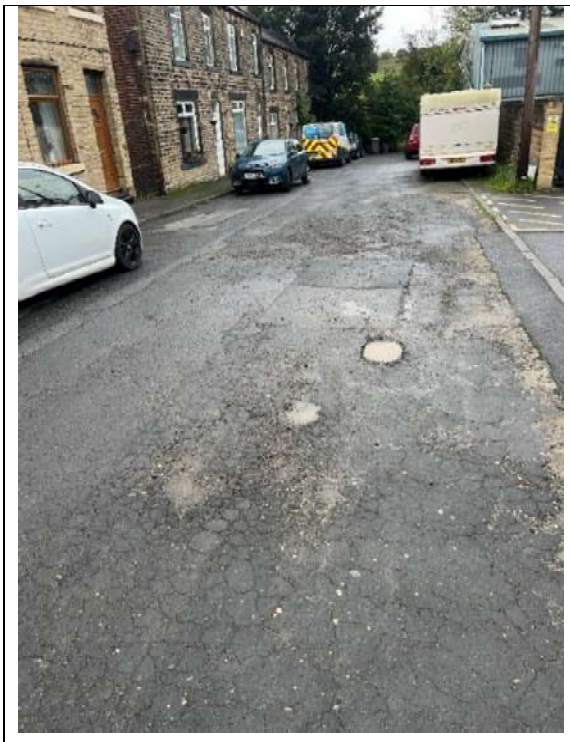
Photo 13 – Deterioration of carriageway, causing pot holes, pooling of water.	Photo 14 – Gully blocked

Photo 15 – Deposits around gully and cover. Gulley is not blocked. Kerbing is cracked and damaged. Carriageway surface is fatigued.	Photo 16 – Kerbing is out of place

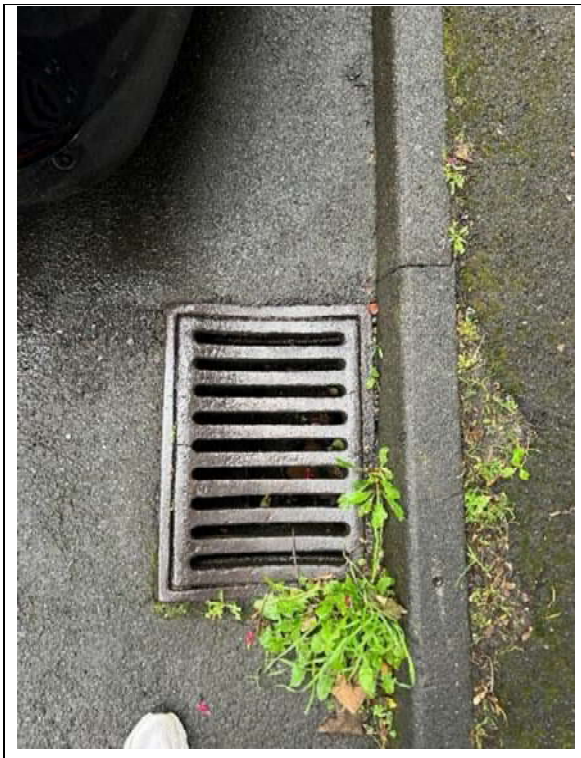
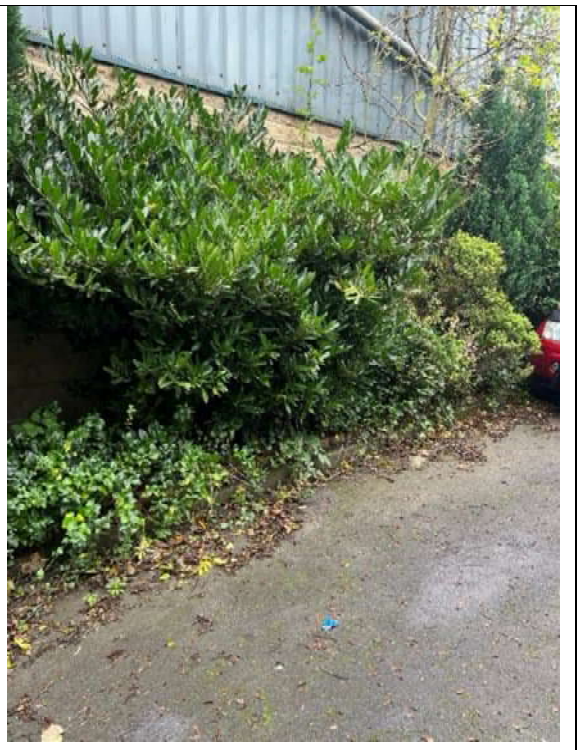
Photo 17 – Gulley at bottom of Taylor Street clear	Photo 18 – Overgrown vegetation

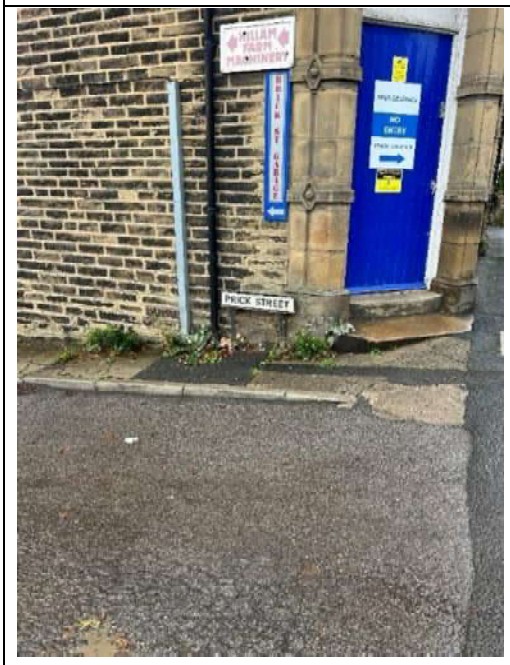
Photo 1 – Street name plate damaged, vegetation overgrown, footway surface cracked, visible trench lines and change in surfacing.	Photo 2 – Footway severely fatigued, visible trench lines

Photo 3 – kerbing not level and cracked, surfacing is fatigued and is pooling of water at far end of junction with Westgate

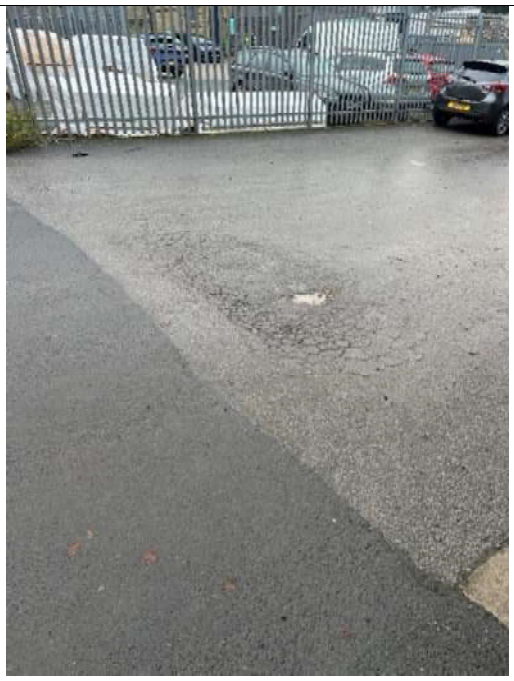
Photo 4 – Fatigued surface with water pooling in centre

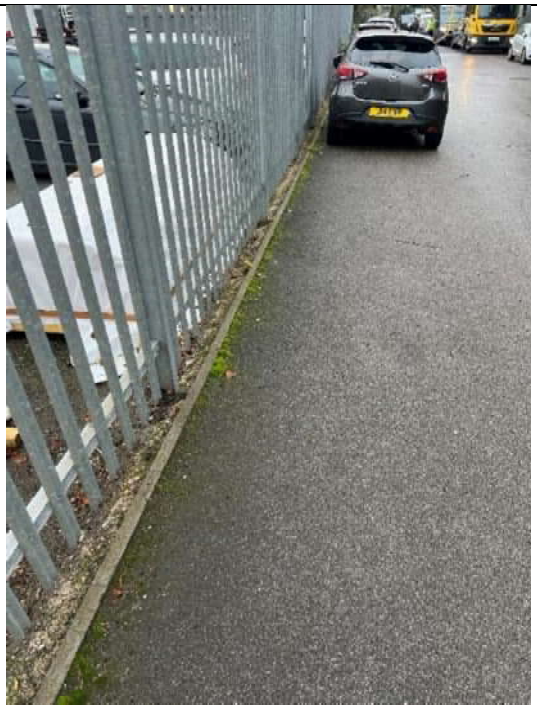
Photo 5 – Public footpath sign is not correctly upright.	Photo 6 – General wear of edging

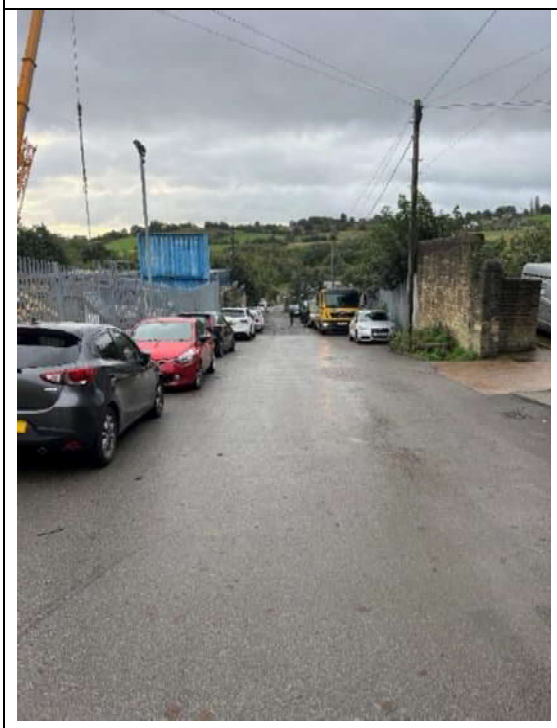
Photo 7 – General wear of carraigeway	Photo 8 – Gully is clear

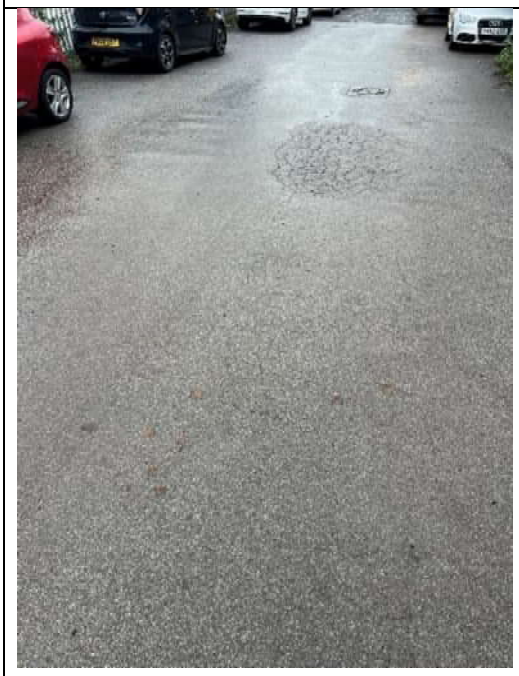
Photo 9 – Fatiguing of surface of carriageway	Photo 10 – General wear of cover

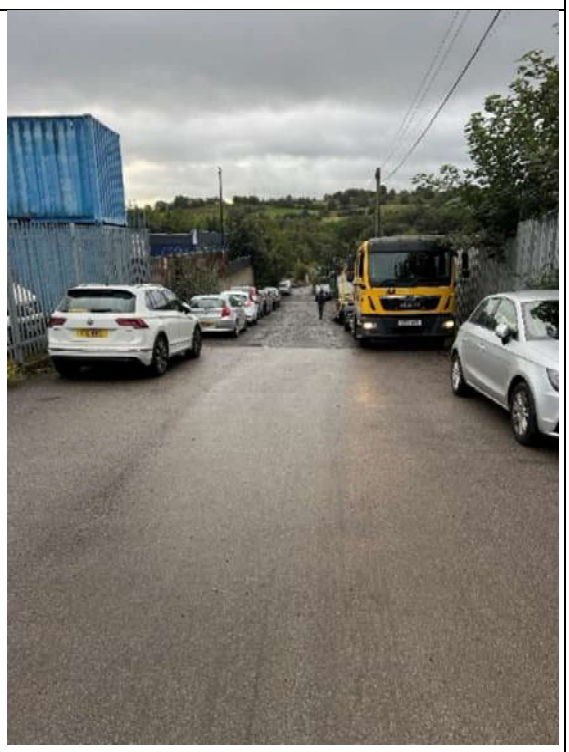
Photo 11 – Overgrown vegetation	Photo 12 – General wear of carriageway , clear surfacing change.

Photo 13 – Severely deteriorated surfacing, pitting and pooling of water.

Photo 14 – Severely deteriorated surface, pooling of water in some areas.

Photo 15 – Brick under surface exposed

Photo 16 – Pooling of water in pot hole on surface, Severely deteriorated surface.

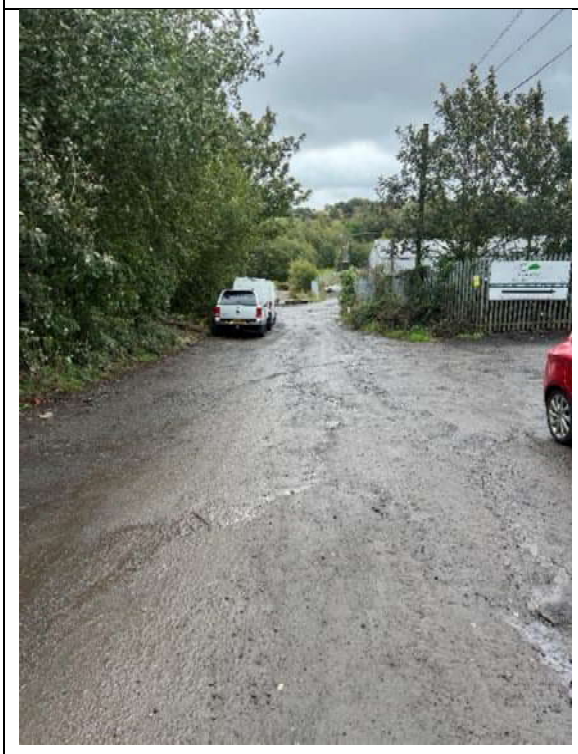
Photo 17 – Severely deteriorated carriageway surfacing	Photo 18 – Severely deteriorated carriageway surfacing

Photo 19 – Severe pot holes at bottom of street, with pooling of water.	 Photo 20 – Severe pot holes at bottom of street, with pooling of water.

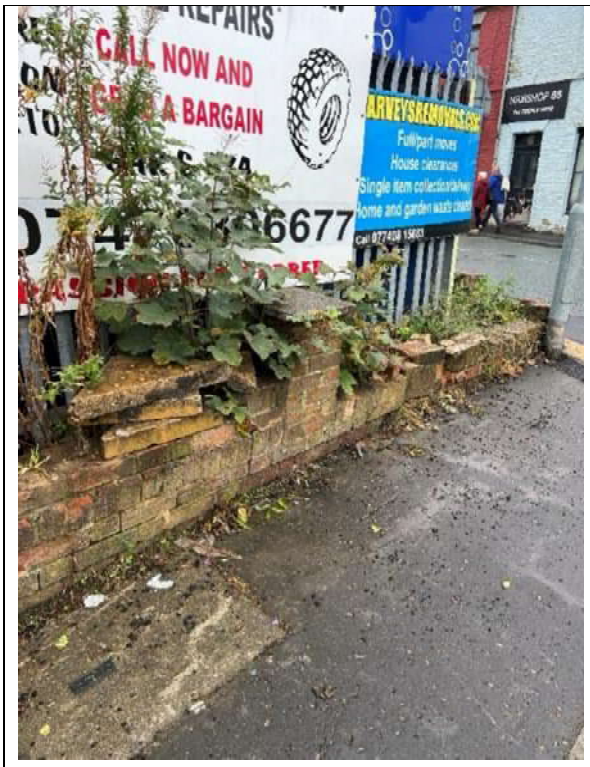
Photo 5 – Damaged brick work, overgrown vegetation	Photo 6 – Debris deposits on footway, scars on footway surfacing. Cover is in an acceptable condition. Kerbing is in acceptable condition.

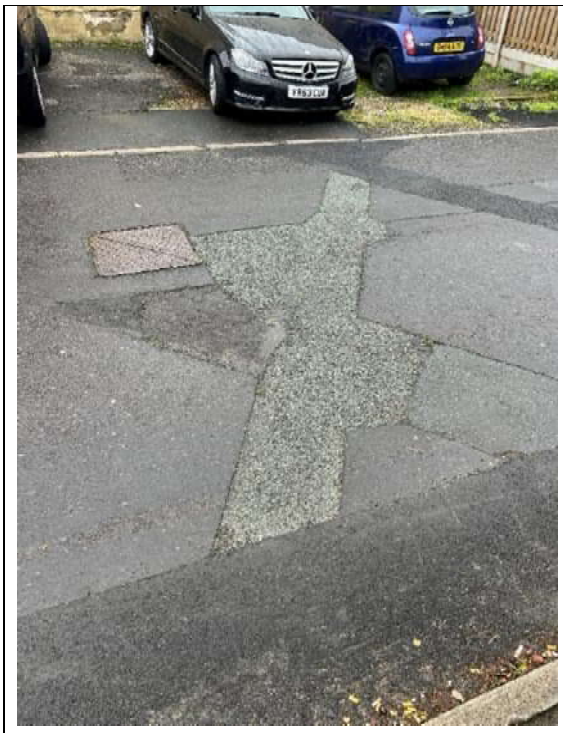
Photo 7 – Trench scars on carriageway surfacing. Iron works in acceptable condition. Debris deposits on kerbside. Kerbing on opposite side of road damaged and out of place.

Photo 8 – Trench scars on surfacing full length of carriageway. General wear of carriageway.

Photo 9 - Severely deteriorated footway surfacing, overgrown vegetation.

Photo 10 – Severely deteriorated footway surfacing, overgrown vegetation.

Photo 11 – Trench scars for length of carriageway, overgrown vegetation on edges of footway and carriageway. Leave deposits on both sides of carriageway.

Photo 12 – Lighting column is slanted

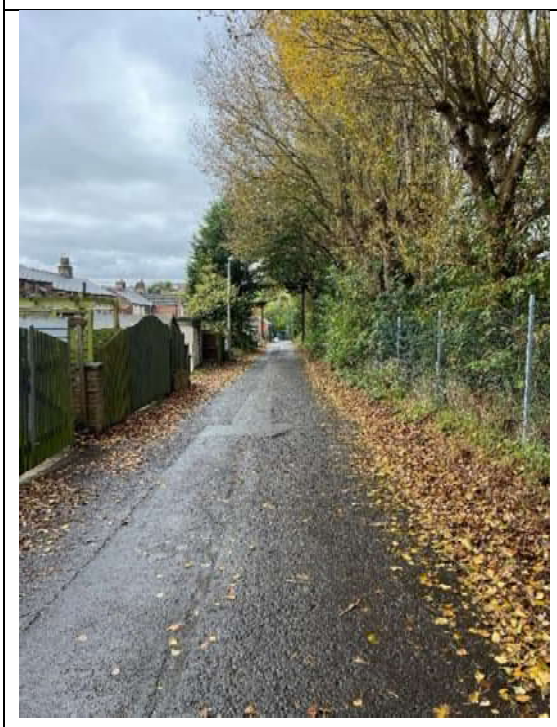
Photo 13 – Trench scars and deterioration of carriageway surfacing, leaf deposits on either side of carriageway.

Photo 14 – Trench scars and deterioration of carriageway surfacing, leaf deposits on either side of carriageway.

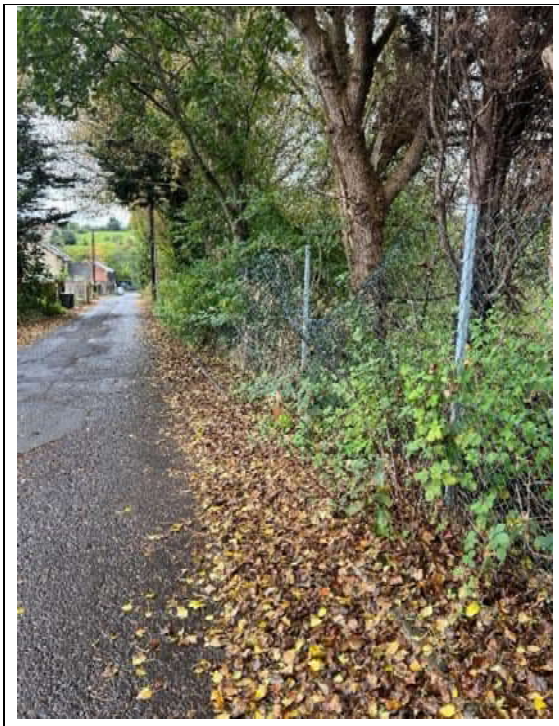
Photo 15 – Damaged fence coming on to highway.	Photo 16 – Lighting column in acceptable condition
