KIRKLEES CULTURAL HEART
HERITAGE STATEMENT: VOLUME 4
LIBRARY AND ART GALLERY: ASSESSMENT OF SIGNIFICANCE

CDT430201-FCB-XX-XX-RP-A-000004
VERSION: V2 | MARCH 2022

FEILDEN CLEGG BRADLEY STUDIOS

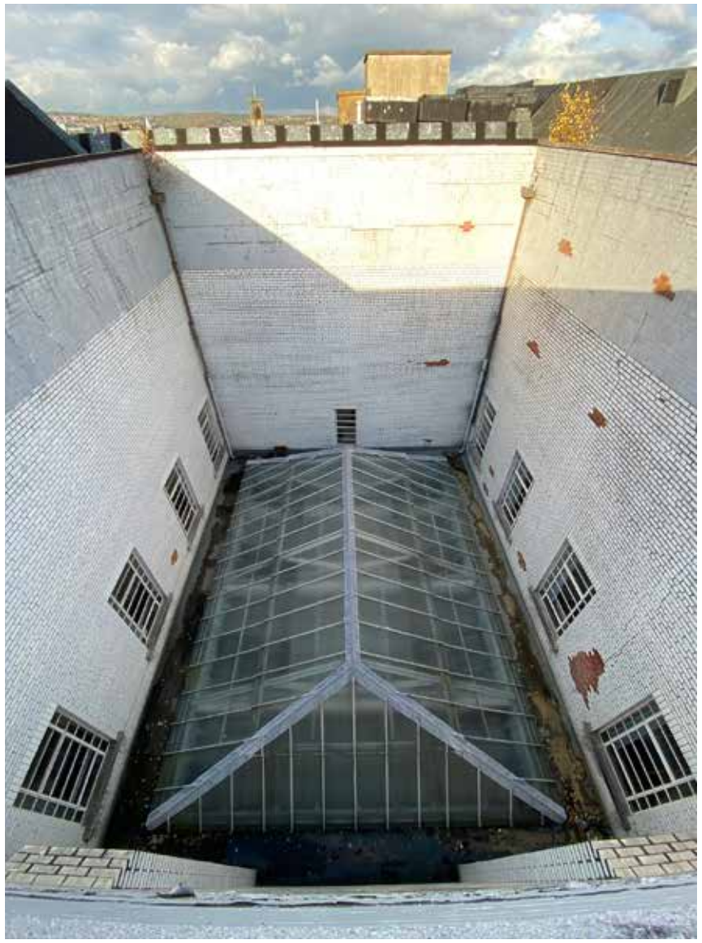
The upper roof discharges rainwater into the lightwell, which is reported to regularly flood and requires weekly maintenance to avoid excessive damage.

4.4.19 - Lightwell above atrium

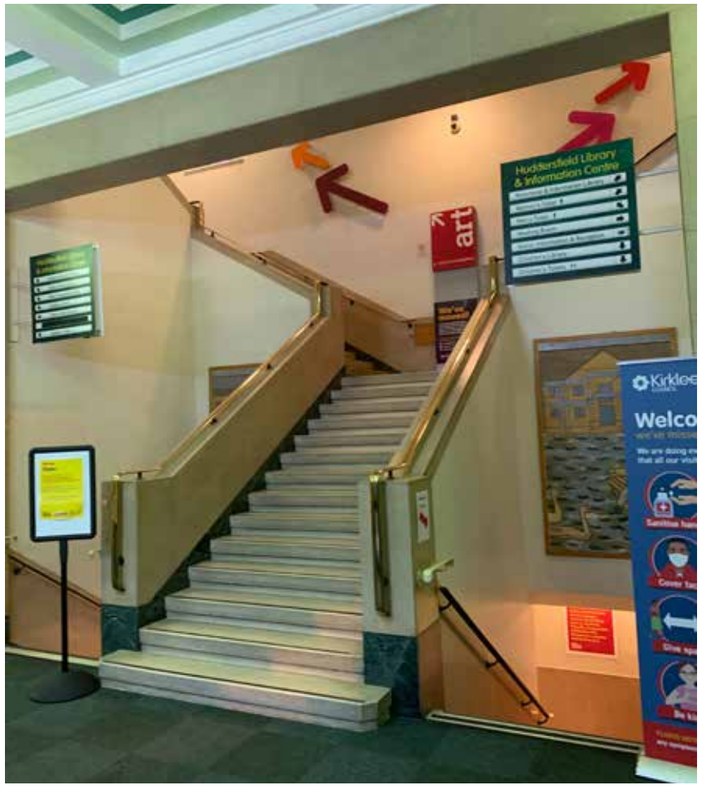
4.5.1 - Entrance Lobby / Reception (Rm.52)

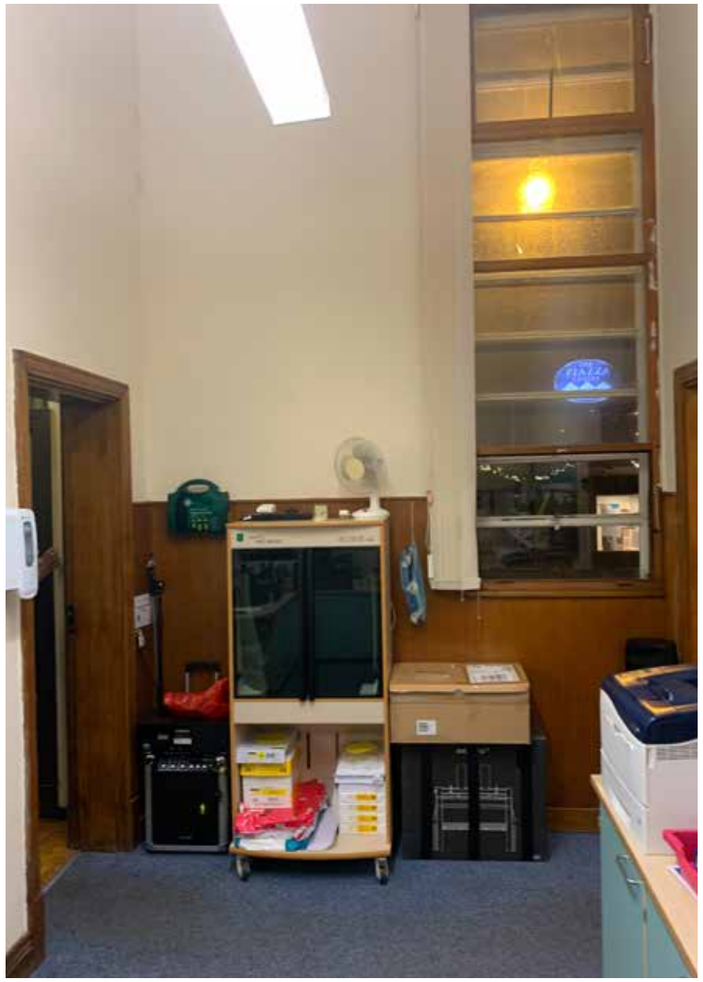
4.5.19 - Transcription Service (Rm.49)

4.5.20 - New partition in Transcription Service (Rm.49)

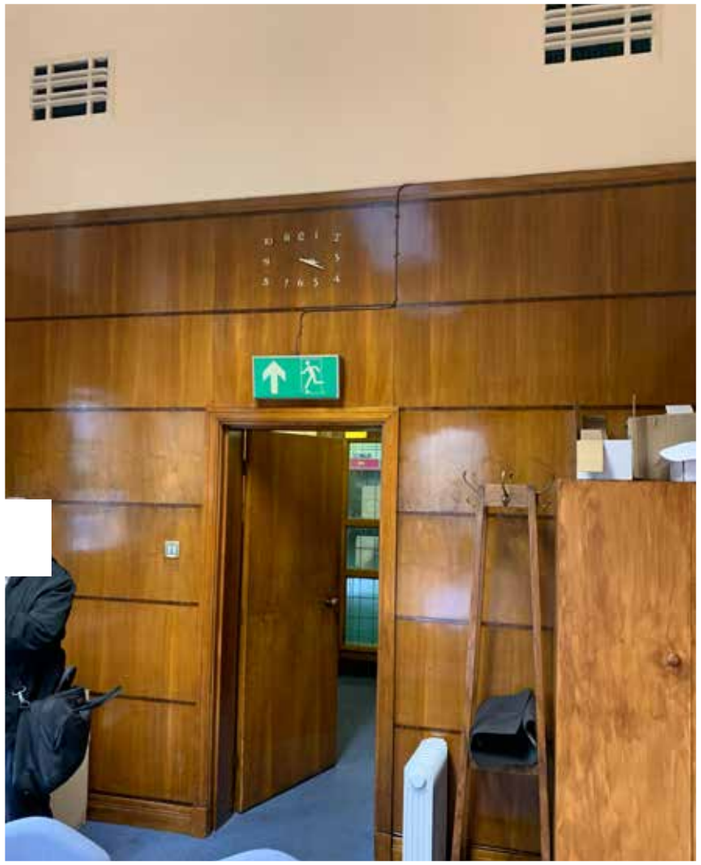
4.5.22 - Committee Room (Rm.57)

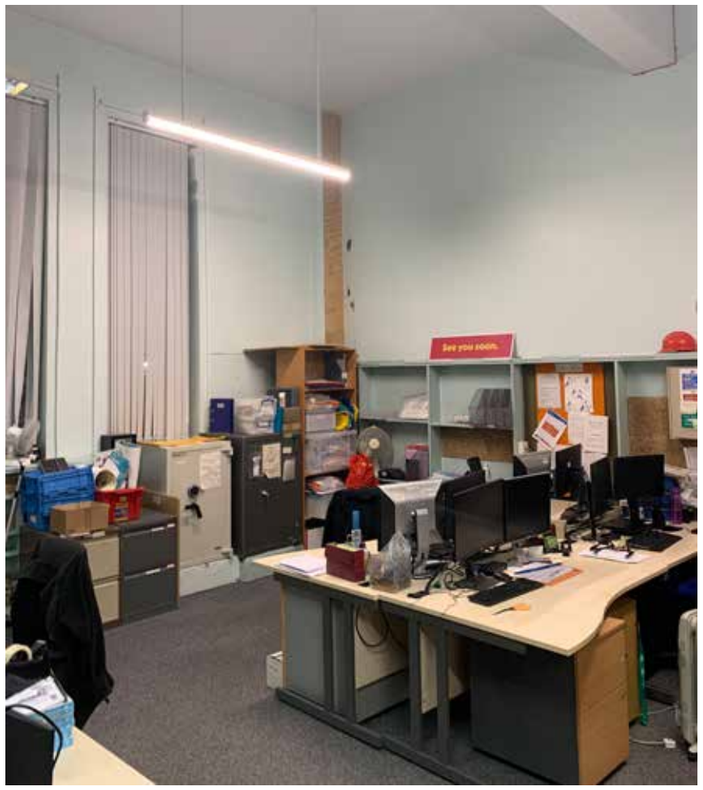
4.5.27 - Administration Office (Rm.39)

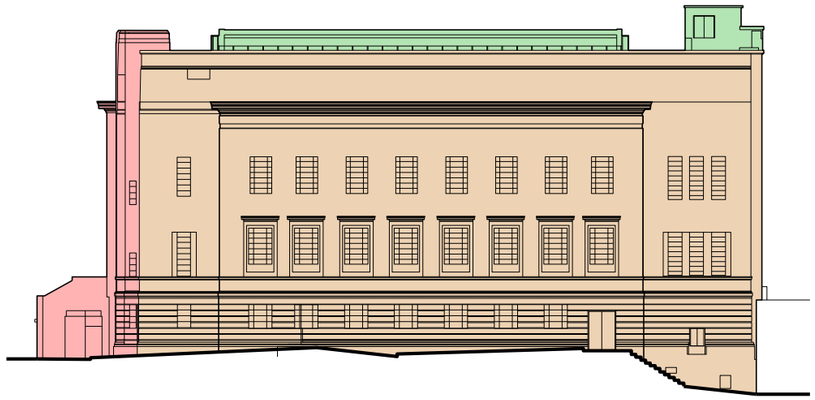
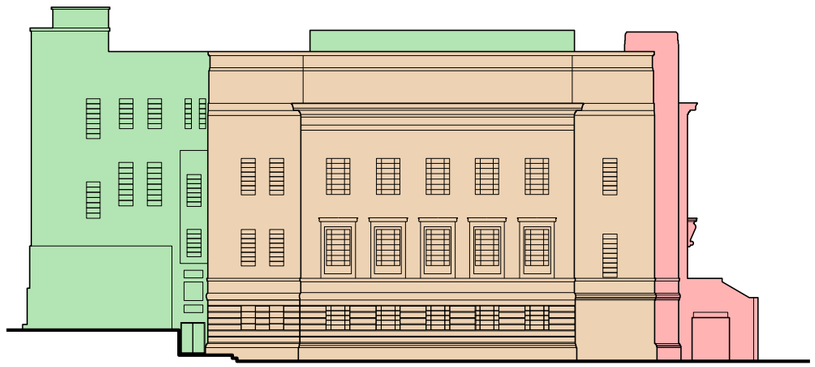
4.9.1 - Heritage significance: Elevations
