Road Safety Audit Stage 1

September 2025

Crossley Lane, Dalton, Kirklees – Road Safety Audit Stage 1

2025-09 Dalton RSA1 – Revision 0

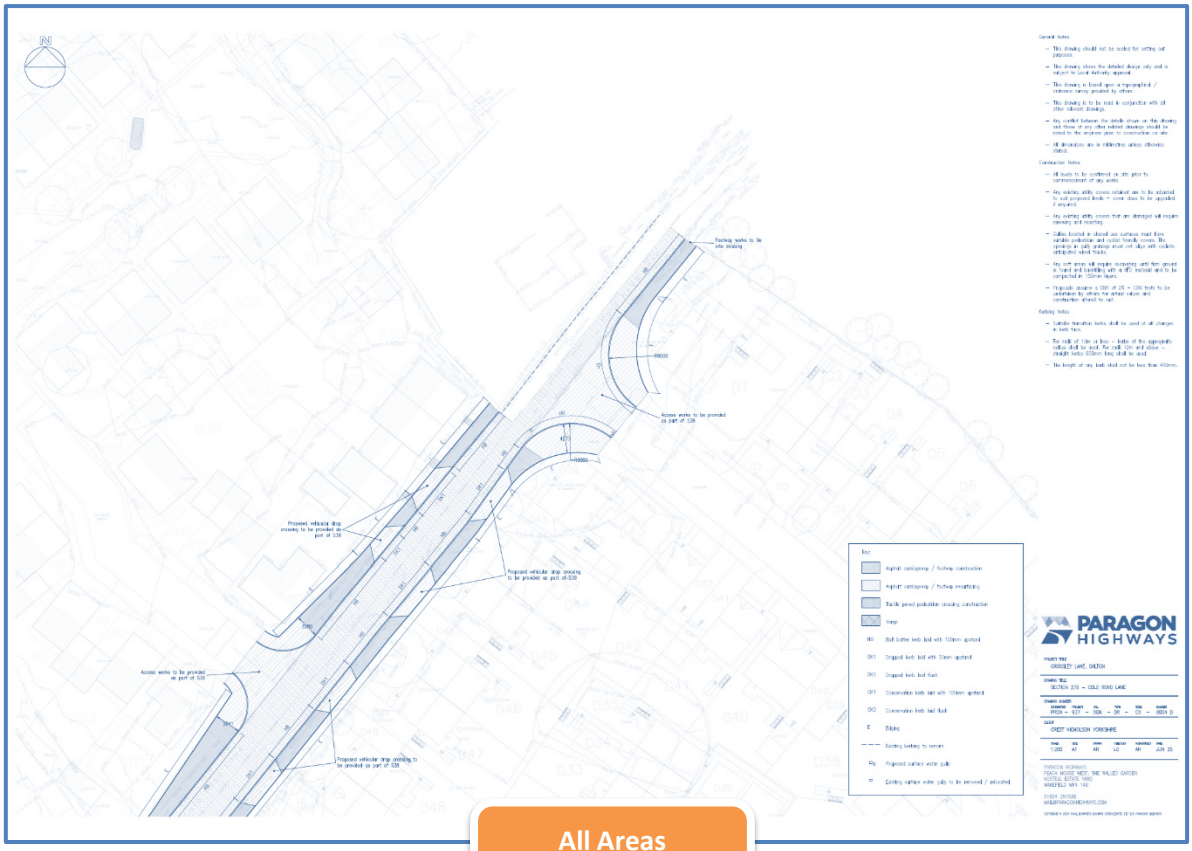
Problem Location Plan

Summary: Drainage – Ineffective drainage of surface water may increase the risk of skidding or loss of control type collisions.

At this early stage, drainage details may not have been considered. It was noted that the development will be generally level but will have a number of features that may trap surface water such as dropped crossings and new junctions. This may increase the risk of standing surface water on the carriageway and in crossing points with detritus buildup in these areas. This may consequently cause skidding type collisions or slips and falls by pedestrians using these areas which can be life changing, especially for older pedestrians.

Summary: Network Management – Increased on-street parking may increase the risk of collisions involving pedestrians and other active mode users or junction related collisions.

The proposals introduce a pedestrian refuge and crossing points on an established residential frontage as well as a second pedestrian refuge and new junctions on what will become a new residential frontage. On-street parking along these roads is likely to increase and may, in some locations, obscure the crossing or junction visibility. This may increase the risk of collisions involving pedestrians and other active mode users or junction related collisions.

Summary: Specific Road Users – Lack of crossing facility may increase the risk of collisions involving users who rely on mobility aids.

There is a desire line along the northern footway of Crossley Lane where no provision has been made for pedestrians with mobility issues, specifically those users with prams, wheelchairs or mobility scooters. The alternatives for these users may require them to use drop kerbs provided for driveways or to cross at locations where visibility to approaching vehicles may be otherwise compromised. This lack of dropped crossings on desire lines may increase the risk of collisions involving users with mobility issues.

There is a desire line to cross Crossley Lane where no provision has been made for pedestrians with mobility issues, specifically those users with prams, wheelchairs or mobility scooters. The alternatives for these users may require them to use drop kerbs provided for driveways or to cross at locations where visibility to approaching vehicles may be otherwise compromised. This lack of dropped crossings on desire lines may increase the risk of collisions involving users with mobility issues.

Summary: Cycles – Width provision for cycles may increase the risk of shunt or side swipe type collisions involving this user group.

Details of kerb-to-kerb widths have been provided at the proposed refuges. At these locations, cyclists are at risk on the main carriageway from vehicles passing too close due to a potential ambiguity of width as they overtake the slower moving cyclist. Incompatible width provision for cyclists may increase the risk of shunt or side swipe type collisions involving this user group.

Summary: Lighting – Insufficient carriageway surface illumination may increase the risk of collisions involving pedestrians during the hours of darkness.

There is currently street lighting provision in the vicinity of the proposed pedestrian crossing points along Crossley Lane. This is likely to provide a standard level of carriageway illumination for a commercial frontage. The introduction of dropped crossings will focus pedestrians to cross at these locations where pedestrians and other active mode users may not have enough contrast against background light from the adjacent development and vehicle headlights. Insufficient carriageway surface illumination at the crossing points may increase the risk of collisions involving pedestrians and other active mode users during the hours of darkness.

It is recommended that all areas are provided with suitable surface water drainage measures to minimise the risk of standing water and detritus. It is also recommended that details of these are provided at the next stage of road safety audit including gully locations, levels and contours.

It is recommended that the scope for waiting restrictions near key junctions and pedestrian refuges is established and, where necessary, provided.

It is recommended that a dropped pedestrian crossing with (ideally) tactile paving is provided across Cold Royd Lane.

It is recommended that a dropped pedestrian crossing with (ideally) tactile paving is provided across Crossley Lane towards the eastern end of the development.

It is recommended, as per advice in LTN 1/20 Chapter 7, that widths between 3.1m and 3.9m may encourage close overtaking by motor vehicles at pinch points and should be avoided.

It is recommended that carriageway surface illumination is provided to a higher class/level in the vicinity of the proposed crossing points. This may be as simple as increasing the output from the existing LED luminaries.
