GEOINVESTIGATE LIMITED
Coal Mining Risk Assessment (CMRA)

LOCATION	The Croft, 150 Denby Lane, Upper Denby, Huddersfield, HD8 8UN
ISSUE DATE	27 November 2024
FOR	K & R Summers
CLIENT REF.	
OUR REF.	G24340

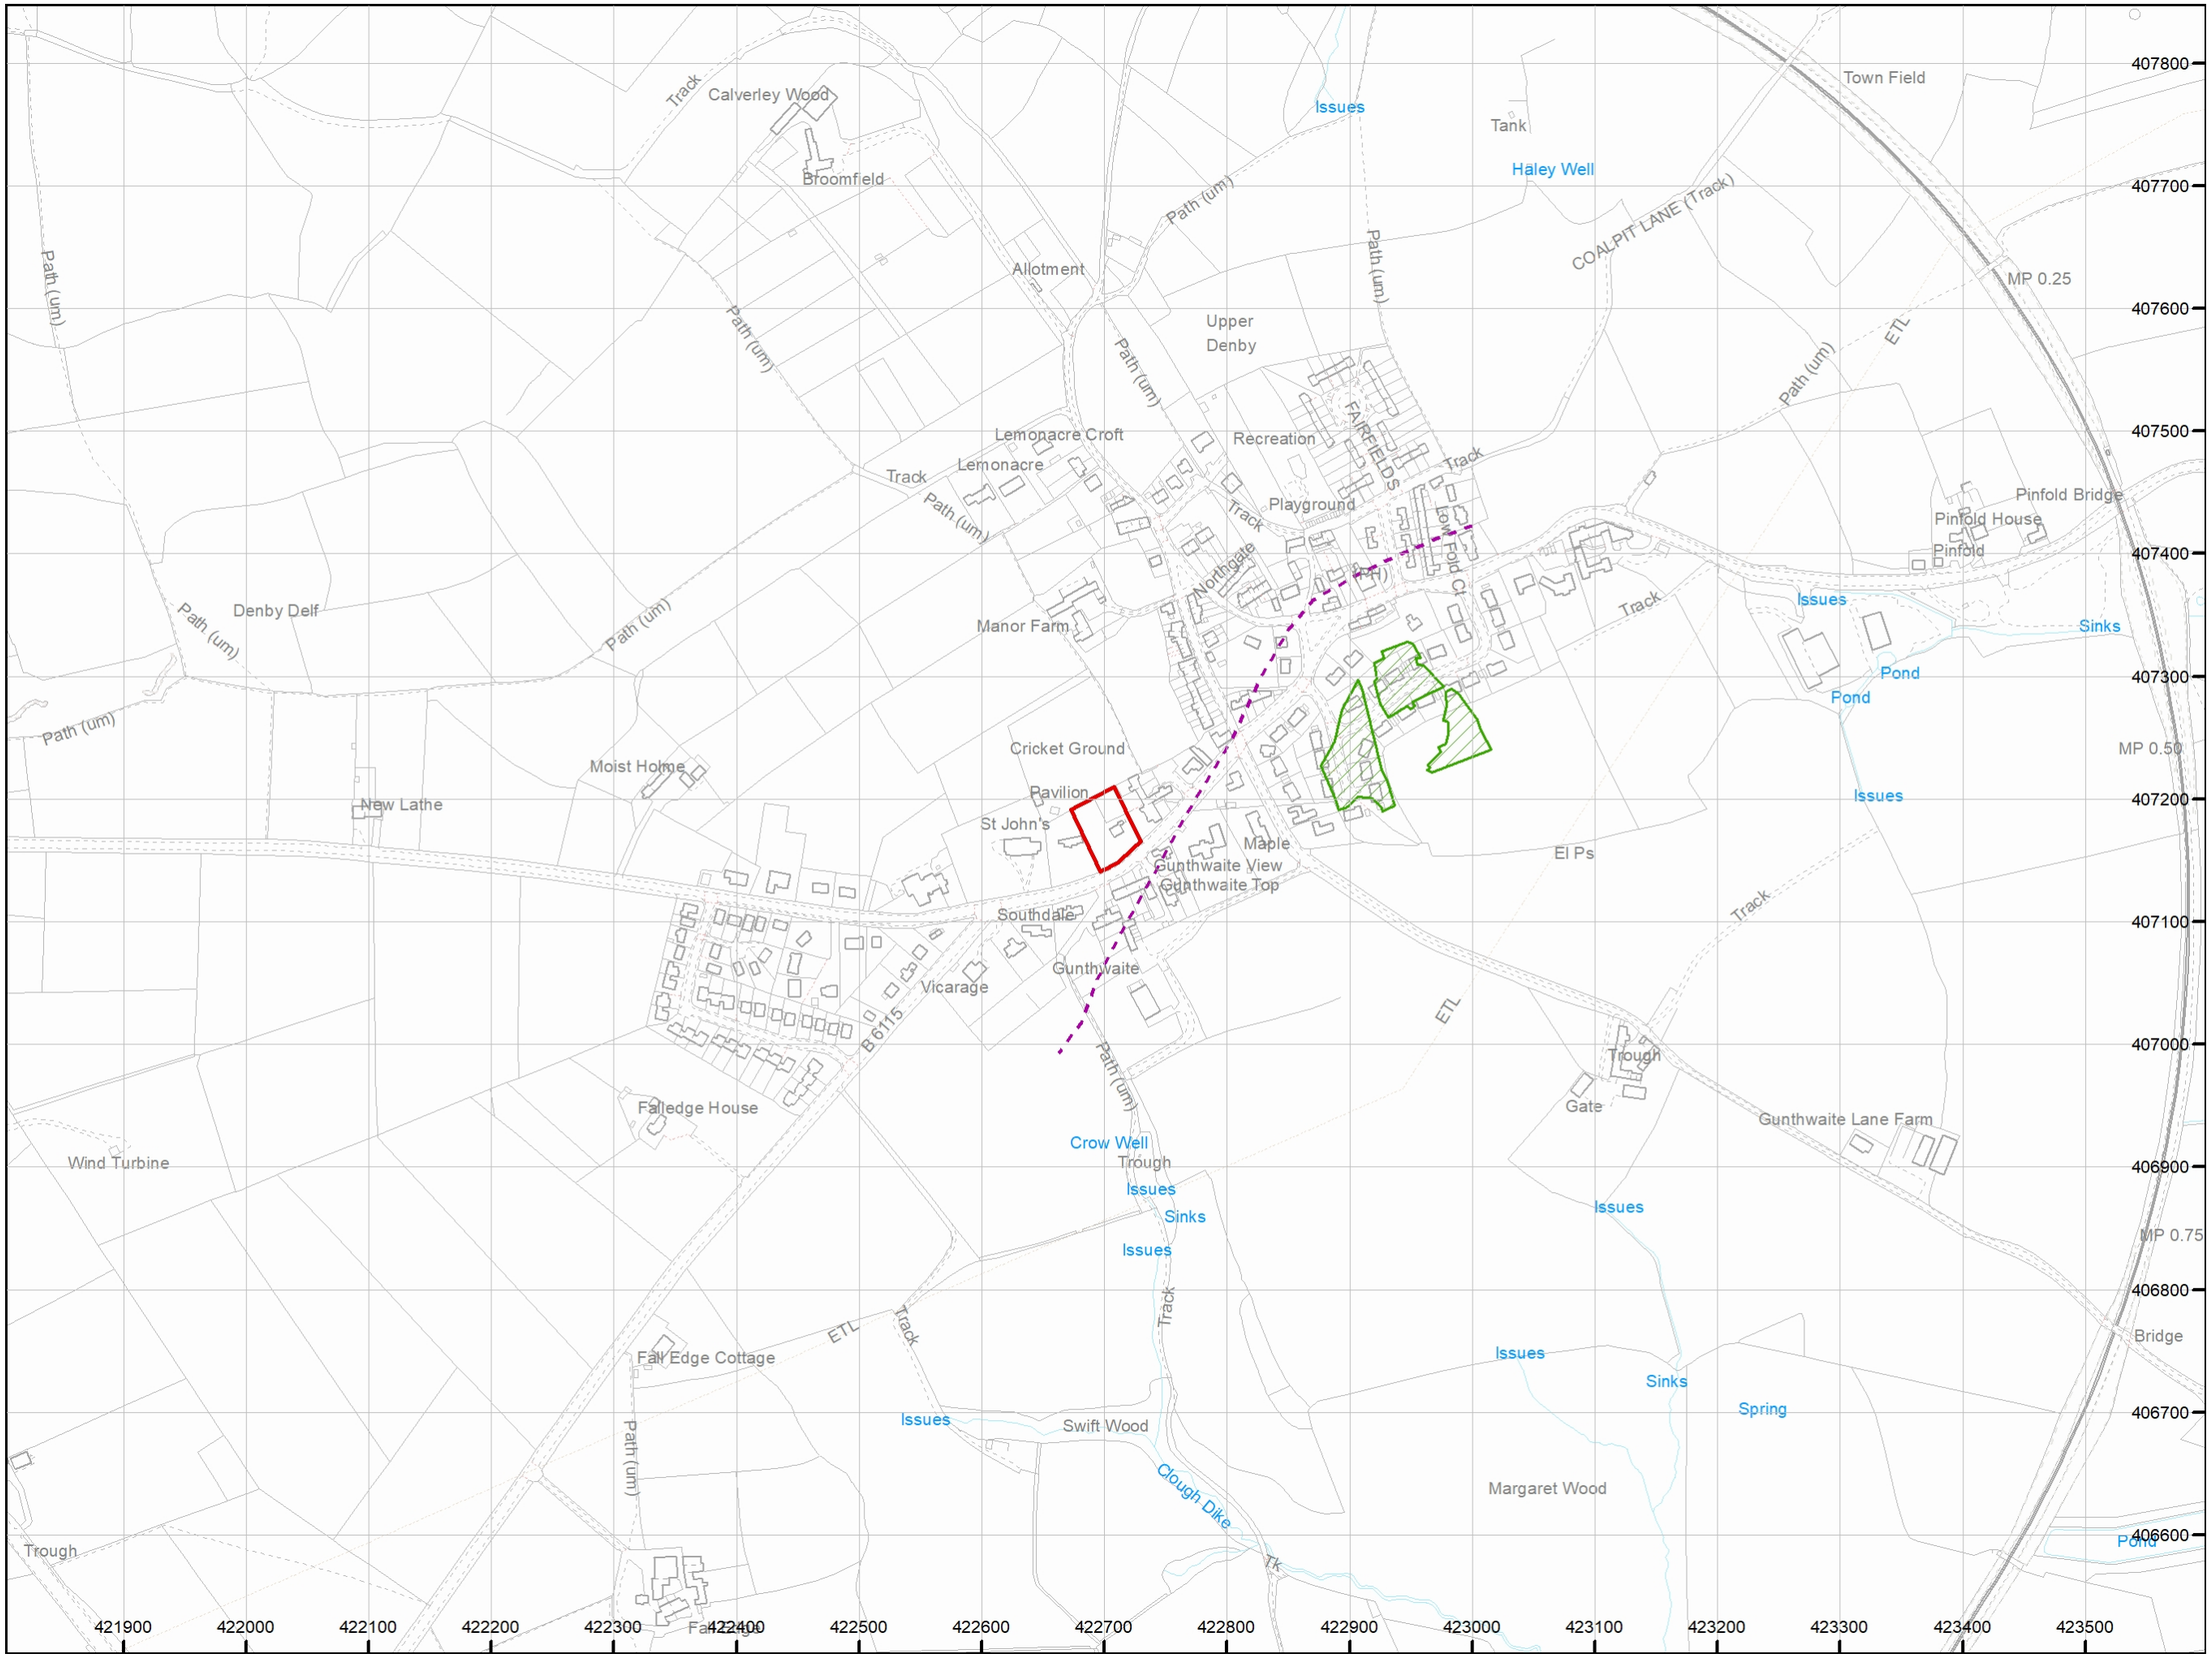
Summary of findings

The CA identify outcrop of the Low Whinmoor Coal 22m South-East of the development area. According to the CA this coal is workable.

Localised small scale opencast mining activity is present some 160m to the East and Northeast of the site.

In Geoinvestigate's opinion this surface working is too distant from the development area to impact surface ground stability though it and the presence of 4 mine adits at this at this locality raises further concern about the presence of shallow workable coal deposits in the vicinity of the proposed development.

Seam name	Mineral	Seam workable	Distance to outcrop (m)	Direction to outcrop	Bearing of outcrop
LOW WHINMOOR	Coal	Yes	22.3	South-East	208
