Heritage Note.

The Priory Pub, Whitechapel Road, Cleckheaton.

On behalf of Highstone Building Services.

Date: May 2025 | Pegasus Ref: P24-2888

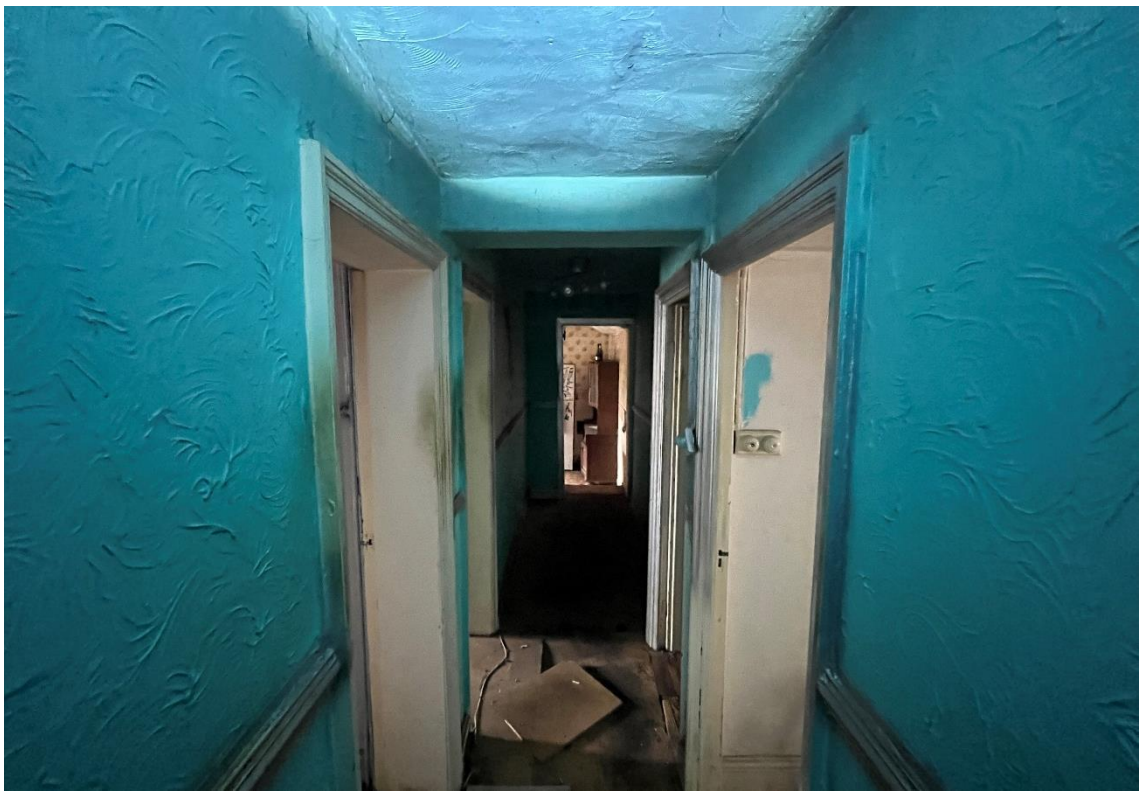
Plate 13: Central corridor of the historic core's first floor.

Plate 14: First floor bedroom with exposed beam.

Plate 15: First floor bedroom within the historic core, with buildout for earlier fireplace.

Plate 16: First floor bedroom of the historic core.

Plate 17: Timber floorboards within the first floor of the historic core.

Plate 18: The kitchen of the first floor eastern extension.

Plate 19: The timber beam within the living space of the eastern extension's first floor.

Plate 20: The function room of the western extension.

Plate 21: Ceiling structure of the function room of the western extension.

Plate 22: Side staircase within the northern extent of the western extension's function room.

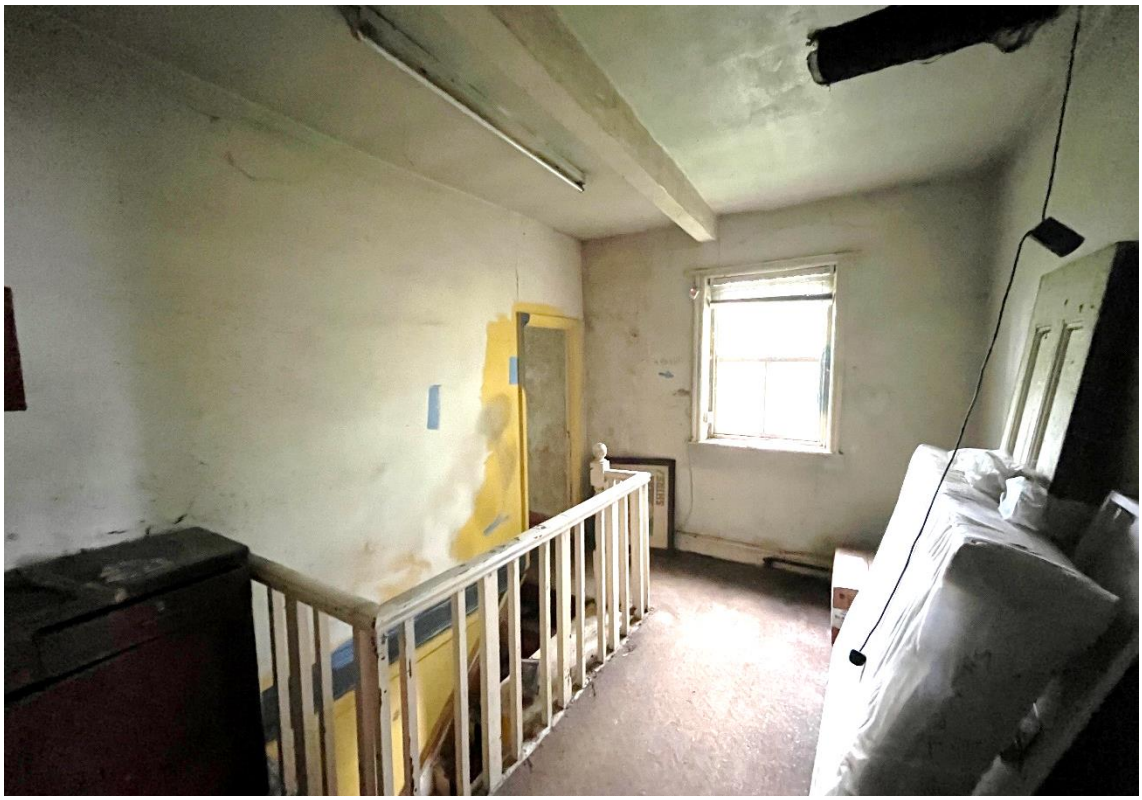
Plate 23: The first floor staircase corridor of the western extension.

Plate 24: Bathroom of the first floor western extension.

Plate 25: Bathroom of the first floor western extension.
