CLIENT
ORION HOMES

CONTRACT
BANKFIELD DRIVE
HOLMBRIDGE
HD9 2QP

TITLE
RETAINING WALL DILAPIDATION SURVEY

JOB No	DRG No	REV
21043	137	B

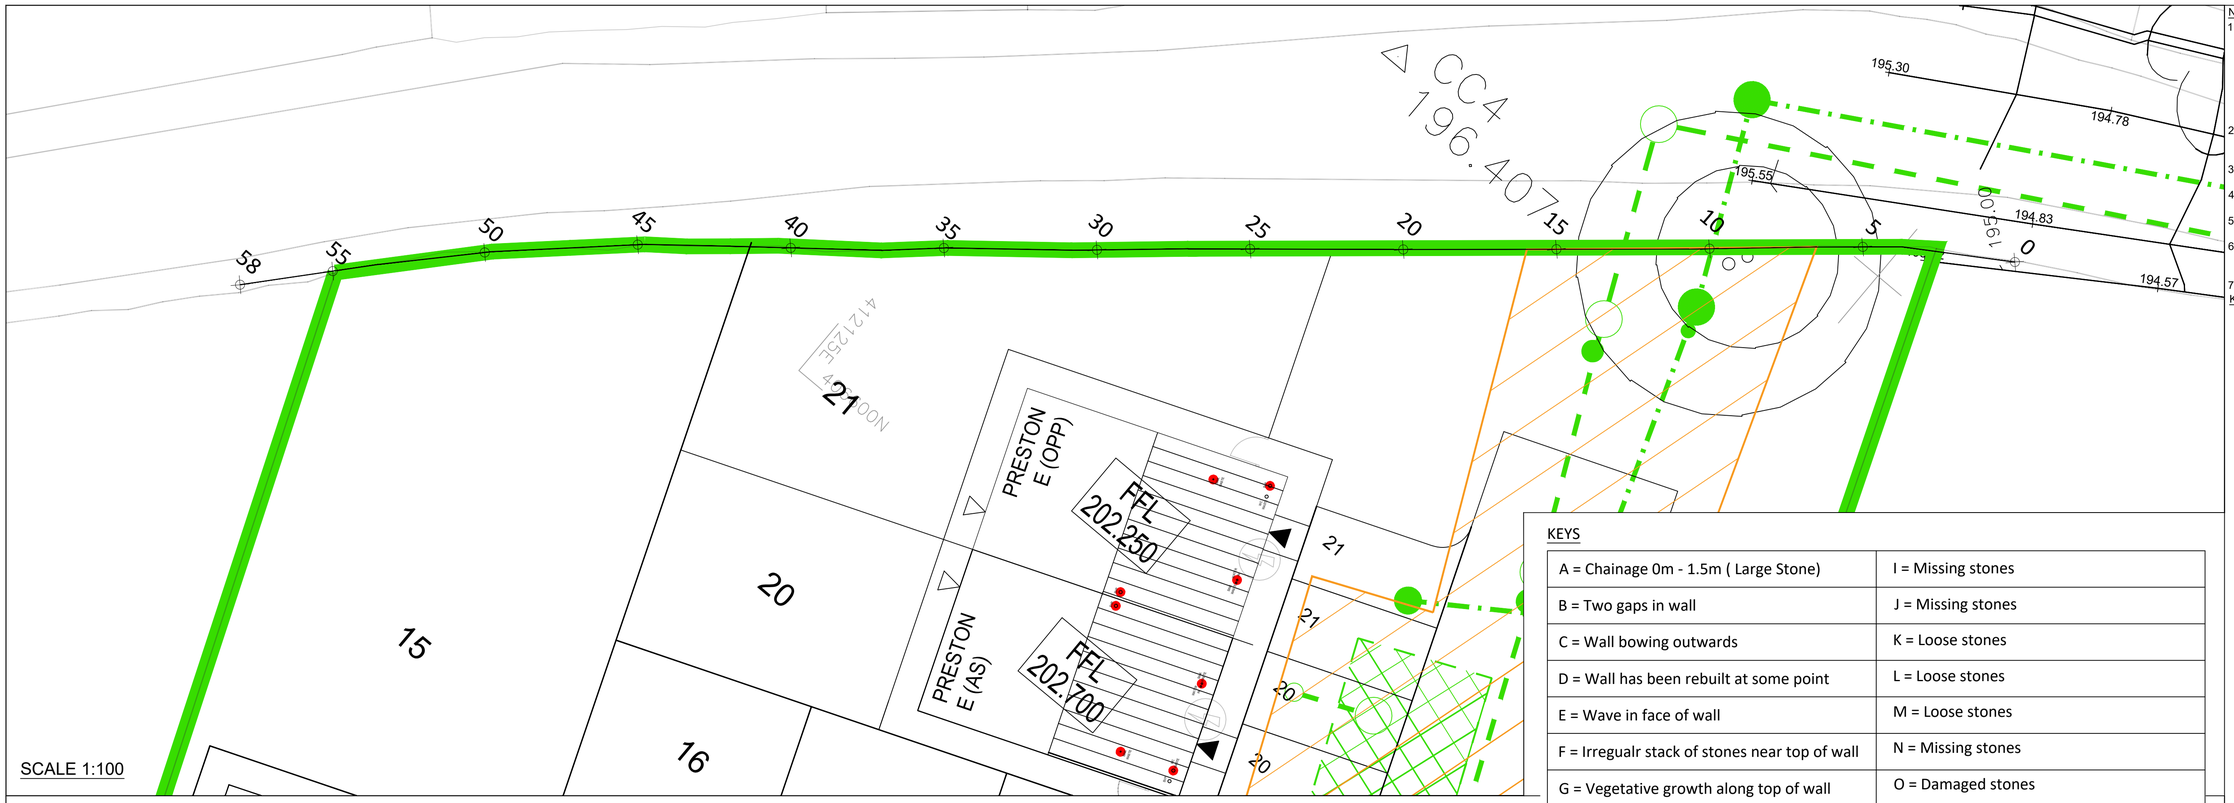
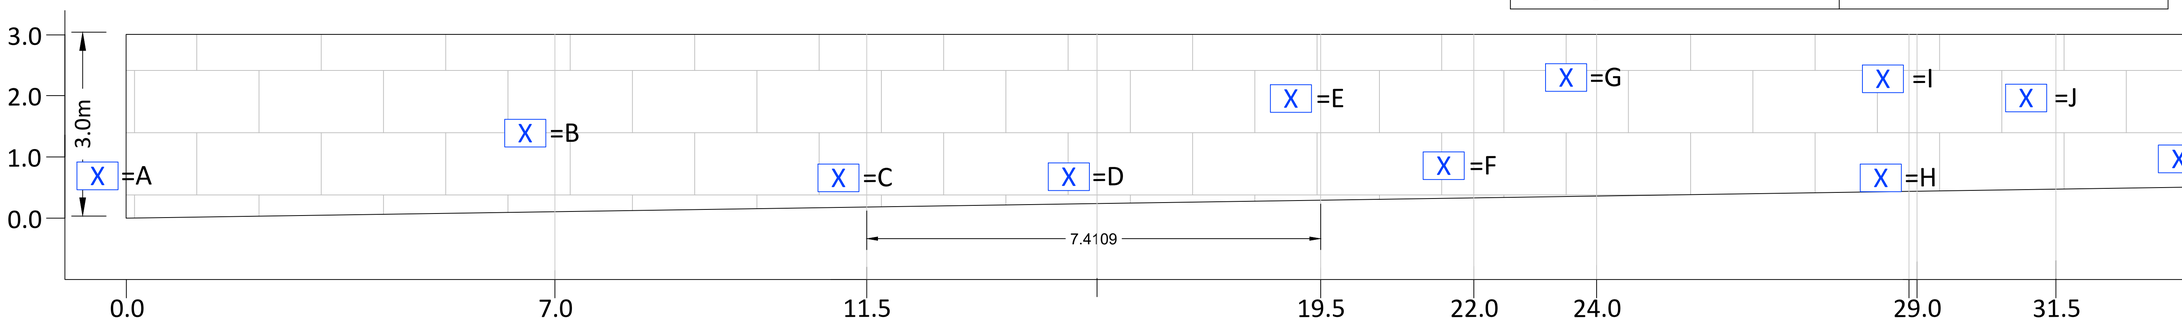
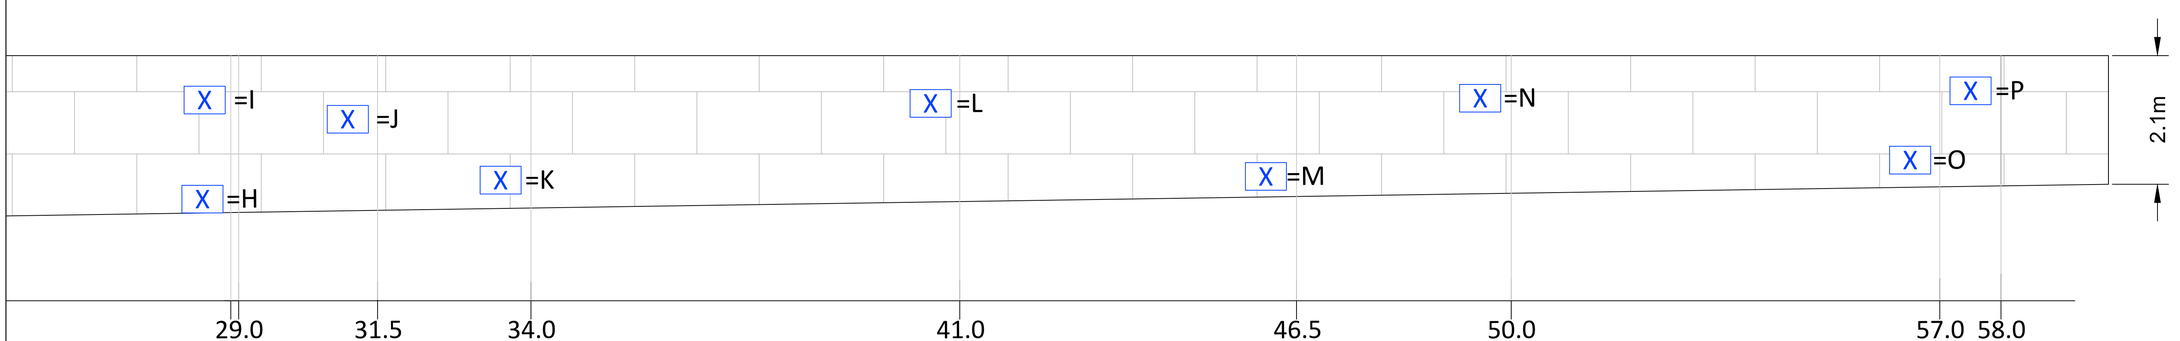
A = Chainage 0m - 1.5m (Large Stone)	I = Missing stones
B = Two gaps in wall	J = Missing stones
C = Wall bowing outwards	K = Loose stones
D = Wall has been rebuilt at some point	L = Loose stones
E = Wave in face of wall	M = Loose stones
F = Irregualr stack of stones near top of wall	N = Missing stones
G = Vegetative growth along top of wall	O = Damaged stones
H = Missing stones	P = Large stones
