Coal Mining Risk Assessment

36 Oxford Road
Dewsbury
WF13 4LL

Date: 2nd July 2025

Version 1

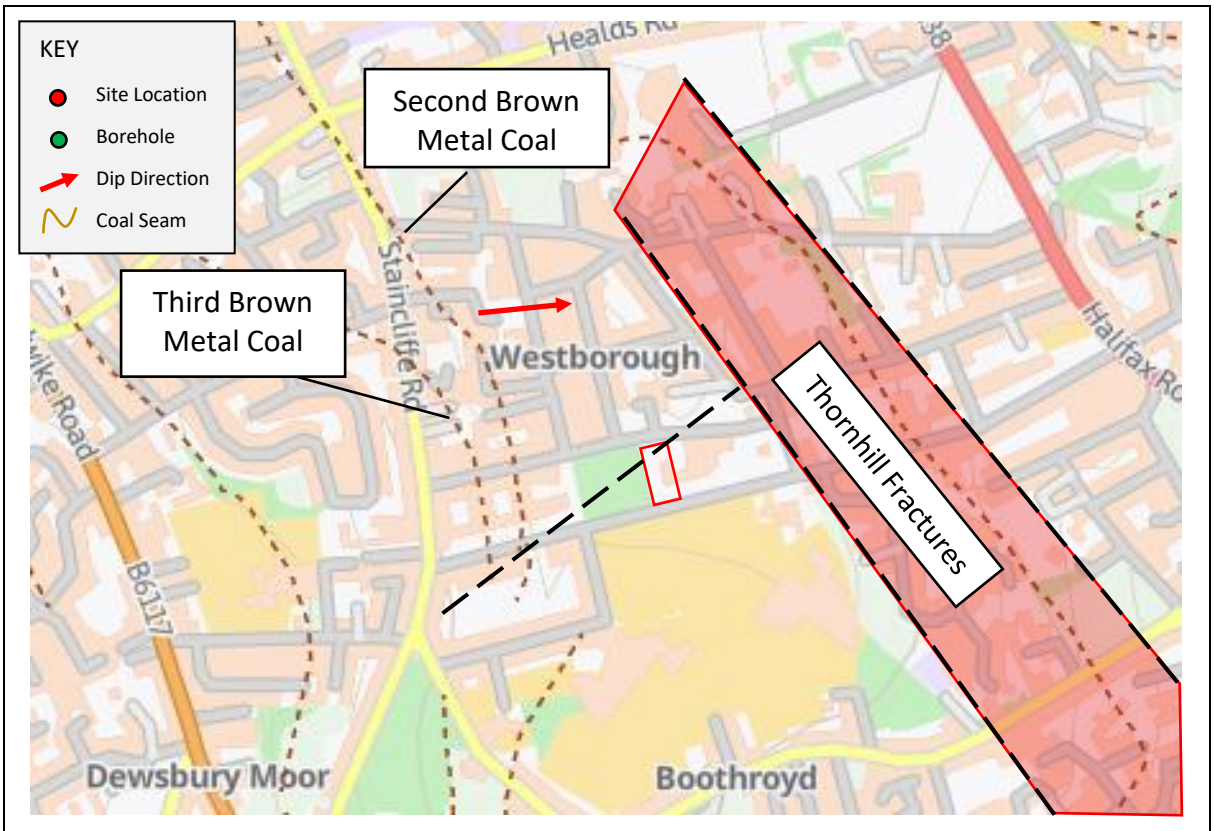
Figure 2) Coal Seam Location Map (Coal Authority Interactive Viewer)

Coal outcrops are shown to be located in close vicinity to the site (see **Figure 2**) that may be encountered at shallow depths beneath the site and could potentially have unrecorded abandoned workings.

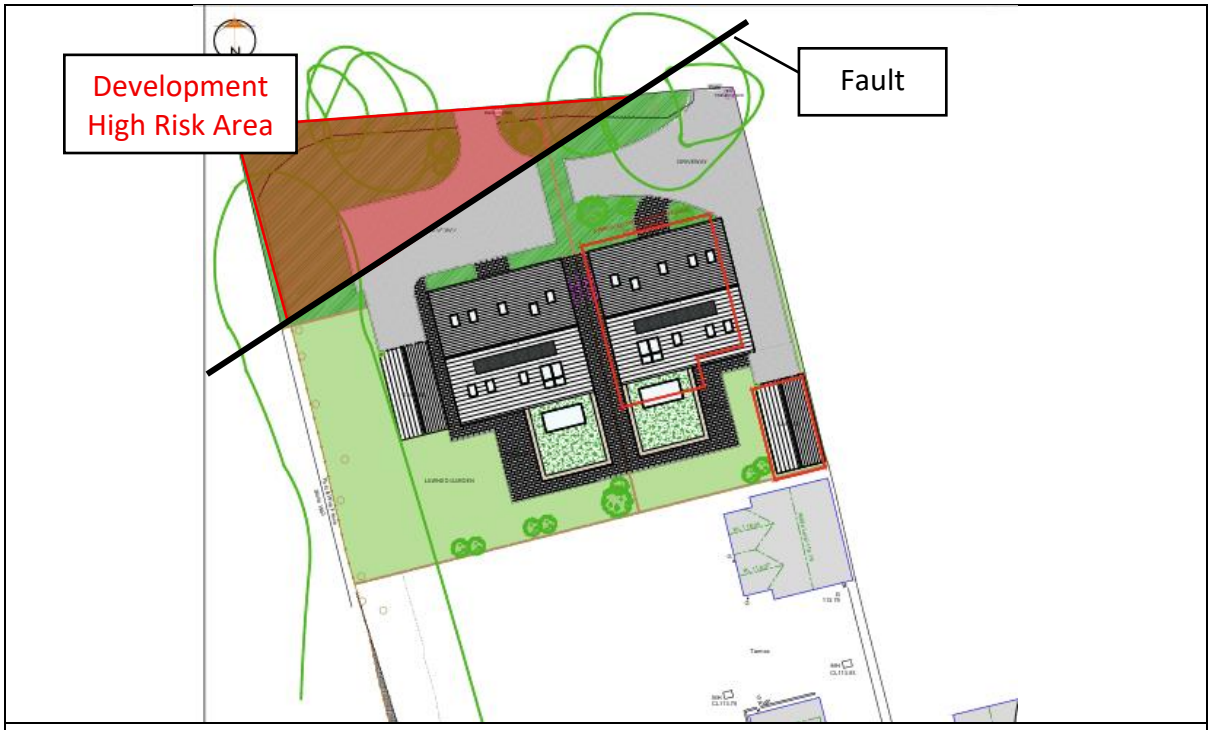
Figure 3) Development High Risk Area

The Coal Authority Interactive Map Viewer (**Appendix G**) has identified that the majority of the site lies outside of the Development High Risk Area (DHRA). However, a small portion of the north-western corner is intersected by the DHRA associated with potential unrecorded shallow mine workings.

Figure 3 below shows that the proposed built development does not intersect the Development High Risk Area which is confined to the north-western side of the fault.

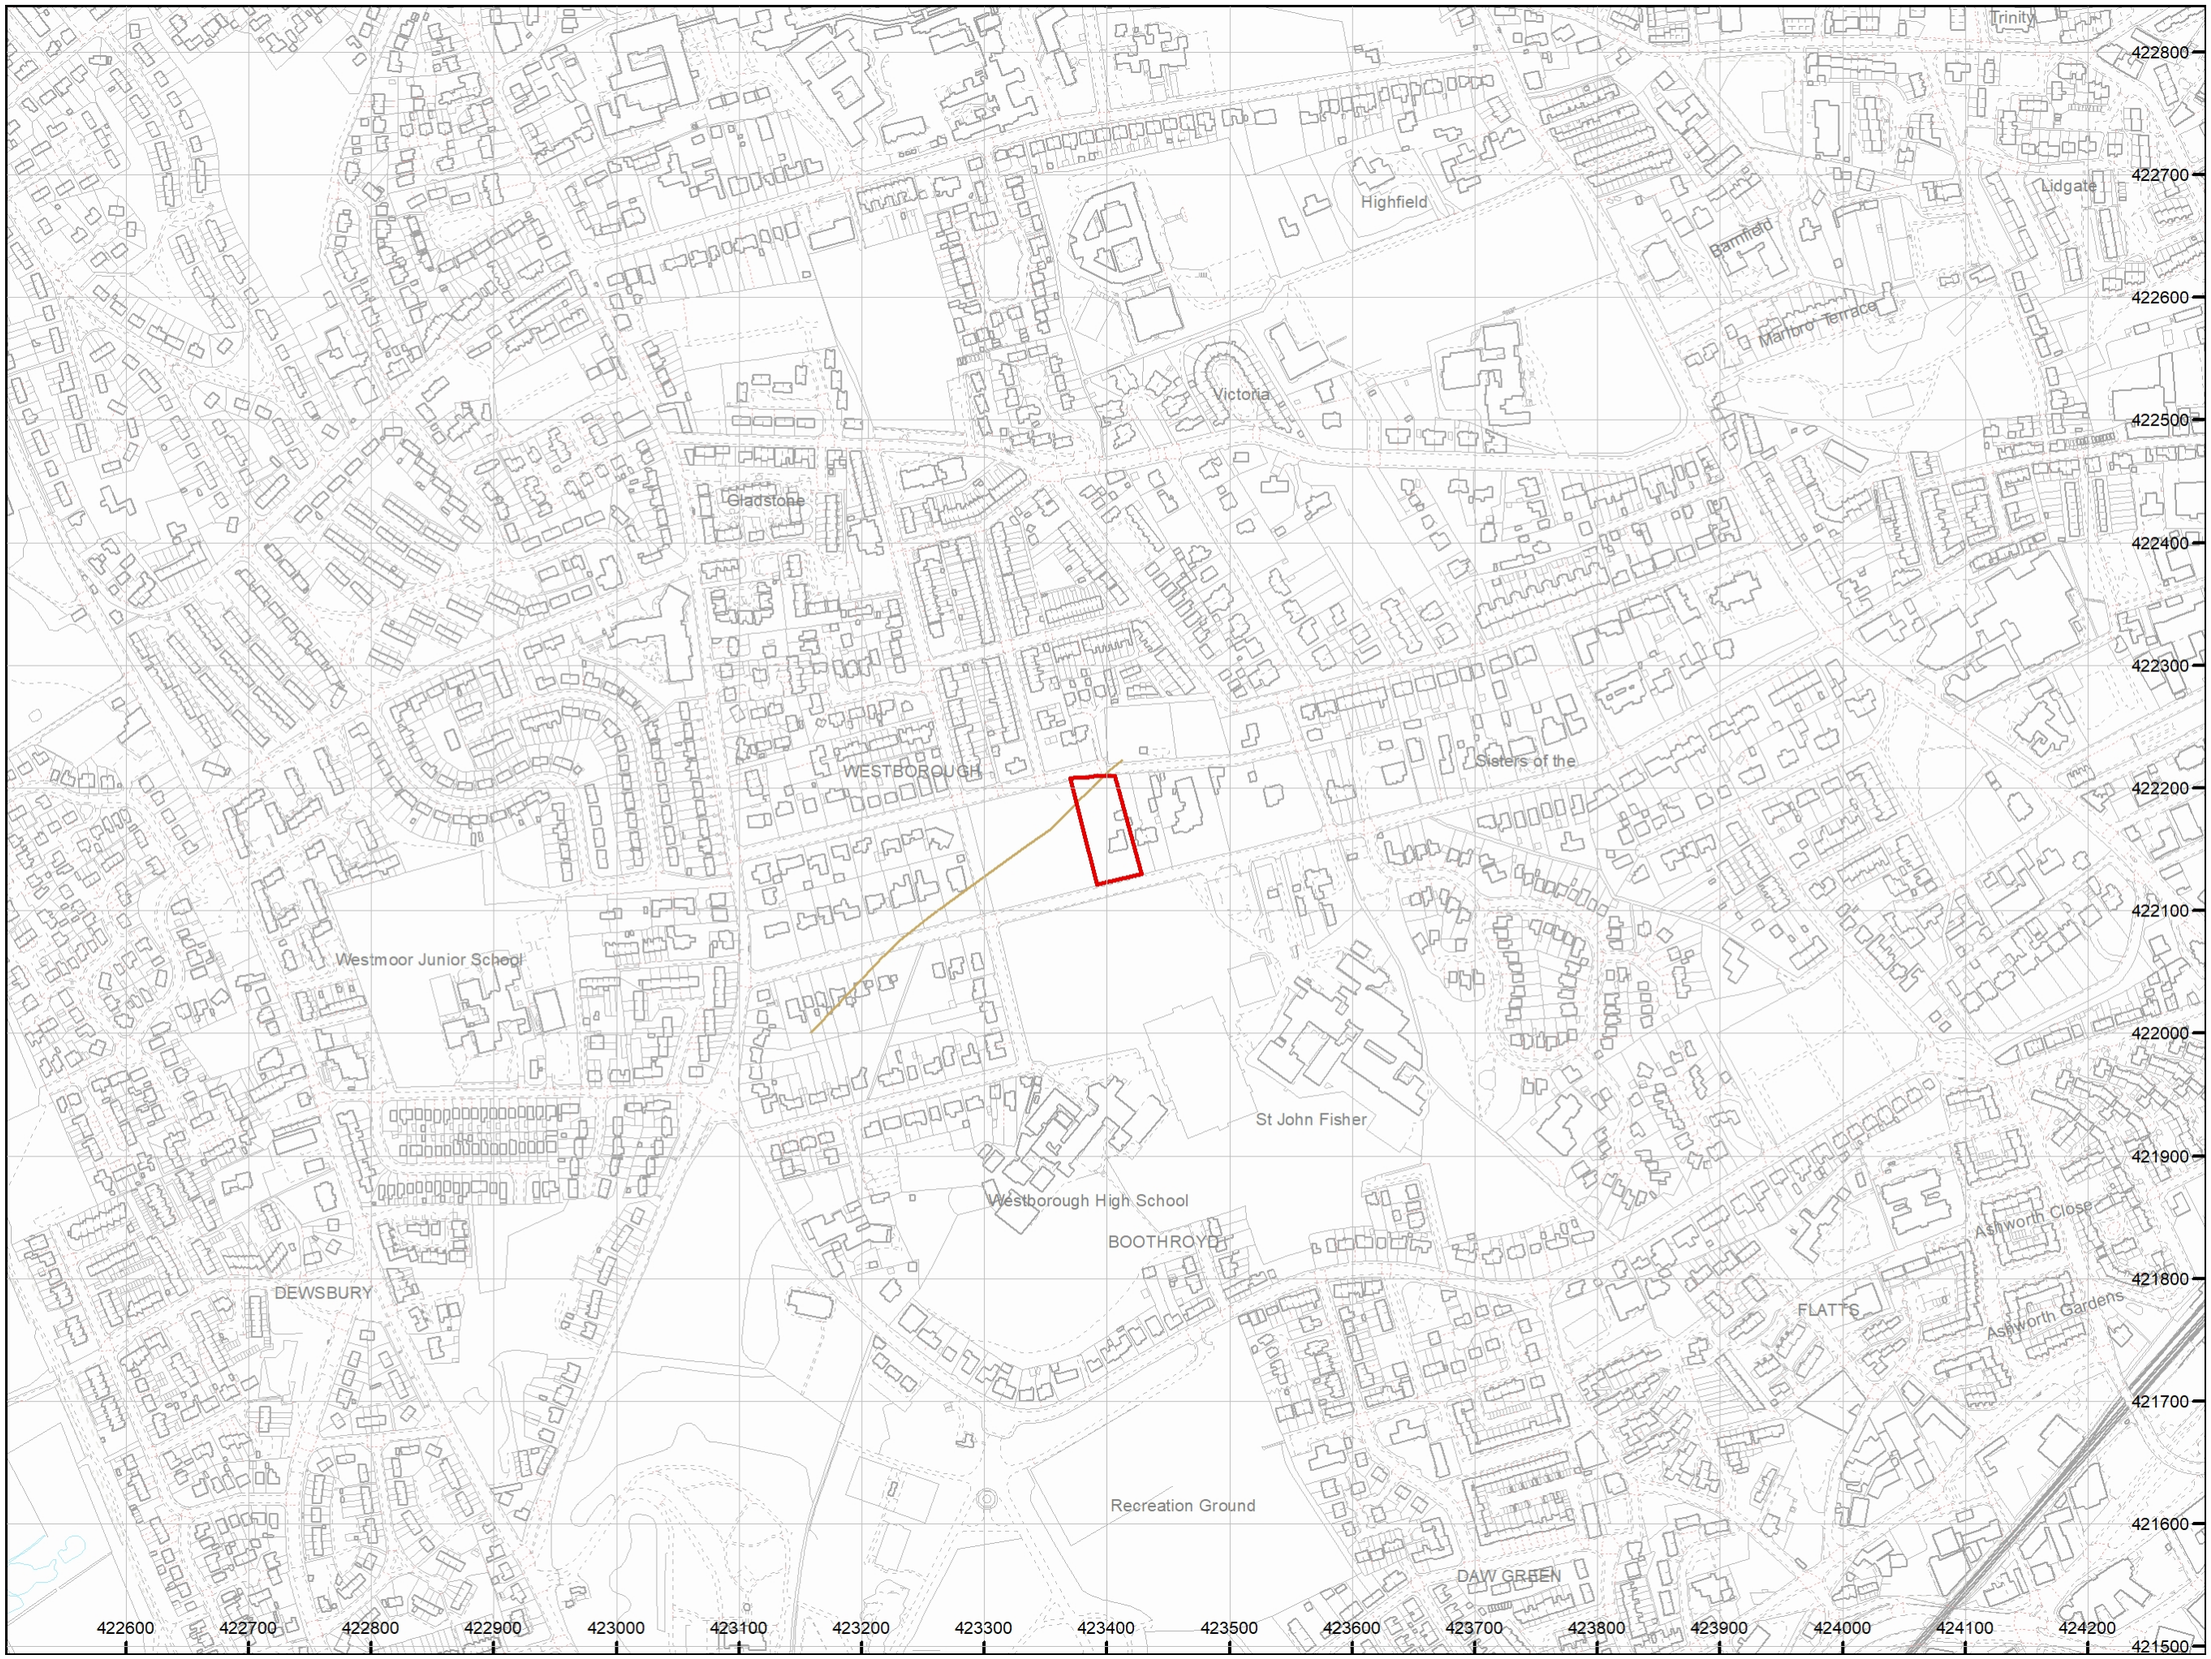
Summary of findings

Fault under or close to the property recorded.
