Client	Kirklees Borough Council			
Site	Huddersfield Open Market, Huddersfield, HD1			
Drawing	Trial Pit Log			
Job No.	**Dwg. No.**	**Rev. No.**	**Scale@A3**	**Date**
25-15006	TP11	0	NTS	-

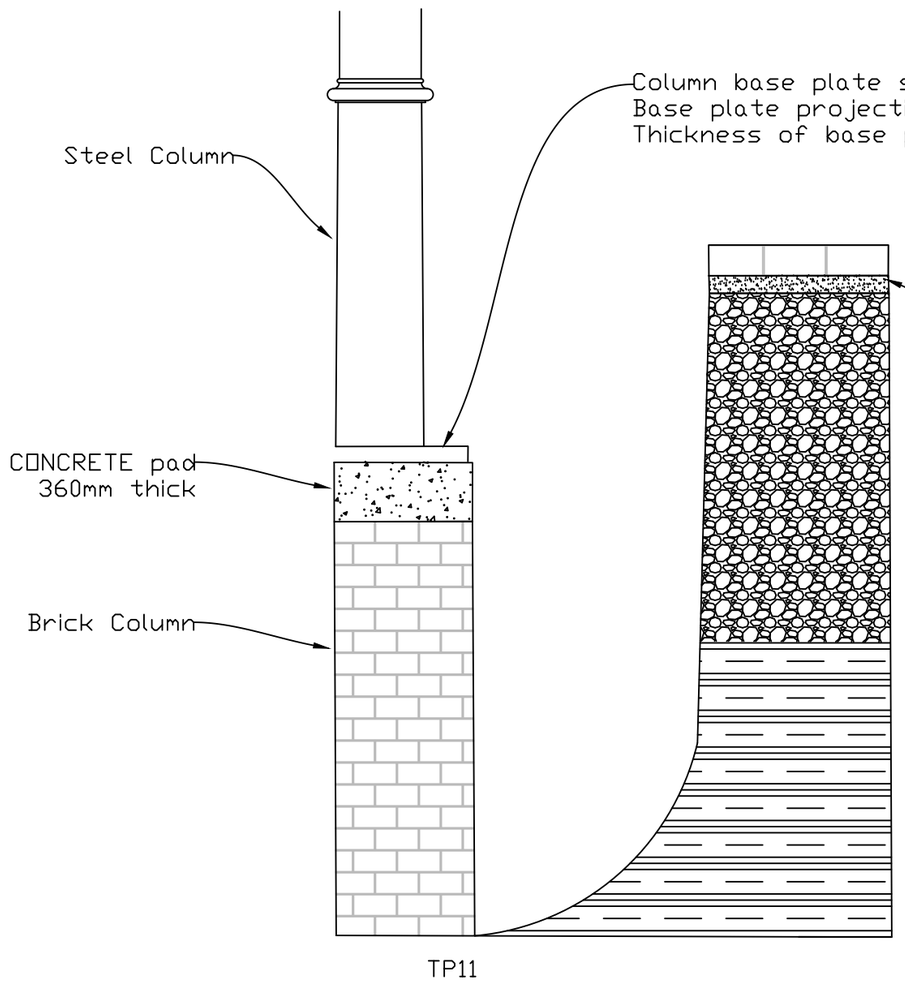
SANDSTONE paving - 0.07mbgl

Brown fine - coarse grained SAND layer - 0.12m

Dark brown locally clayey gravelly SAND. Low cobble content. Gravel is fine to coarse angular to subround of brick and sandstone (MADE GROUND) - 1.1mbgl

Firm becoming firm to stiff brown locally grey slightly gravelly slightly sandy silty CLAY - 1.9mbgl

Trial pit dry on completion

Base of brick column not proven at 1.65mbgl

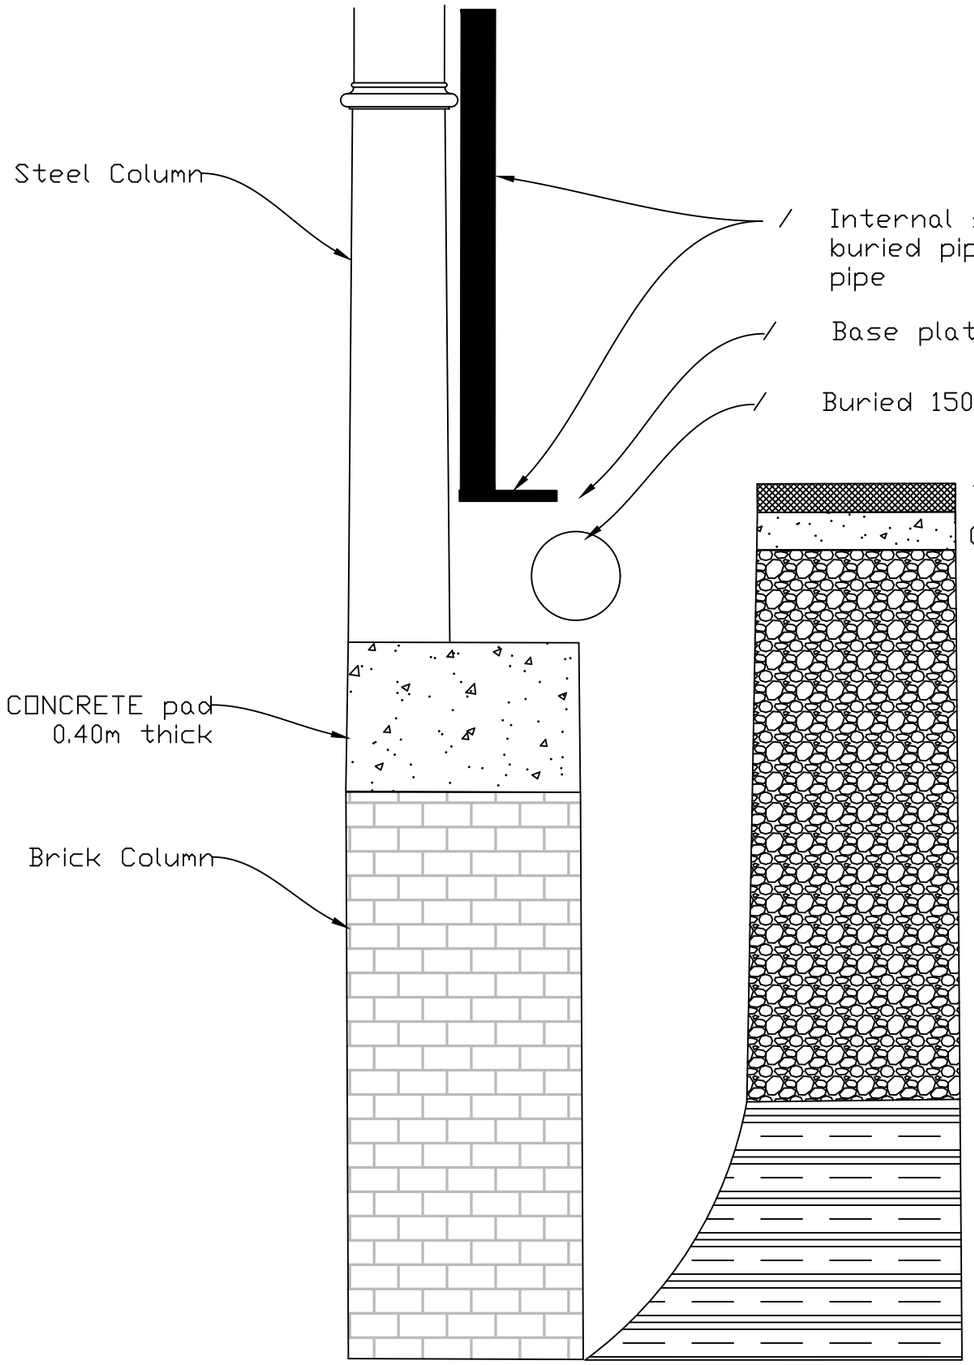
TP12

Internal surface water gully and associated buried pipe work set in CONCRETE and down pipe

Base plate / base of column shown to be encased in CONCRETE

Buried 150mm brown ceramic drain its top concealed in concrete, its bottom MADE GROUND

TARMAC overlying thin coarse sand layer - 65mm

CONCRETE layer 0.20m (no reinforcement layer present)

Brown very clayey SAND and GRAVEL with medium cobble content. Gravel is fine to coarse angular to subround of brick slate and sandstone (MADE GROUND) - 1.45mbgl

Brown / grey slightly gravelly sandy CLAY. Gravel is fine to coarse subagular to subround of mustone sandstone and quartz (possibly reworked CLAY - 2mbgl

Trial pit dry on completion

Base of brick column not proven at 2mbgl

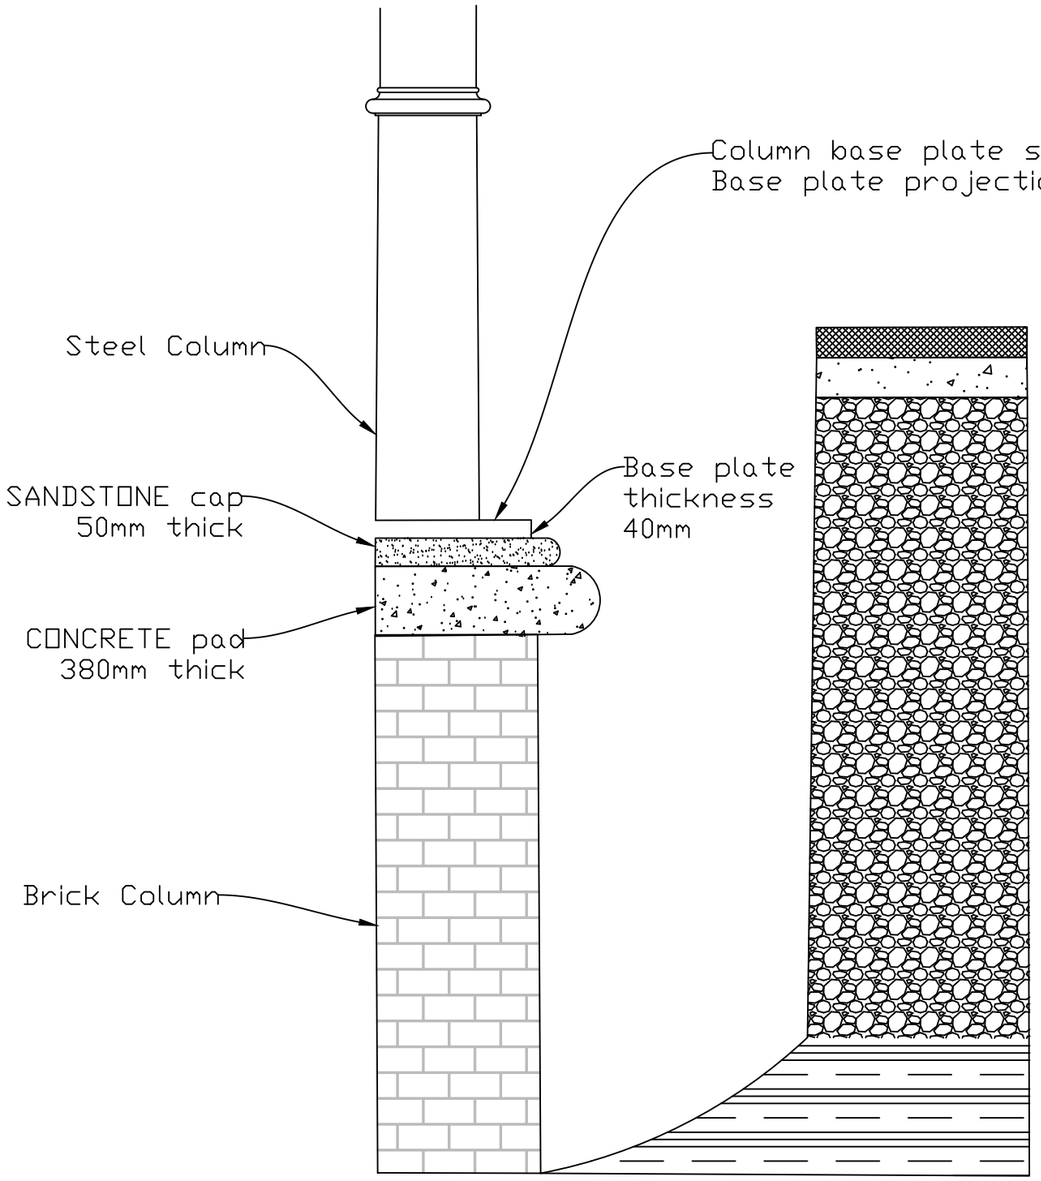
TP13

TARMAC - 45mm

CONCRETE layer 0.14m (no reinforcement layer present)

Dark brown very clayey SAND and GRAVEL. Medium cobble content. Gravel is fine to coarse angular to subround of brick ceramic slate & sandstone (MADE GROUND) - 1.41mbgl

Firm grey / brown slightly gravelly slightly sandy silty CLAY. Gravel is fine to coarse subangular to subround of brick sandstone, and mudstone (MADE GROUND)

Trial pit dry on completion

Base of brick column not proven at 1.9mbgl

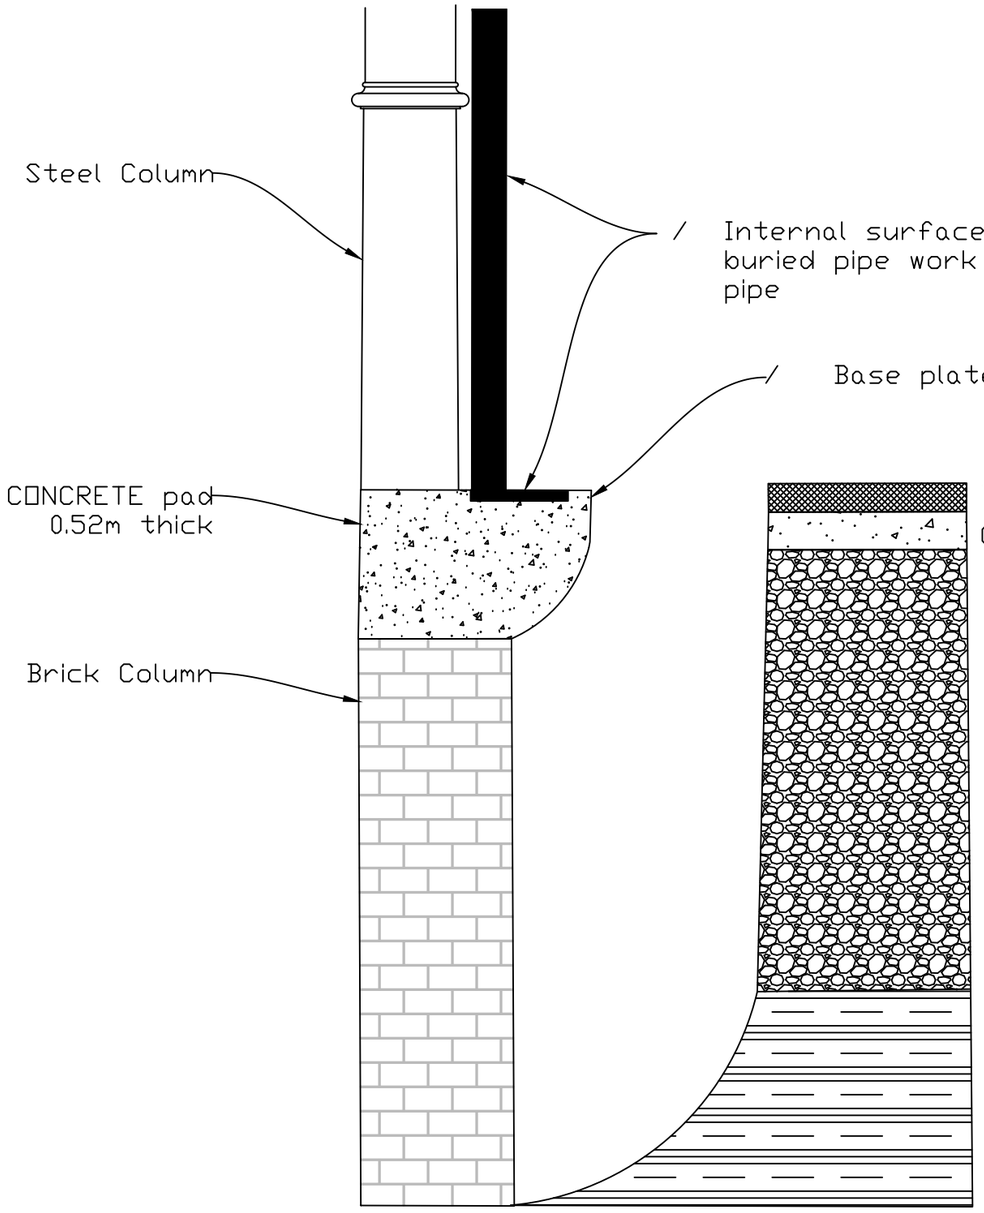
TP14

TARMAC - 45mm

CONCRETE layer 0.14m (no reinforcement layer present)

Brown very clayey SAND and GRAVEL with medium cobble content. Gravel is fine to coarse angular to subround of brick slate ceramic coal and sandstone (MADE GROUND) - 1.41mbgl

Brown / grey slightly gravelly sandy CLAY. Gravel is fine to coarse subagular to subround of mustone sandstone and quartz, with occasional coal fragments (possibly reworked CLAY - 1.85mbgl

Trial pit dry on completion

Base of brick column not proven at 1.85mbgl

TP14: Not possible to confirm the presence of steel pad at the base of column due to the presence of surface water drains

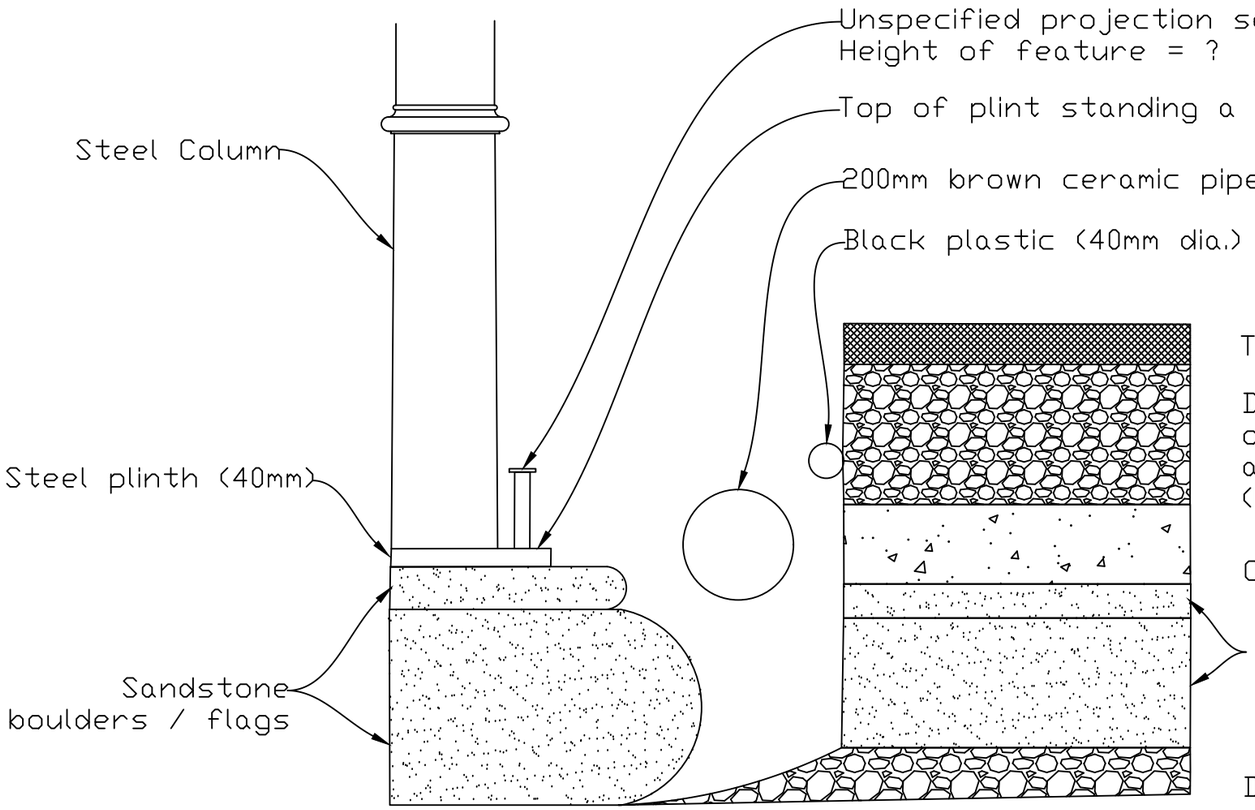
Unspecified projection set within plinth
Height of feature = ?

Top of plint standing a 0.85mbgl, plate projection 160mm

200mm brown ceramic pipe crossing trench on a NE/SW alignment standing at 0.55mbgl

Black plastic (40mm dia.) pipe extending along trench on a E/W alignment at 0.41mbgl

TARMAC - 0.1m

Dark brown slightly silty sandy GRAVEL with occasional fragments of plastic sheeting. High cobble content. Gravel is fine to coarse angular to subround of brick, slate, ceramic sandstone & mudstone (MADE GROUND) - 0.61m

CONCRETE (no reinforcement present) - 0.63m

2nr boulders of fine & medium grained sandstone / flags

Dark grey locally red clayey gravelly sand with occasional sandstone cobbles and small boulders. Gravel is fine to coarse angular to subround of brick sandstone & slate (MADE GROUND) - 1.34m

Unable to progress beyond 1.34mbgl due to the presence of brown ceramic pipe within pit excavation

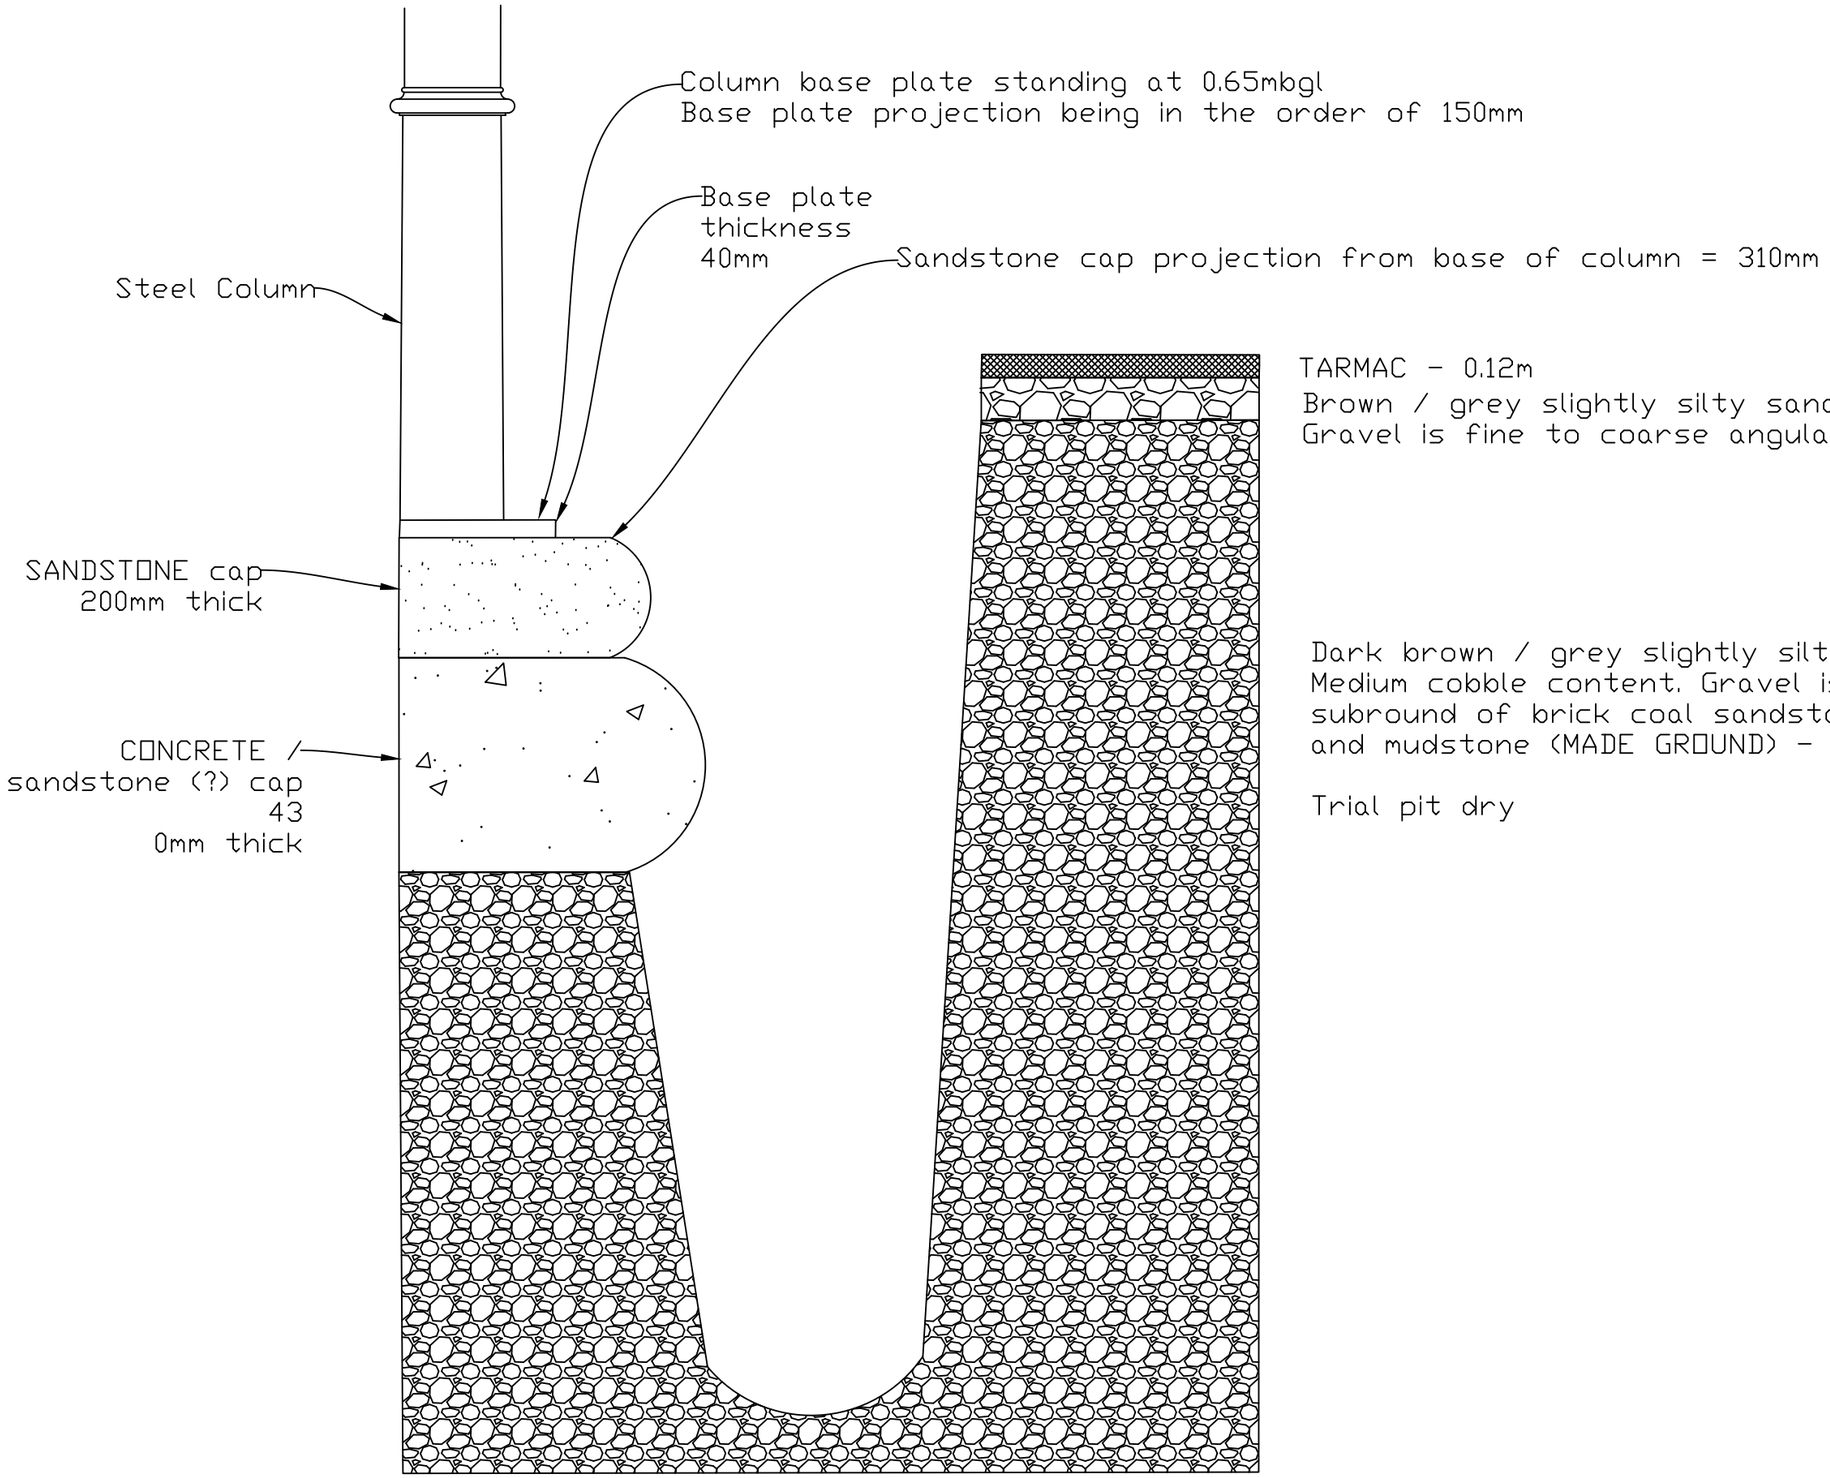
Client	Kirklees Borough Council			
Site	Huddersfield Open Market, Huddersfield, HD1			
Drawing	Trial Pit Log			
Job No.	**Dwg. No.**	**Rev. No.**	**Scale@A3**	**Date**
25-15006	TP16	0	NTS	-

TP16: Showing steel supporting column to be set of steel pad supported on sandstone blocks

TP16: Staff resting on sandstone blocks supporting steel column

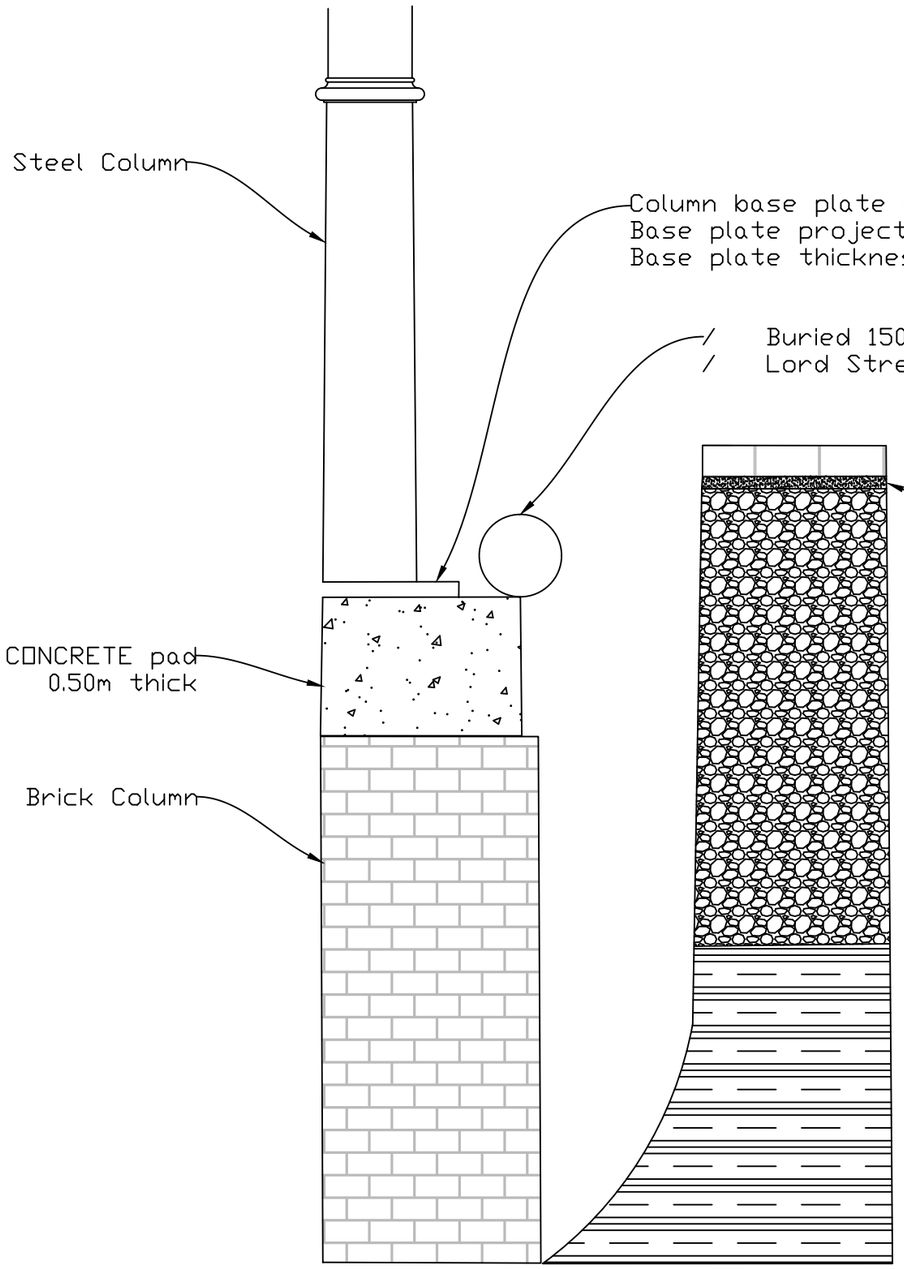
TP17

SANDSTONE paving - 0.07mbgl

Brown fine - coarse grained SAND layer - 0.2mbgl

Brown very clayey SAND and GRAVEL with medium cobble content. Gravel is fine to coarse angular to subround of brick concrete slate and sandstone (MADE GROUND) - 1.2mbgl

Brown / grey slightly gravelly sandy CLAY. Gravel is fine to coarse subangular to subround of mudstone sandstone and quartz (possibly reworked CLAY - 1.8mbgl

Trial pit dry on completion

Base of brick column not proven at 1.8mbgl

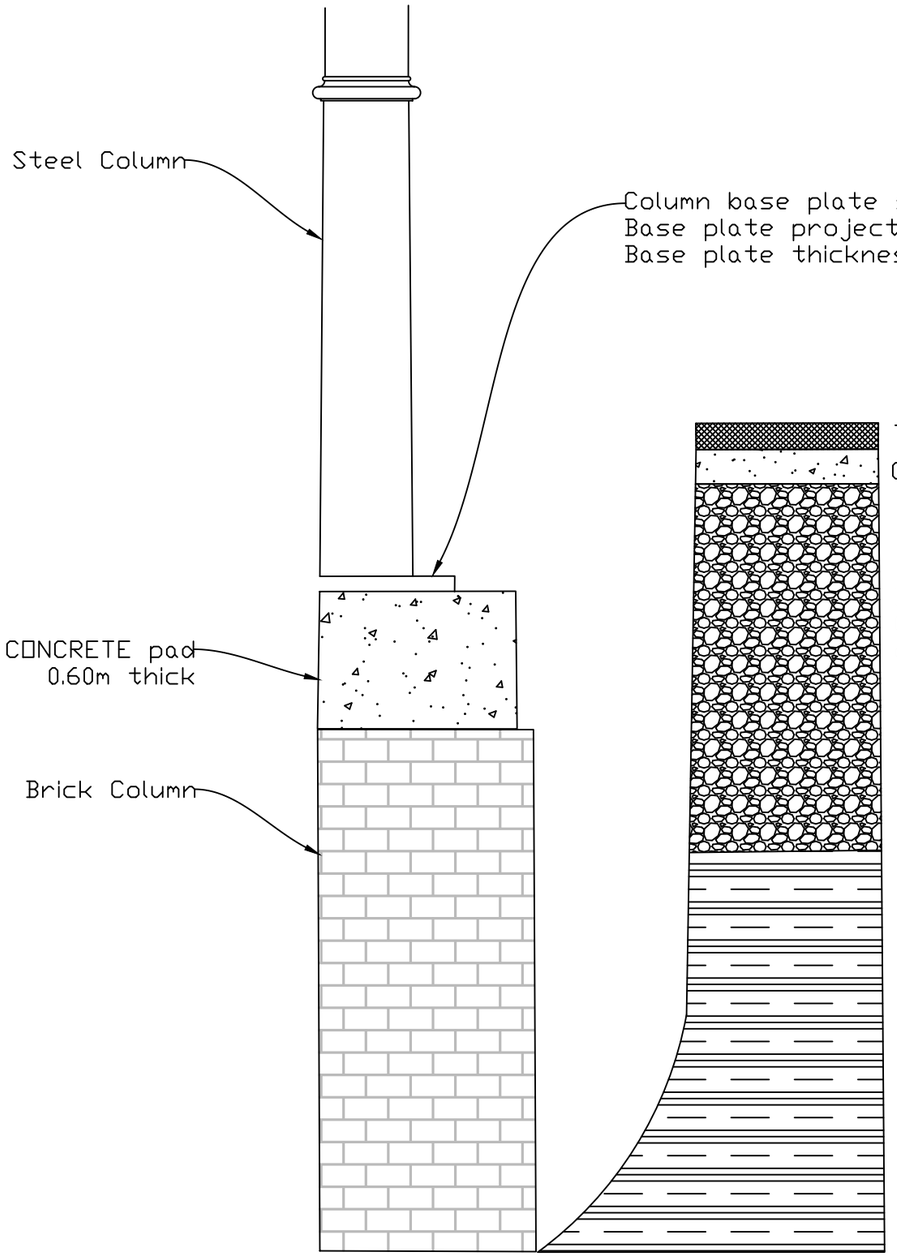
TP18

TARMAC overlying thin coarse sand layer - 80mm

CONCRETE layer 0.24m (no reinforcement layer present)

Brown very clayey SAND and GRAVEL with medium cobble content. Gravel is fine to coarse angular to subround of brick ceramic cinders glass slate and sandstone (MADE GROUND) - 1.1mbgl

Brown / grey slightly gravelly sandy CLAY. Gravel is fine to coarse subangular to subround of mudstone sandstone and quartz (possibly reworked CLAY - 2.0
mbgl

Slight seepage at the base of pit

Base of brick column not proven at 2.0mbgl

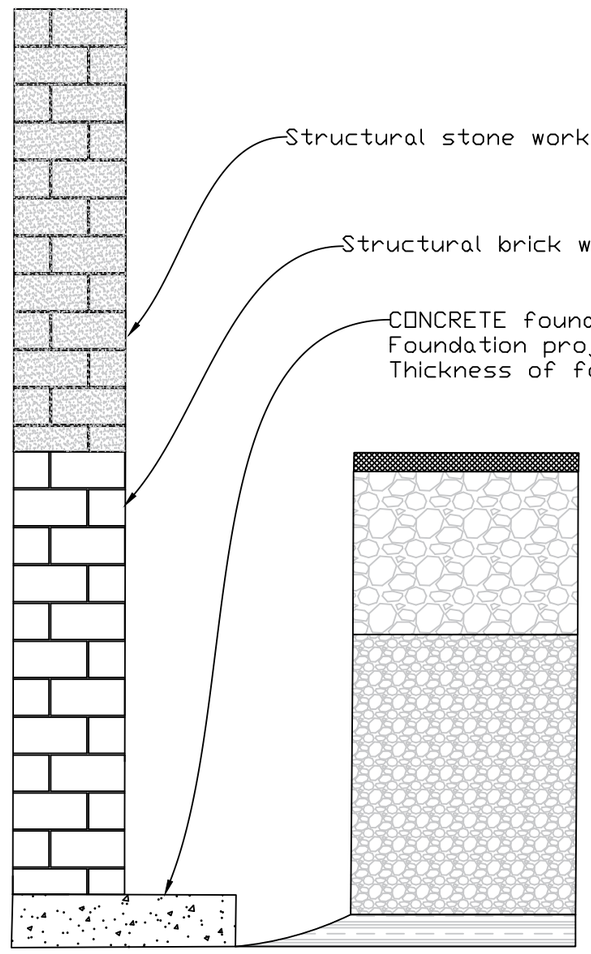
TARMAC - 0.1m

Light brown slightly silty sandy GRAVEL (sub-base) Gravel is fine to coarse angular of limestone & sandstone (MADE GROUND) 0.5mbgl

Brown slightly silty locally clayey very gravelly SAND. High cobble content. Gravel is fine to coarse angular to subround of mudstone quartz sandstone (MADE GROUND) 2mbgl

Stiff brown slightly gravelly slightly sandy silty CLAY, Gravel is fine to coarse of various angularities & lithologies - 2.2mbgl
