Airborne Sound Insulation testing in accordance with Test Standards BS EN ISO 140-4:1998
Impact Sound Insulation testing in accordance with Test Standards BS EN ISO 140-7:1998

Report Reference Number: 96357

This report describes the test procedure and the results obtained from the pre-completion sound insulation testing at
Redevelopment, 337b Wakefield Road, Denby Dale, Huddersfield, HD8 8RT.

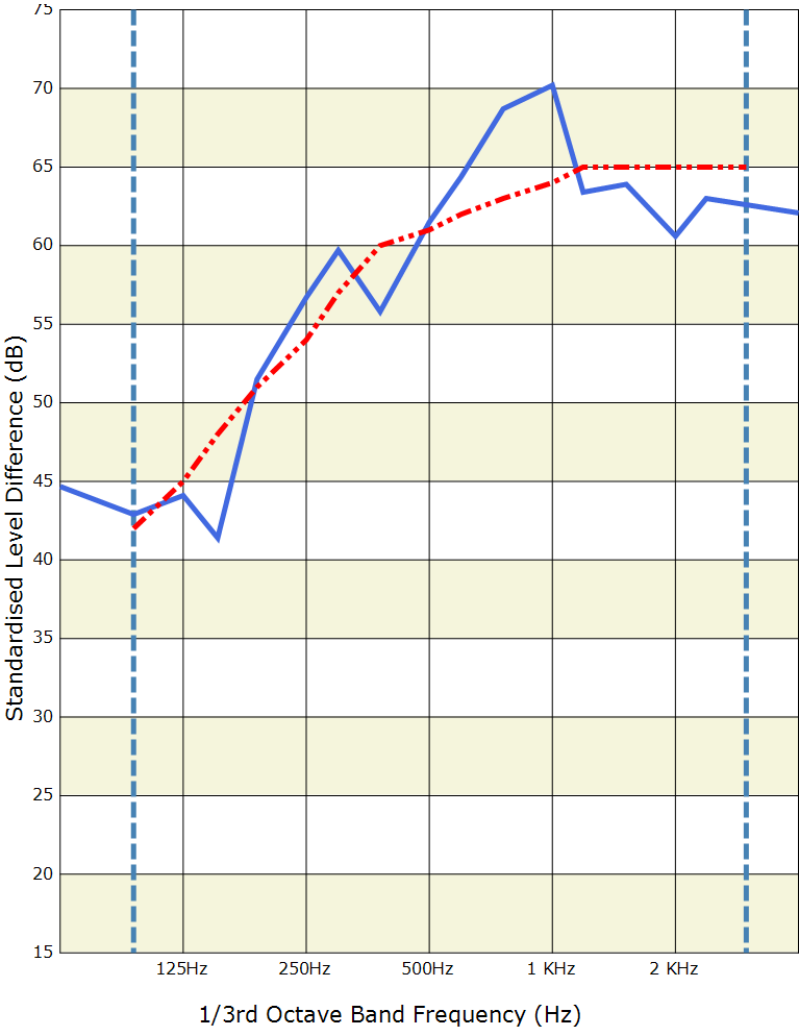
Above graph shows frequency range according to the curve of reference values within BS EN ISO 717-1

$D_{nT,w}$ (C; C_{tr}) [dB]: 61 (-2, -5) dB
$D_{nT,w}$+ C_{tr} [dB]: 56 dB
Minimum Pass Level [dB]: 43 dB

PASS
Adverse Aggregated Deviations [dB]: 23.2

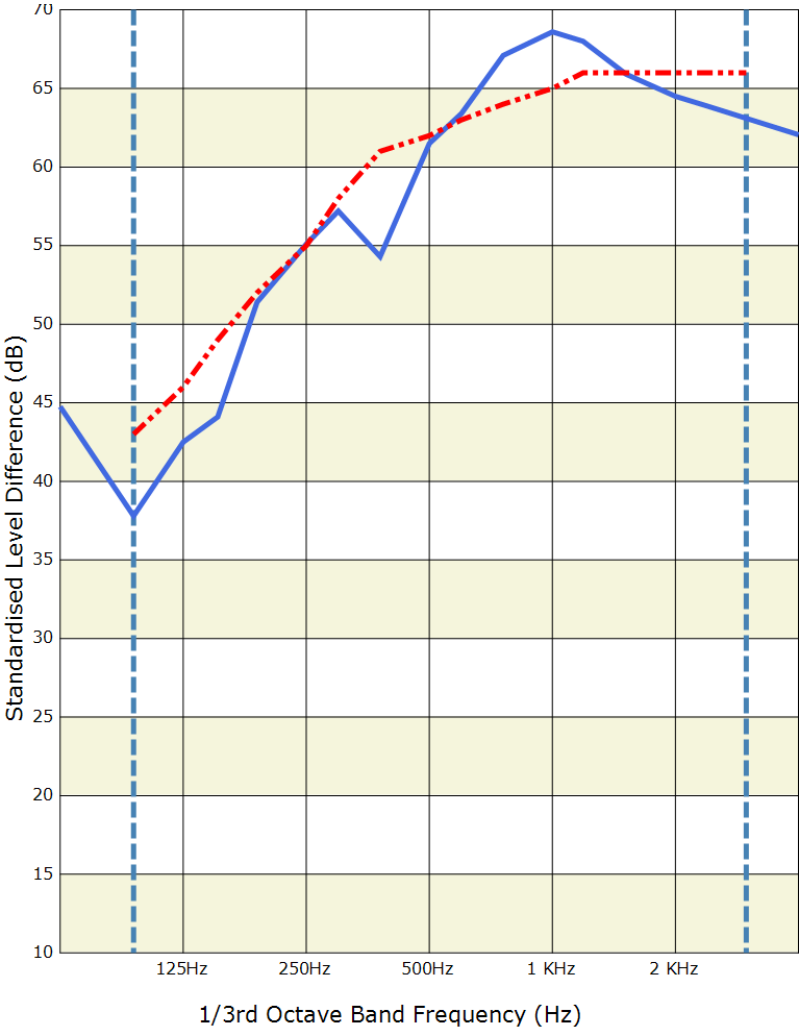
Above graph shows frequency range according to the curve of reference values within BS EN ISO 717-1

$D_{nT,w}$ (C; C_{tr}) [dB]: 62 (-2, -8) dB
$D_{nT,w}$+ C_{tr} [dB]: 54 dB
Minimum Pass Level [dB]: 43 dB

PASS
Adverse Aggregated Deviations [dB]: 28.8

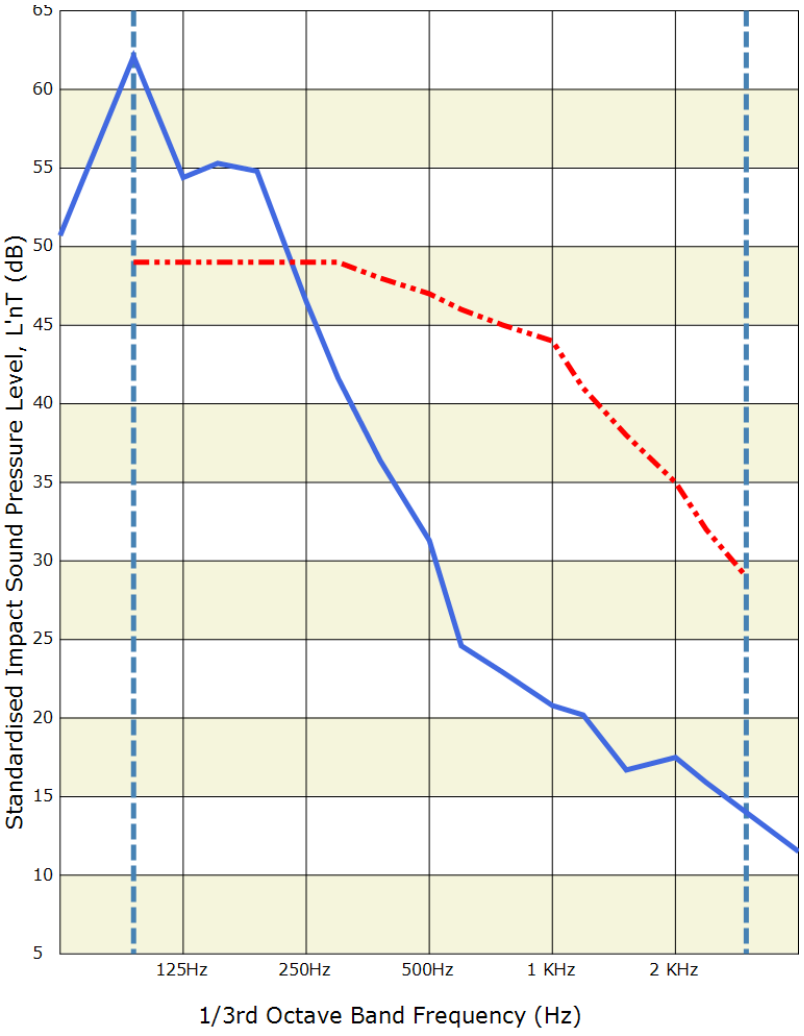
Above graph shows frequency range according to the curve of reference values within BS EN ISO 717-2

$L'_{nT,w}$ (CI) [dB]: 47 (2) dB
Maximum Pass Level [dB]: 64 dB

PASS
Adverse Aggregated Deviations [dB]: 30.6
