## INTRODUCTION

This section of the Conservation Management Plan considers the significance of specific rooms, elements and outbuildings and makes recommendations for the future management of the school as a heritage asset.

Royds Mount was constructed sometime between 1862 and 1867, the architect and contractor are unknown.

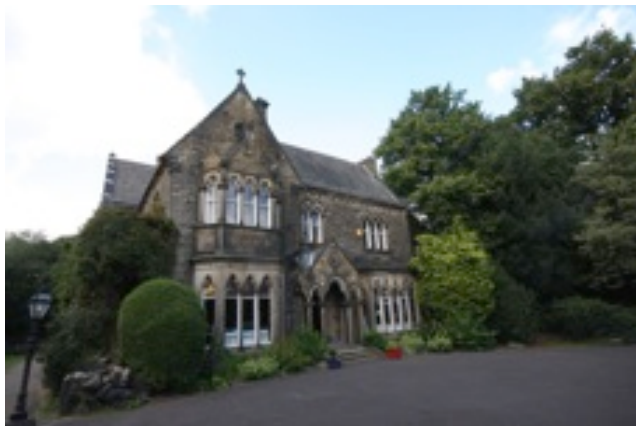
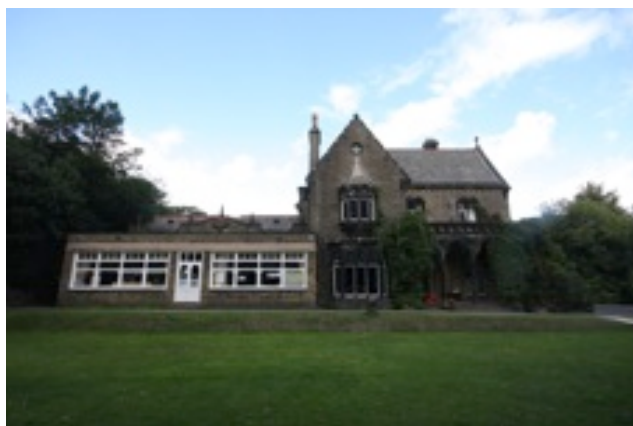
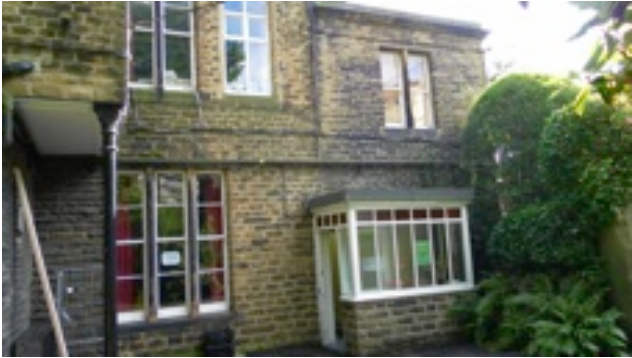
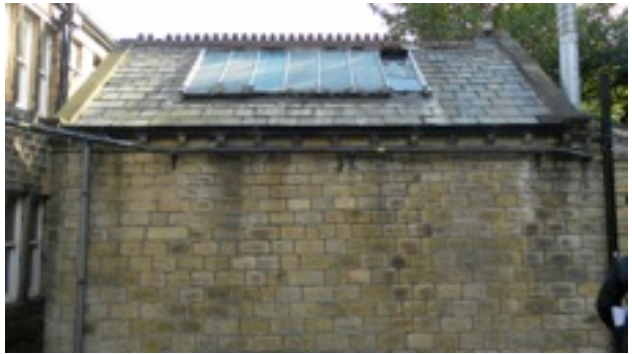
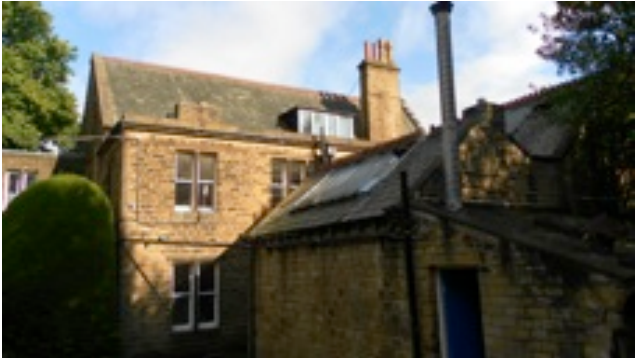
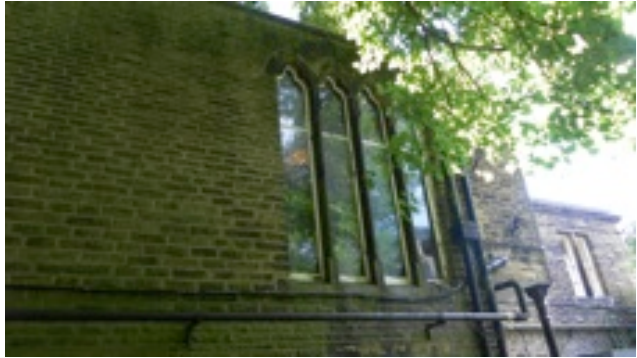
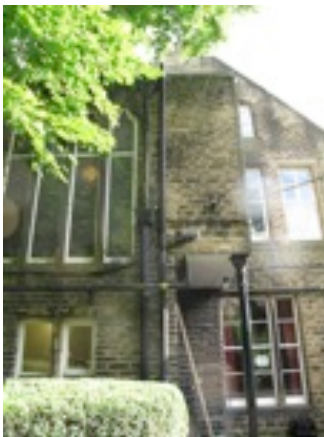
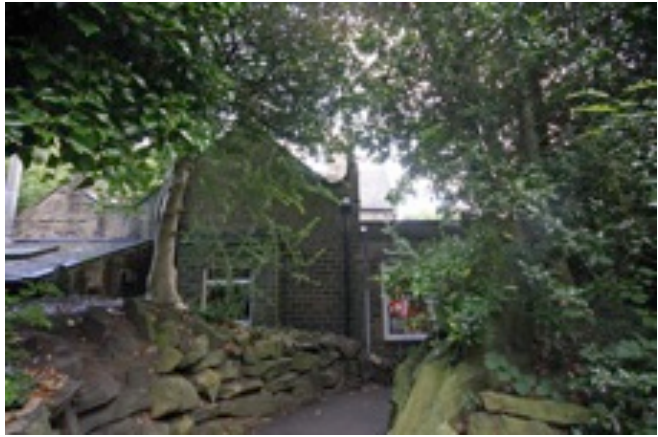
Some of the tall chimney pots have been replaced with modern lower ones.

The stone work to the roof of the oriel window is in a poor state of repair also there is spalling to the balcony stonework. Pointing is poor especially to the kitchen.

The garden room which replaced a conservatory is part of the houses morphology but does not enhance the Gothic appearance of the house to this elevation but rather is a more prominent feature. There may be an opportunity to replace/remodel this elevation.

Where facings, carving, drips or cills are eroded, stone indents in matching material should be used rather than building up the surface with render or mortar. Past mortar repairs should be assessed regularly and replaced with stone indents should they start becoming detached or cause erosion of the surrounding masonry. Plastic rainwater and soil vent pipes should be replaced with cast iron.

Consideration should be given to replacing the modern chimney pots.

Rerouting of the gas pipe to the east and north elevations would improve the appearance of the building, as would rationalisation of rainwater goods, drain pipes and branches.

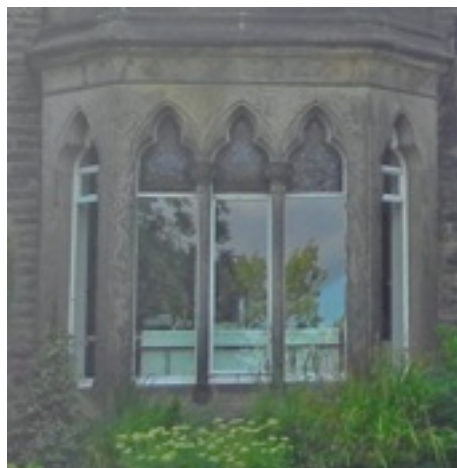
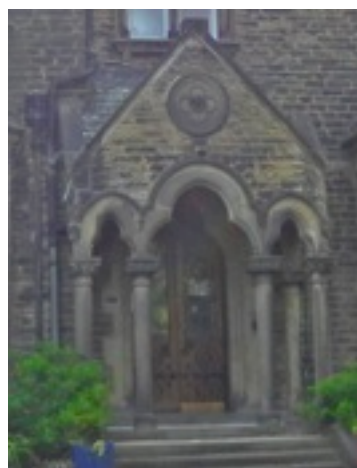
| Element | Significance |
|---|---|
| Windows and Doors | High |

The formal access to the house is located on the east elevation with a porch giving the visitor protection from the weather. The stained glass window panels in the wide oak doors provide light to the lobby.

Windows generally have their original frames and glass. The cusped Gothic windows largely retain their original stained glass however some windows have been adapted to allow part of the window to open. Plate glass has also been retained in places to the lower part of the Gothic windows.

Secondary glazing may be considered, though care should be taken to ensure it is a reversible solution, which does not further divide areas of glazing nor detract significantly from the internal spaces or finishes.

Some windows have been altered in the past. If further alterations are proposed, there is scope for greater flexibility, though where original sash frames remain, these should be retained.

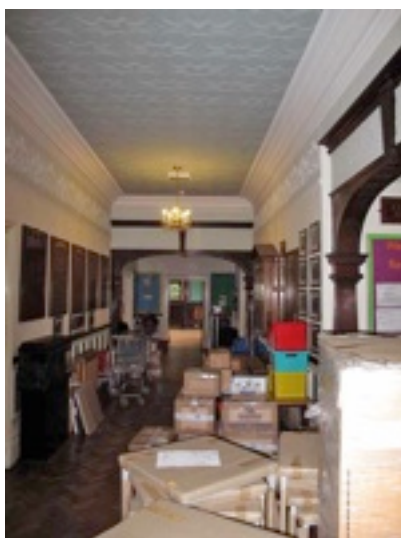
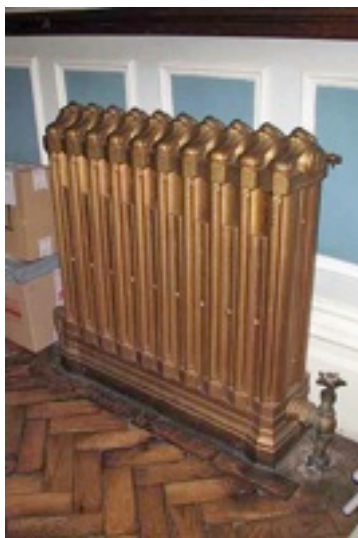
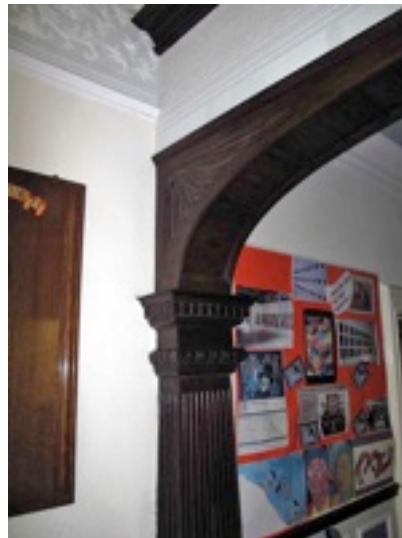
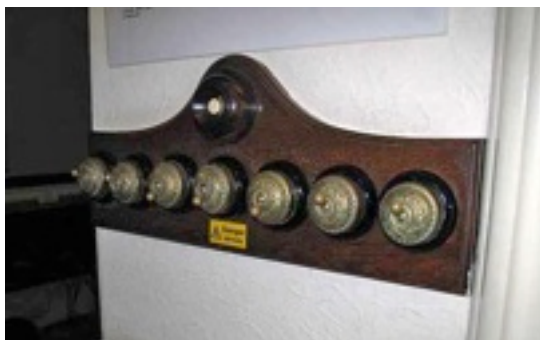
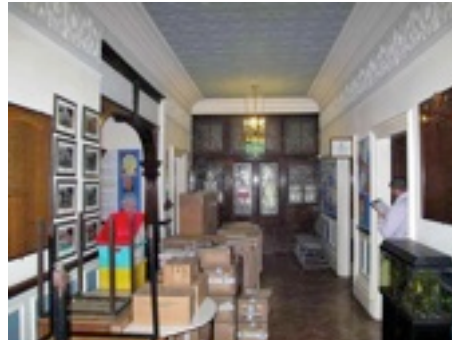
| Room | Location | Use | Original Use | Significance |
|---|---|---|---|---|
| 002 | Ground Floor | Hall | Hall | High |

Many of the original features and those of the 1893 alterations are retained in situ. The wood parquet floor is probably later, dating from the mid 20th century. The wainscot paneling and other joinery is probably original however it has been painted but it would have been varnished. The radiator is an original Jobsons radiator which is rare. An in situ staircase leads from the hallway to a half landing. A classically detailed archway separates the different development stages of the house. The wallpaper is probably historic. Photographs and boards displaying former pupils names are displayed upon the walls and are part of the social history as a school. A bank of seven original brass light switches and push electric bell button on a hardwood board remains in situ.

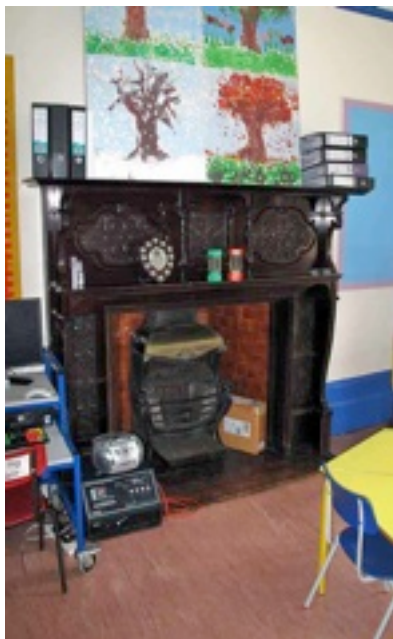
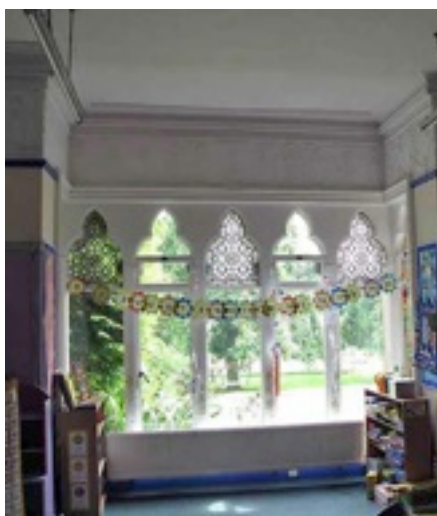
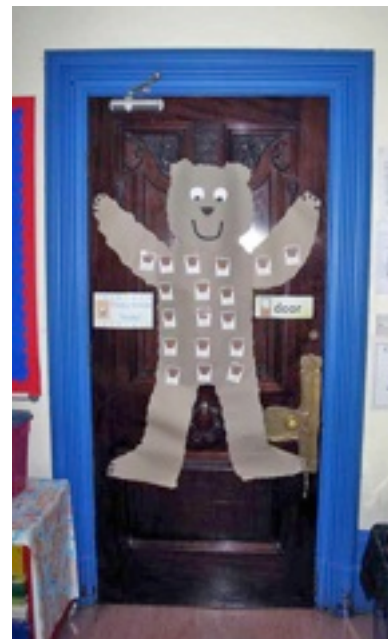
| Room | Location | Use | Original Use | Significance |
|---|---|---|---|---|
| 003 | Ground Floor | Classroom | | High |

The room's historic fabric is retained in situ. The door is a later addition is a fine example of an Art Nouveau as it the doors brass plate. The shirking and picture rail have been painted which would of been originally varnished. Some of the cusped windows have been altered to incorporate openings which probably date from when the house became a school. The embossed frieze is probably original and either Anaglypta or Lincrusta. The plaster cove has been slightly altered to the right of the bay window, probably resulting from a repair. The room retains its original fire place. The floor covering is modern.

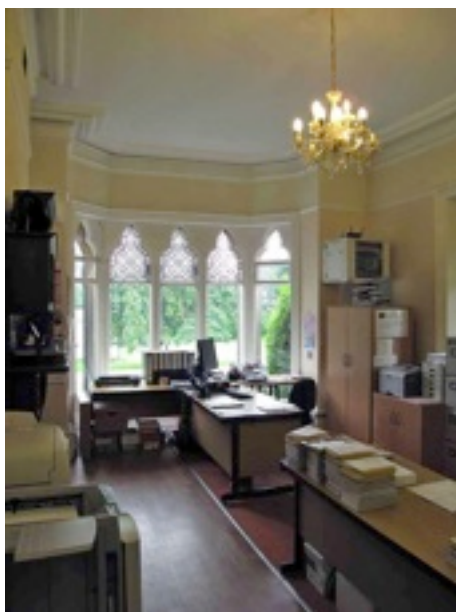
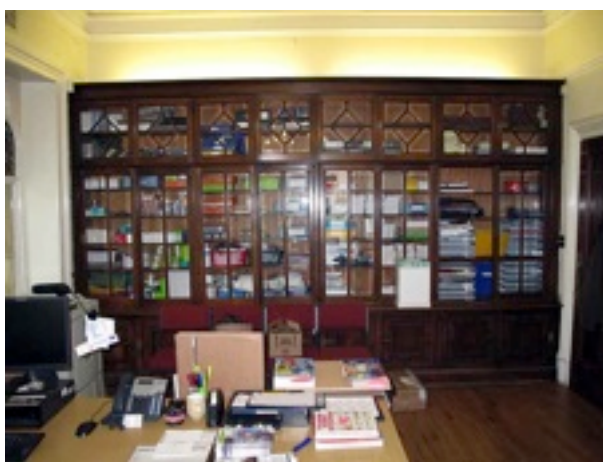
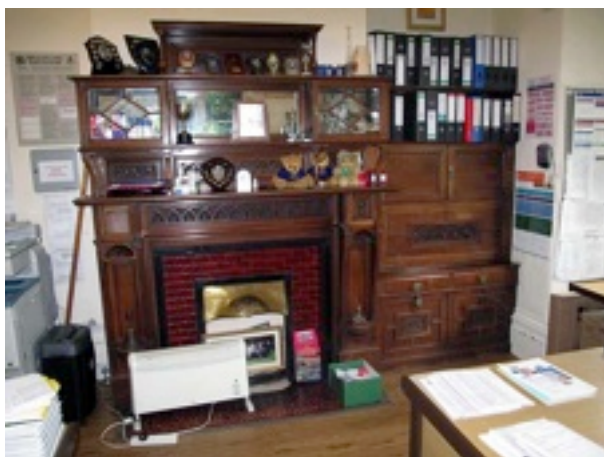
| Room | Location | Use | Original Use | Significance |
|---|---|---|---|---|
| 004 | Ground Floor | Admin Office | | High |

The historic fabric is largely retained in situ which includes joinery and fire place, the windows have partly been adapted to allow an opening and have probably been done when the house become a school. Original light switches have also been retained and continued to be used. The fireplace is also original however the fire may be a post addition. The room also has a wall unit constructed of hardwood and glass, the age of the unit is unknown.

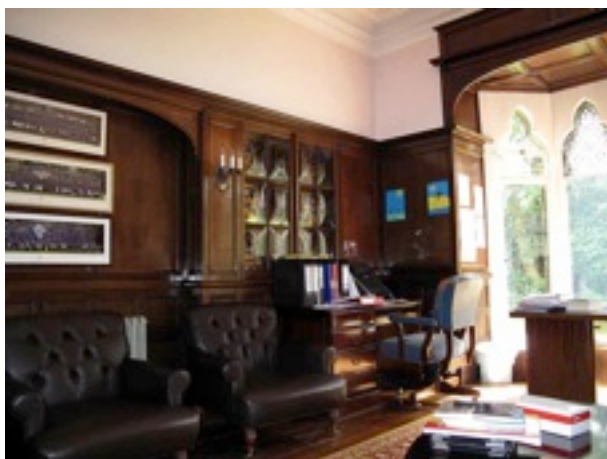
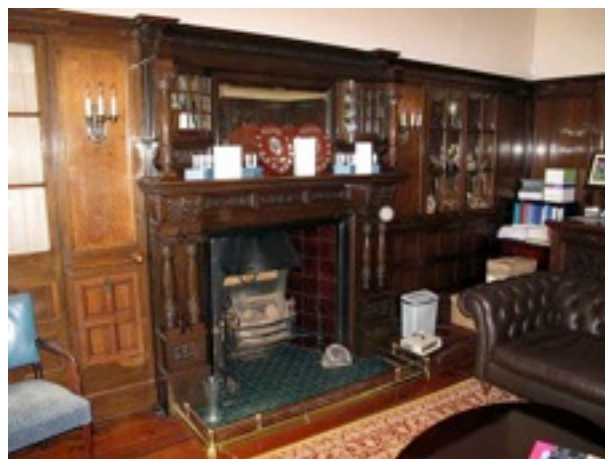
| Room | Location | Use | Original Use | Significance |
|---|---|---|---|---|
| 005 | Ground Floor | Heads Study | | High |

This room retains some of its original fabric, notably the plaster coving, quarry glass to the windows, however some of the window like the previous rooms have been adapted for openings. The timber panelling is historic but probably a remodeling when the house was extended in c.1893. The fire place is probably original to the 1867 house.

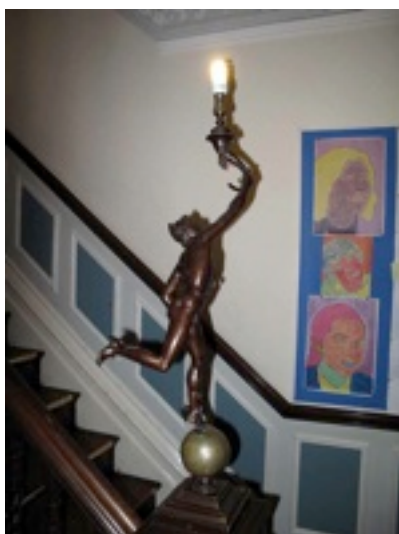
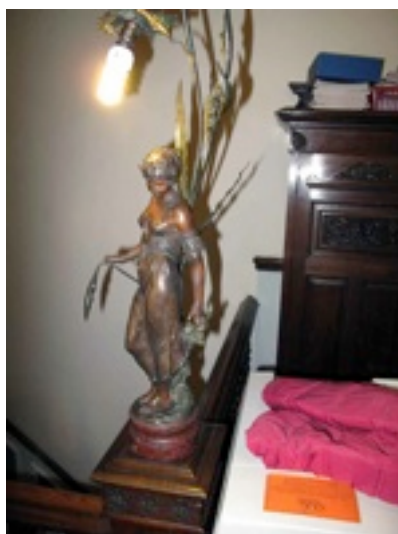
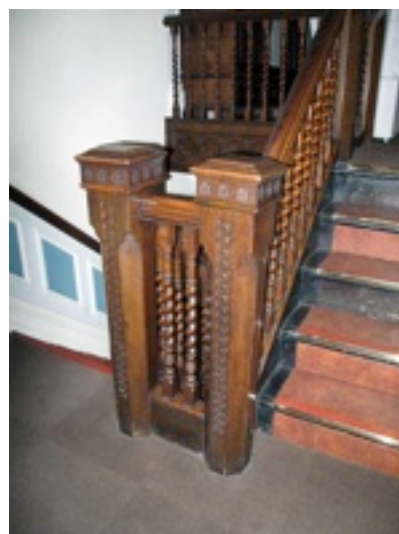
Original oak stairs with barley twist balustrade. Torchères (Light fittings to newels) are probably later and dating from when the house was converted to electricity. The bottom torchère figure depicts 'Mercury' and is similar to one which was displayed on a pedestal outside the main elevation (now removed). The first floor torchère figure is Art Nouveau in style. The wainscot paneling and dado continue from hallway up to the half landing. The ceiling also retains its original plaster coving, picture rail and either Lincrusta or Anaglypta frieze.

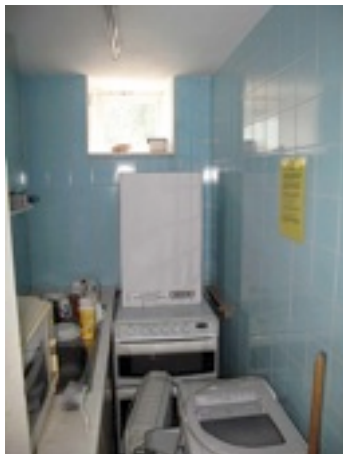
| Room | Location | Use | Original Use | Significance |
|---|---|---|---|---|
| 109 | First Floor | Toilet | Dark room | None |

Modern refit housing toilets, originally the area was a dark room and part of the Lunn's 1903 addition.

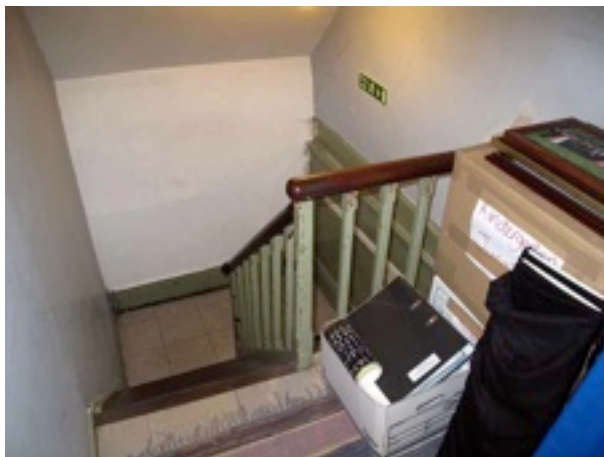
| Room | Location | Use | Original Use | Significance |
|---|---|---|---|---|
| 202 | Attic | Landing | Landing | None |

Little historic interest. Balustrade missing.
