## **SPRINGHEAD FARM SCHOLES MOOR ROAD SCHOLES HOLMFIRTH HD9 1RU**

### **1.0 Introduction**

- 1.1 We are instructed by Mr & Mrs P Crompton care of Townsend Planning Consultants, 10 Rishworth Street, Wakefield, WF1 3BY to undertake a survey of the farm buildings within the yard of the subject property, Springhead Farm, Scholes Moor Road, Scholes.

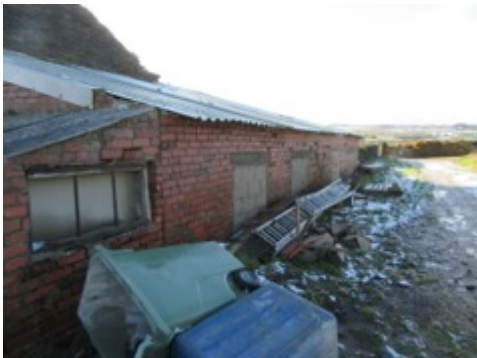
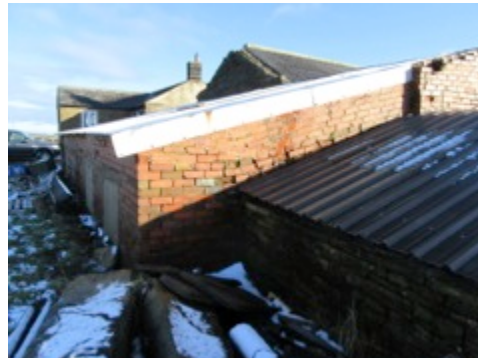
#### 4.0 Milking Parlour

- 4.1 This is a single-storey building at the right hand side of the complex and has a mono-pitched, profiled steel sheet covered roof structure, surmounting solid brick walls.

- 4.2.1 Overall the covering is weatherproof with no evidence of water ingress. Metal sheet covered roofs are not suitable for habitable buildings and will require removing as a matter of course to comply with current Building Regulations.
- 4.2.2 There is evidence of insect attack in the structural members in the roof. You should anticipate treating timbers against further deterioration. The extent of the infestation does not appear to be impairing the structural members.

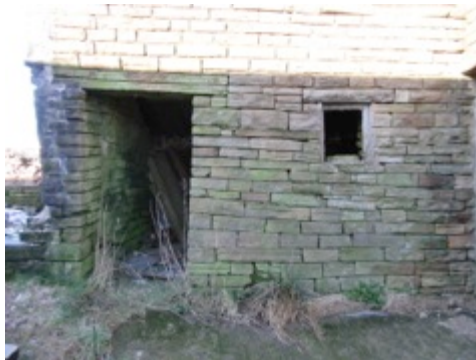
#### 4.5 Rear Right Hand Side Store

- 4.5.1 The roof is a mono-pitched construction with a covering of profiled metal sheets supported on a timber frame. The covering and structure are in serviceable condition.

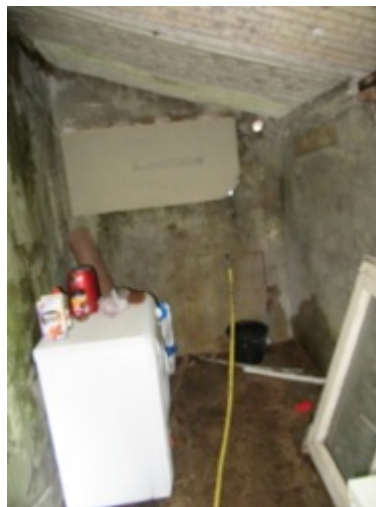
- 4.6.3 Internally there are no significant structural defects in the walls or floor.
