# **FLOOD RISK ASSESSMENT**

**Land at  
Cellars Clough,  
Nr Marsden,  
Huddersfield,  
West Yorkshire  
HD7 6NB**

**E15/6518/FRA001A**

**April 2016  
REVISED September 2017**

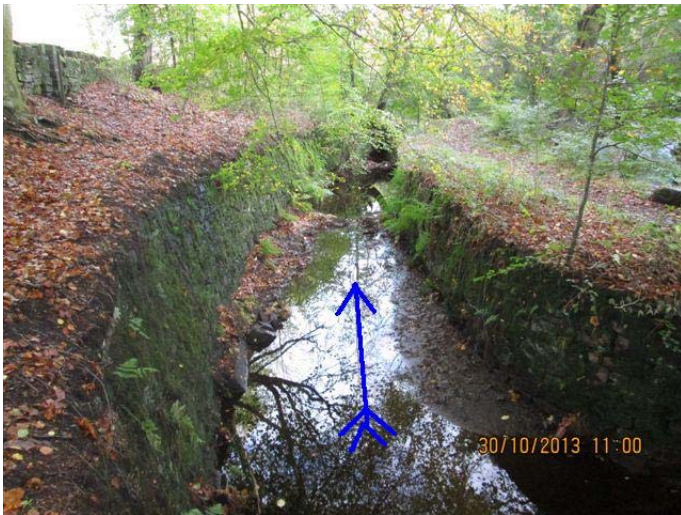
**3. Masonry lined inlet channel**

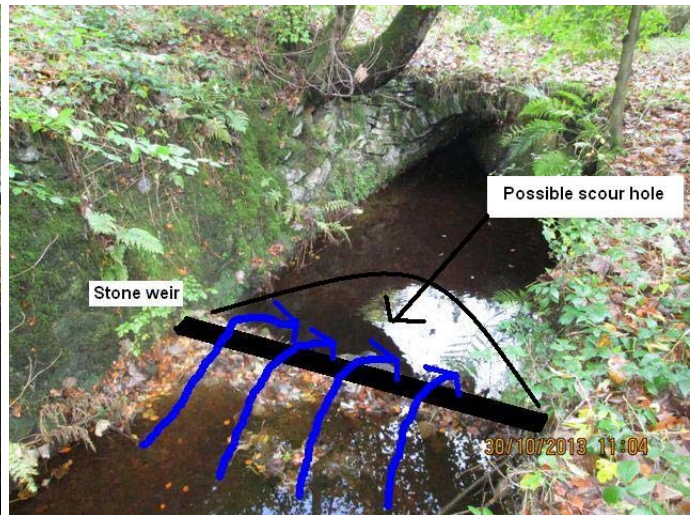
**4. Stone weir in inlet channel**

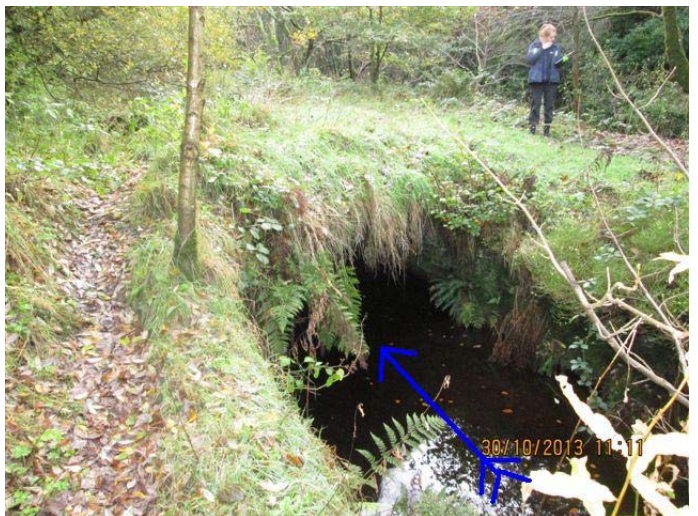
**6. Bridge over inlet channel**

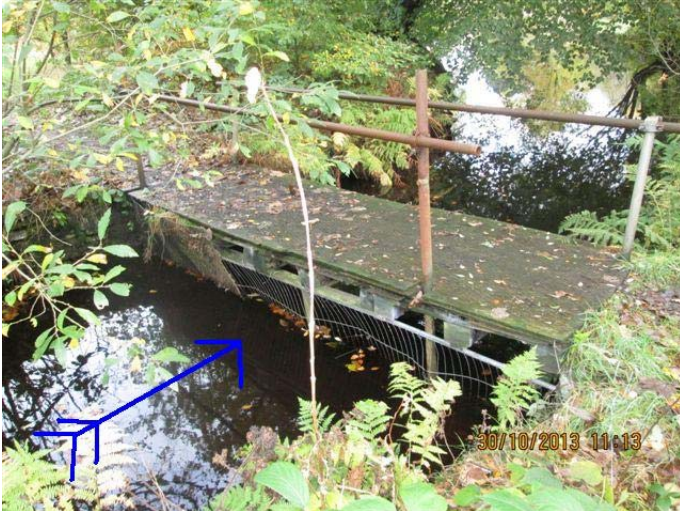
**7. Scaffold access bridge over inlet channel**

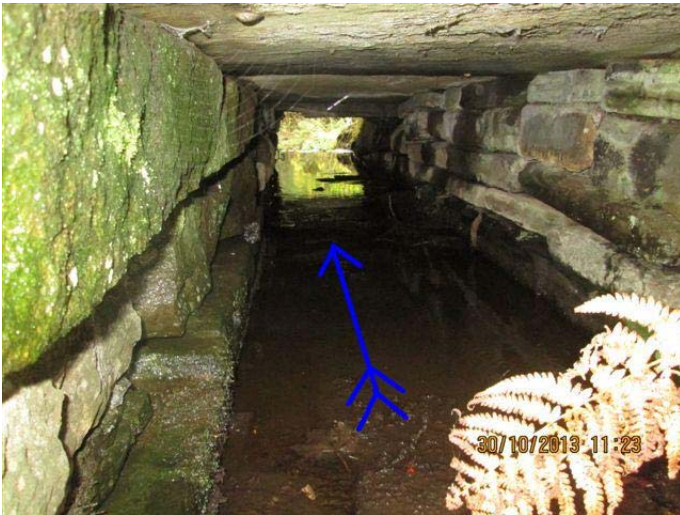
**9. Rectangular culvert from overflow**

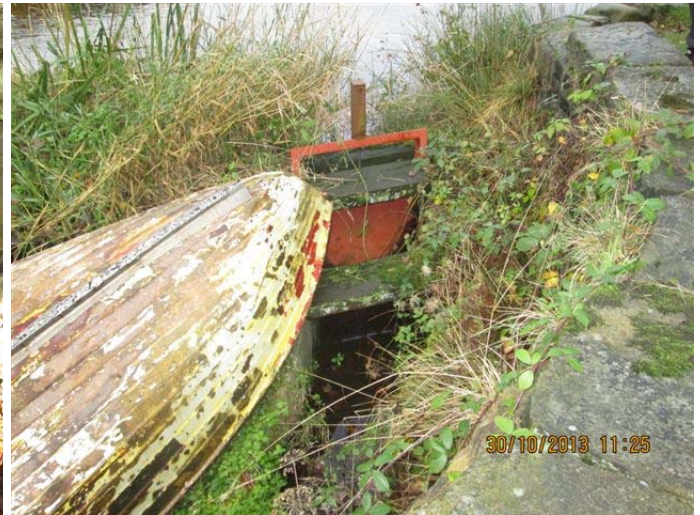
**10. Sluice control on left side of overflow**

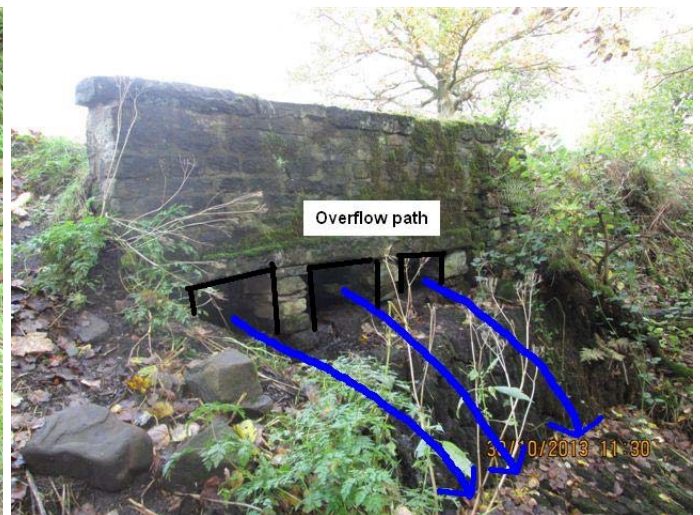
**12. Culverts from overflow into watercourse**
