Cellars Clough, Marsden

Road Safety Audit
Stage 1
August 2018

Project No: 1048

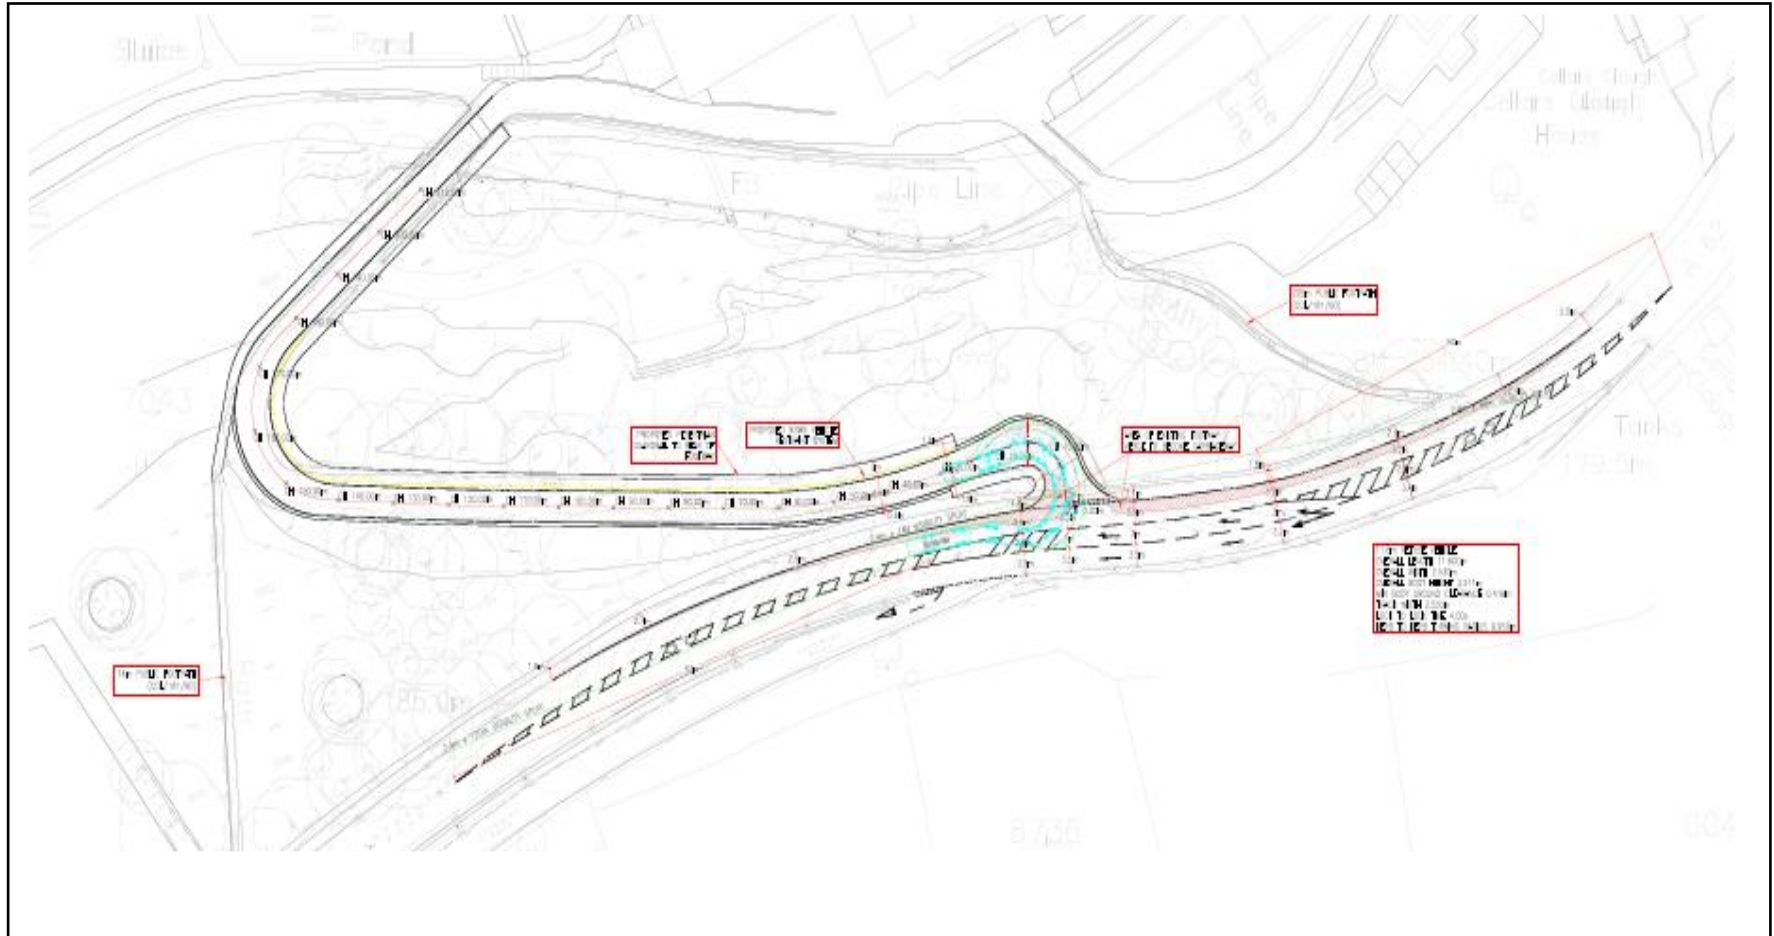
Figure 1 indicates the extents of the scheme considered under this Stage 1 Road Safety Audit in accordance with the Audit Brief.
