**Former Mill Building**

**Dobroyd Mills**

**Jackson Bridge, Hepworth**

**Client:** Mr Z Hinchcliffe  
**Project Number:** 15271  
**Date:** 22<sup>nd</sup> May 2016

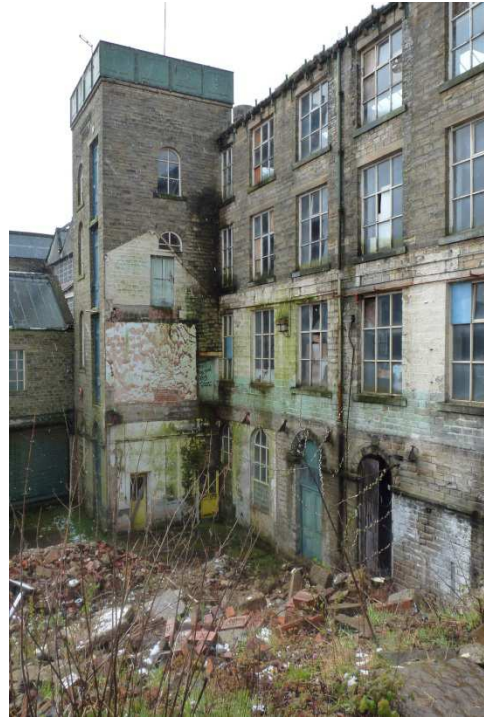
Lean-to extension now demolished

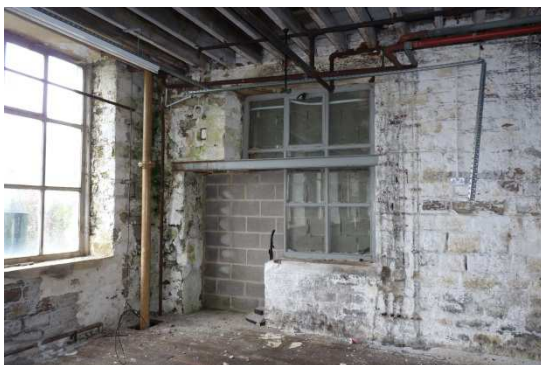
- 6.7 There have been some alterations to gable wall and door positions where access has been created to the mill extensions at the south. There are also subsequent alterations of the original openings.

Alterations to the south gable wall window

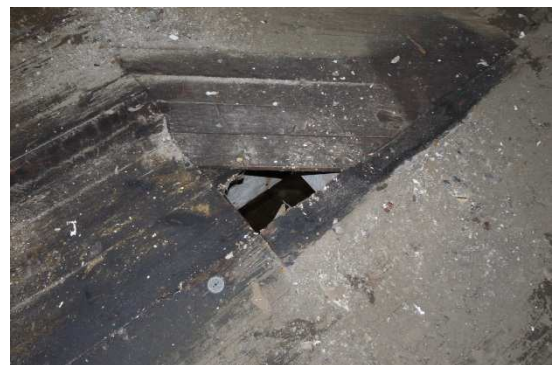
Hole through the floor

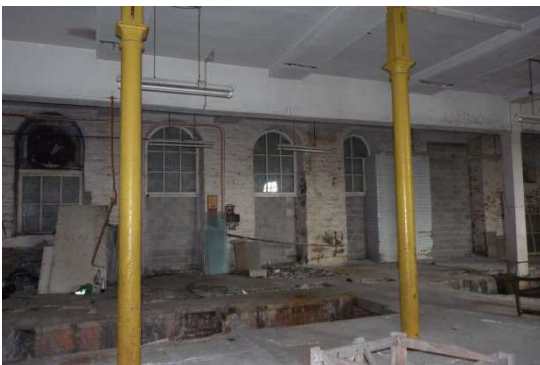
- 6.12 The northern part of the ground floor is of concrete construction and has several exposed large ducts in it. These appear to have been used as part of a washing or dyeing process. Again cast iron columns, painted yellow, support the 1<sup>st</sup> floor over.

Ducts in the floor

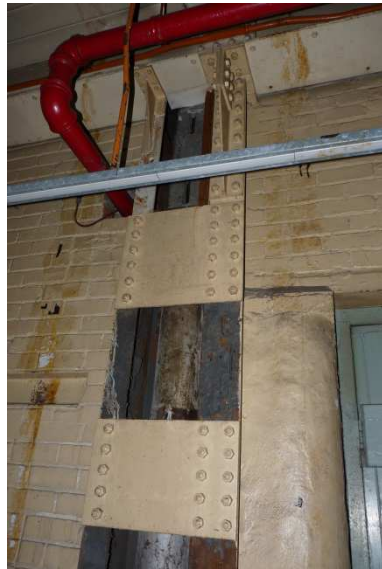
Additional steelwork strengthening

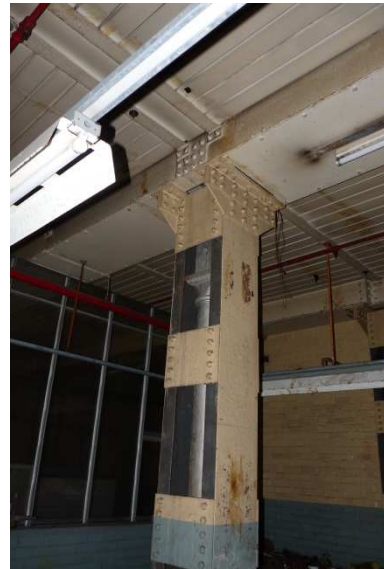
Additional steelwork around a column

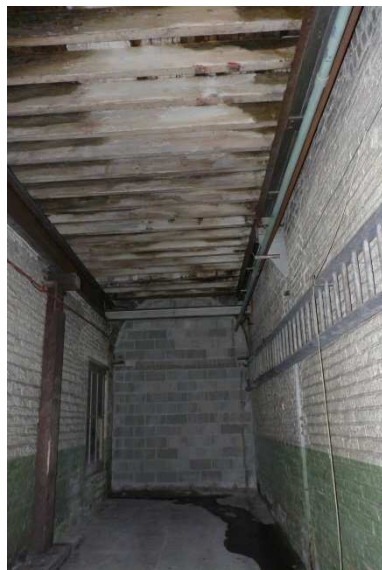
Blocked up entrance arched
