# RICS **Building Survey**

34 Thornhill Road, Huddersfield, HG3 3DD

5<sup>th</sup> April, 2018

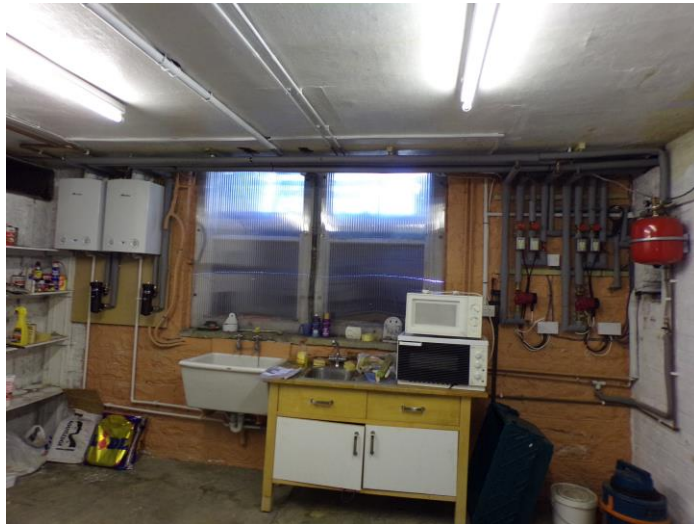
View of cellar

- F9 The cellar is accessed via a staircase off the rear lobby. 1
- Other The area is as originally built with the property. Inevitably, based on age, the cellar will not have been built to resist damp and ground moisture penetration.
- The area has not been fitted out for habitation and is used as a storage area only. Adequate ventilation has been provided.
- The cellar is in satisfactory condition bearing in mind its intended use. Normal maintenance will be needed.

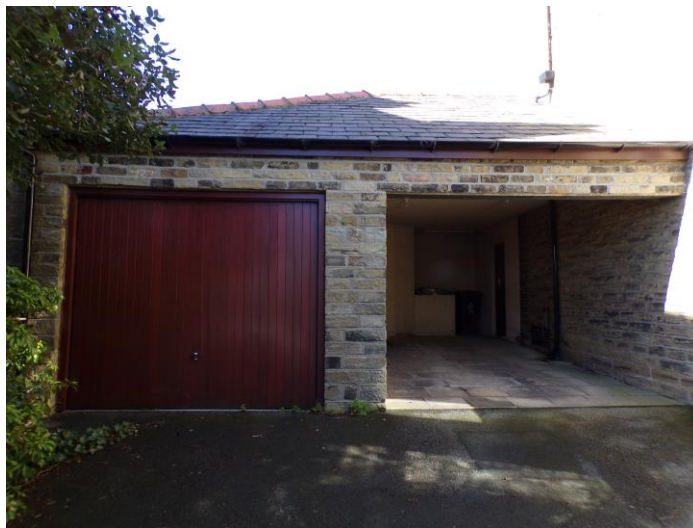
Garage

The garage /carport is in satisfactory condition generally but there is evidence of normal weathering. Normal maintenance will be required.
