## Phase 1 GeoEnvironmental Desk Study

120 Laund Road

Salendine Nook

**Report No. A0697/17**

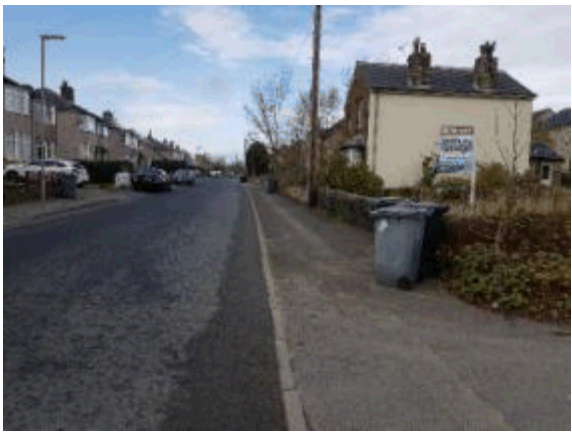
| <p align="center"><b>Plate 1 Laund Road, adjacent to the west of the site.</b></p> | <p align="center"><b>Plate 2 Access Road in the west of the site, facing northeast.</b></p> |

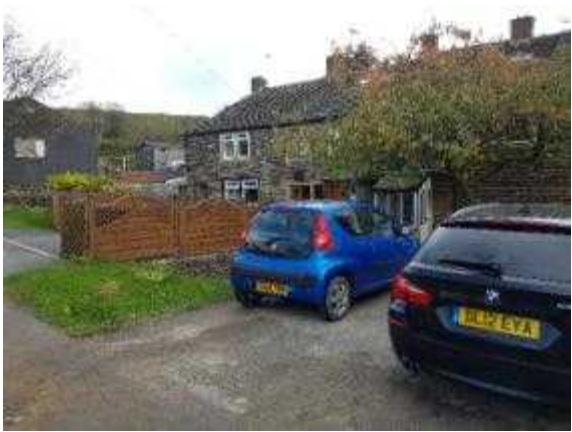
| <p align="center"><b>Plate 3 Adjacent residential dwellings, facing northeast.</b></p> | <p align="center"><b>Plate 4 Residential dwelling and private gardens in the northwest of the site.</b></p> |

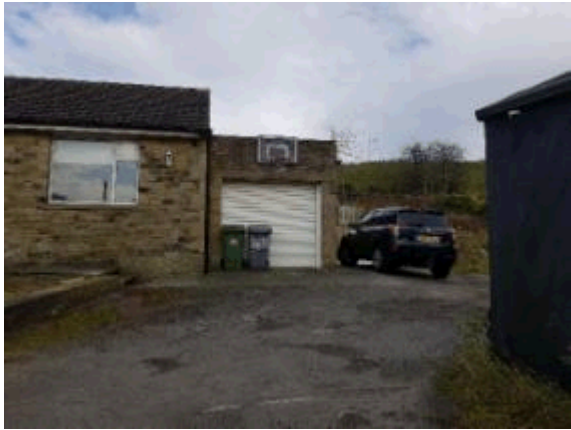
| <p><b>Plate 5</b> Domestic garage adjoining the eastern façade of the residential dwelling.</p> | <p><b>Plate 6</b> Rear of the residential dwelling, facing north.</p> |

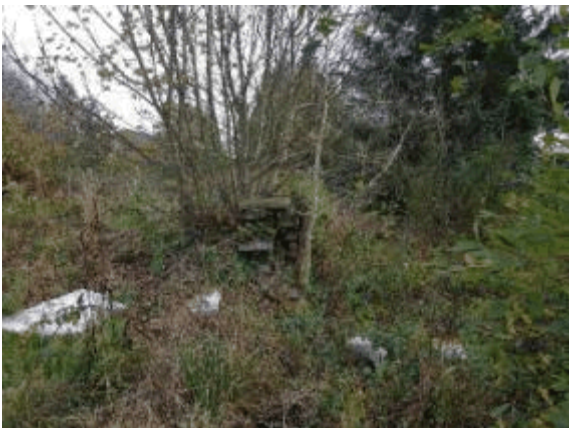
| <p><b>Plate 9</b> Low rise brick wall in the southeast of the site.</p> | <p><b>Plate 10</b> Retaining wall along the eastern boundary and adjacent open farmland.</p> |

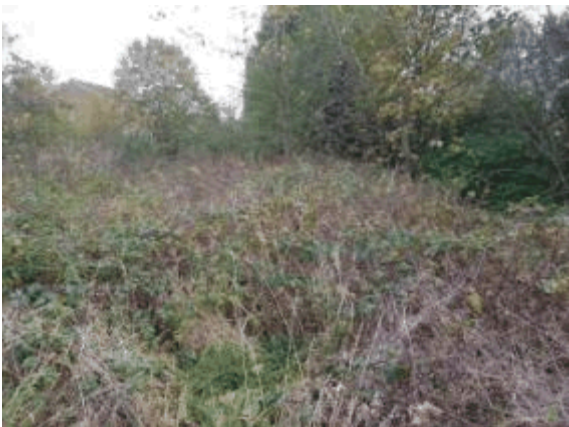
| <p><b>Plate 11</b> Overgrown vegetation and mature trees in the southeast of the site.</p> | <p><b>Plate 12</b> Looking north across the north of the site.</p> |
