# Cumberworth Lane, Denby Dale

Road Safety Audit

Stage 1

Project No: 1242

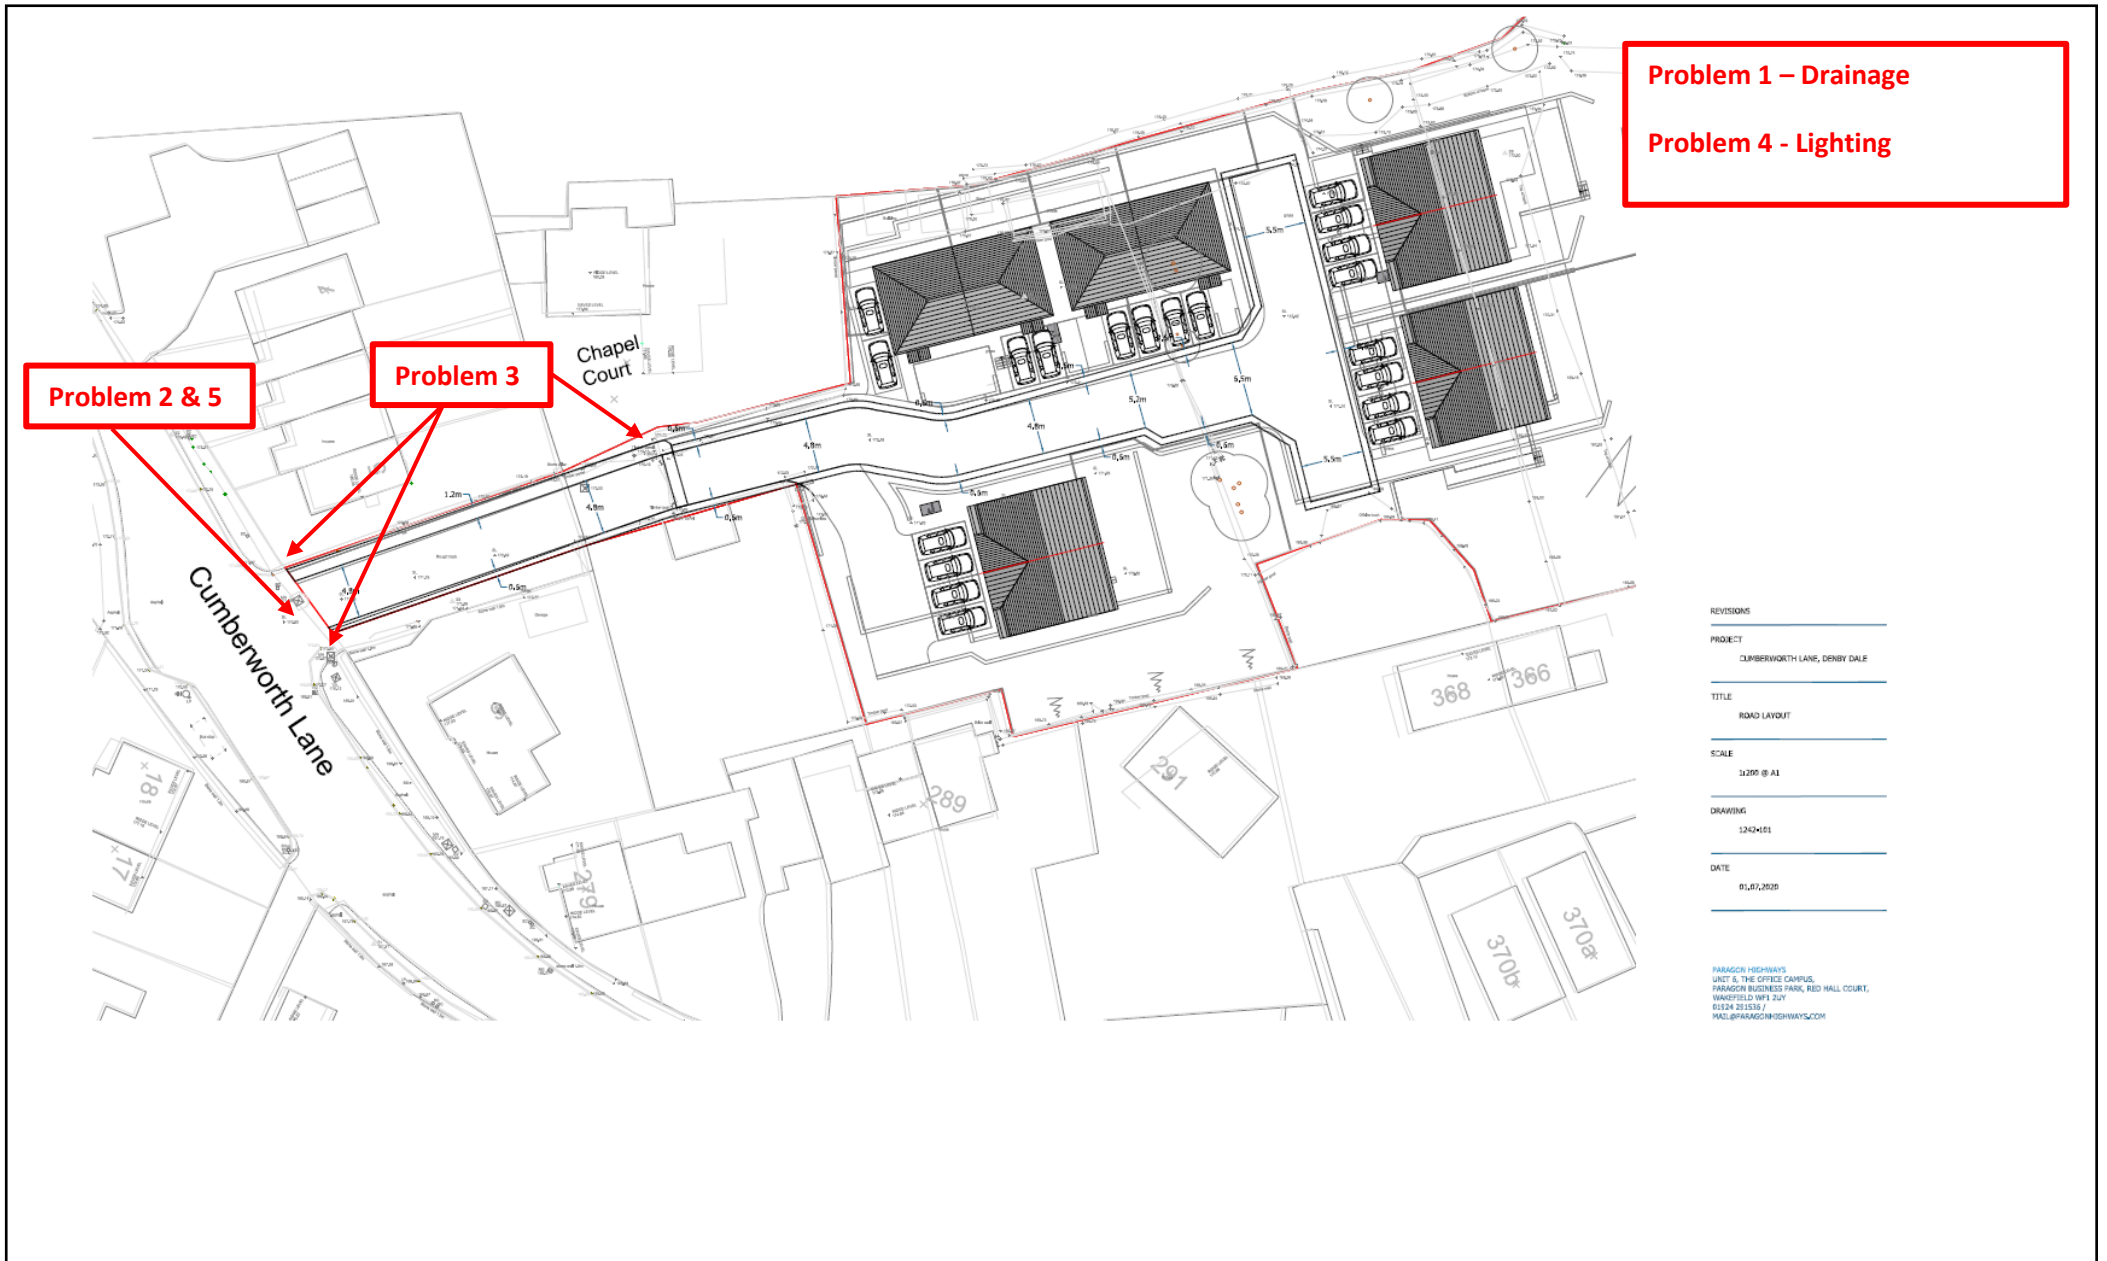
## APPENDIX B – PROBLEM LOCATION PLAN

**Detail:** There are no details of any drainage provision along the site frontage or within the new access road. The drawings do not show any drainage detail or proposed gullies along the site frontage at the new junction with Cumberworth Lane or along the new access road. Failure to adequately drain the area, particularly at the new junction could lead to loss of control collisions due to skidding or failure to give way, especially during icy conditions in the winter months. Furthermore, standing water can lead to premature carriageway deterioration resulting in potholes. There is an existing gully on the south-east side of Cumberworth Lane below the proposed access road but this may not be in the most suitable position.

**Summary:** Risk of collisions due to position of existing bus stop and inadequate sightlines.

**Recommendation:** Ensure there is adequate drainage especially at the junction and at any low spots within the new highway.

**Recommendation:** Ensure that adequate sightlines can be achieved and that the existing bus stop and clearway do not create a problem for vehicles exiting the new development.

**Recommendation:** Provide dropped crossings at suitable locations where pedestrians are expected to cross or step into the road and ensure that the proposed ramp does not create a trip hazard.

**Recommendation:** Provide adequate street lighting to current guidelines at the new junction and along the access road.

**Recommendation:** Provide suitable junction markings to indicate the edge of carriageway as a minimum or give way markings if deemed necessary.
