Pre-development Arboricultural Report

Date of report: 22nd August 2018 (updated 27th March 2020)

Reference: OWA084 PDR

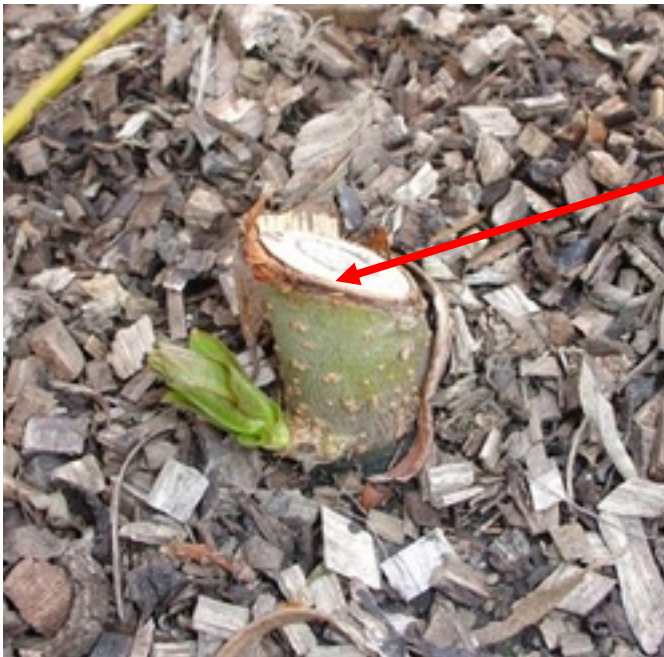
This is taken from the above website and shows how the cut should be made.

You can see the new growth appearing already.

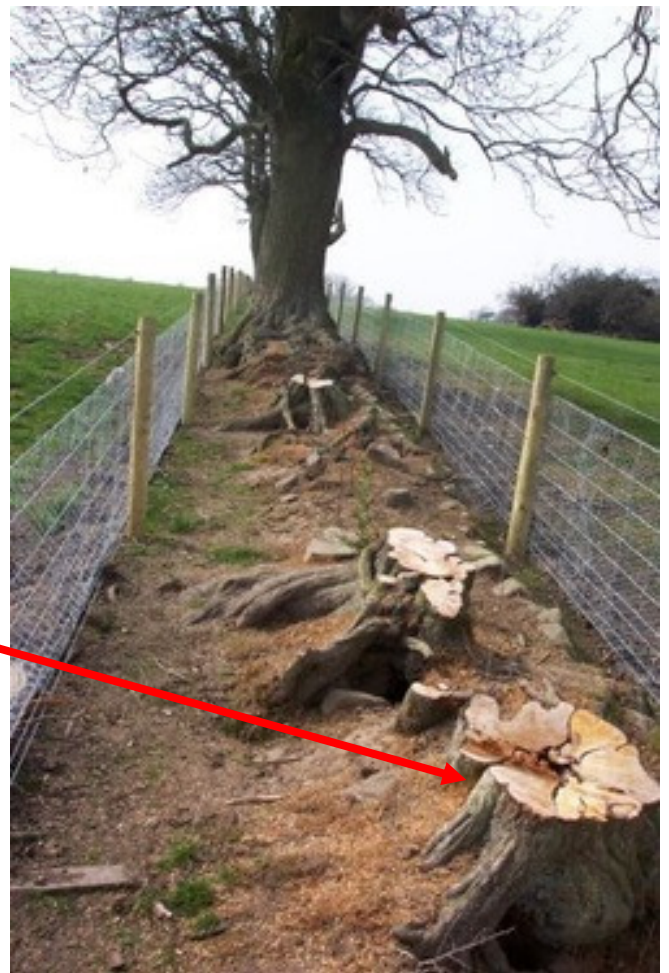
Note that the hedge in the picture has been fenced; this is to keep stock out. Fencing is not required at Church Lane, Mirfield to successfully rejuvenate the Hawthorn.
