# Mine Entry Interpretive Report

9 RILEY LANE, KIRKBURTON, HUDDERSFIELD, HD8 0RZ

| Our reference: | 51001424330002 |

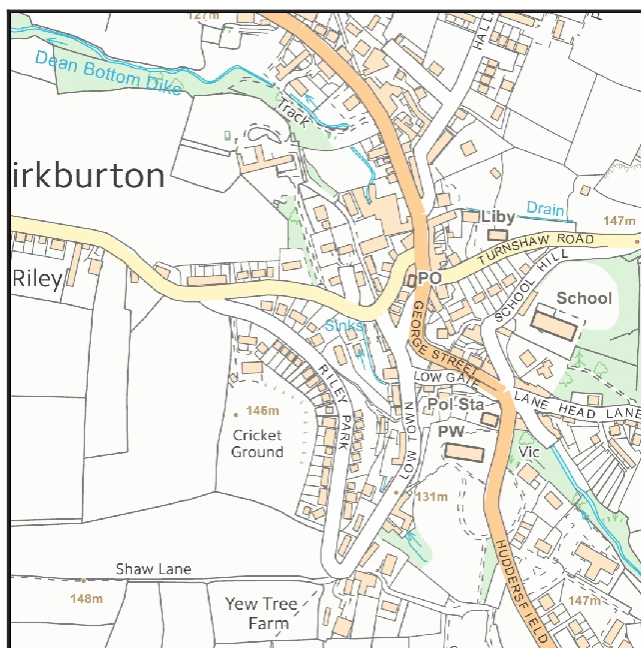
Approximate position of property

The possibility of subsidence damage to the garden areas/other buildings is very small but should not be discounted completely.

In our opinion, the main building (as shown on the plan) is not at risk of coal mining subsidence damage from the subject mine entry. This is because it is not within the area of possible ground movement.
