## STRUCTURAL INSPECTION REPORT

Original Farmhouse, Yew Tree Farm,  
Farnley Tyas  
For John Radcliffe and Sons

Date 05/11/2021  
Ref **4011/SIR002**

### **STRUCTURAL INSPECTION REPORT – ORIGINAL FARMHOUSE (BUILDING 6)**

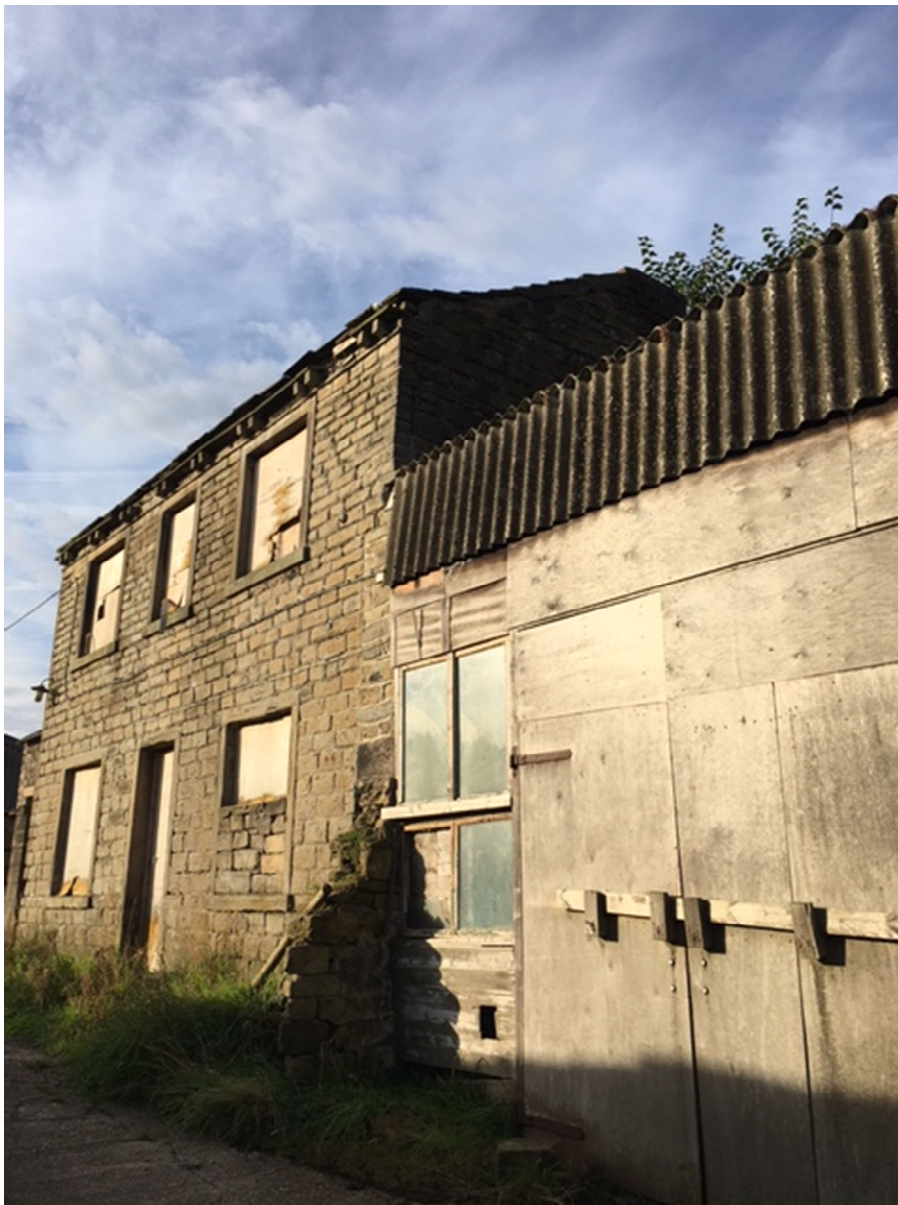
The original farmhouse building is a two-storey stone-built structure with a dual pitch roof. External inspection of the building confirms a York stone roof. Attached to the southern gable, there is a single storey dual pitched roof outbuilding of similar construction, and a temporary farm canopy structure is attached to the north.

The two-storey element of the building is approximately 8m long by 5.5m wide on plan and approximately 5m to eaves. The roof pitch is approximately 20 degrees.
