STRUCTURAL INSPECTION REPORT

Original Farmhouse, Yew Tree Farm,
Farnley Tyas
For John Radcliffe and Sons

Date 05/11/2021
Ref **4011/SIR002**

STRUCTURAL INSPECTION REPORT – ORIGINAL FARMHOUSE (BUILDING 6)

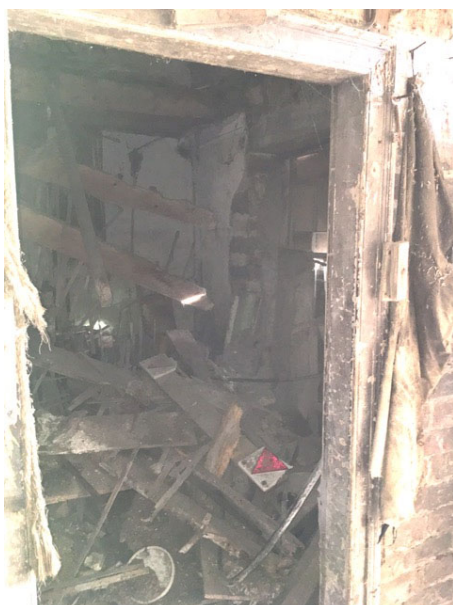
Safe internal inspection of the building is not possible. However, a partial inspection revealed a section of completely collapsed first floor construction and evidence of widespread structural deterioration due to water penetration.

Collapsed first floor and ceiling structures

The collapse of the first floor and the associated loss of lateral restraint to the external walls render the building unsafe and consequently it should be secured against entry immediately.

The controlled demolition of the building is therefore recommended under a contract which should include all necessary CDM measures.
