Refurbishment / Demolition Asbestos Survey

**Lowdham Leisure World,
Blackmoorfoot Road,
Huddersfield, HD4 5NU**

Issue number:	1
Survey number:	7168
Survey date:	10/06/2021
Client:	Redrow Homes Ltd
Survey carried out by:	Phil Cox
Survey compiled by:	Graham Brown
Survey checked by:	Phil Cox
Survey Issued	21/06/2021

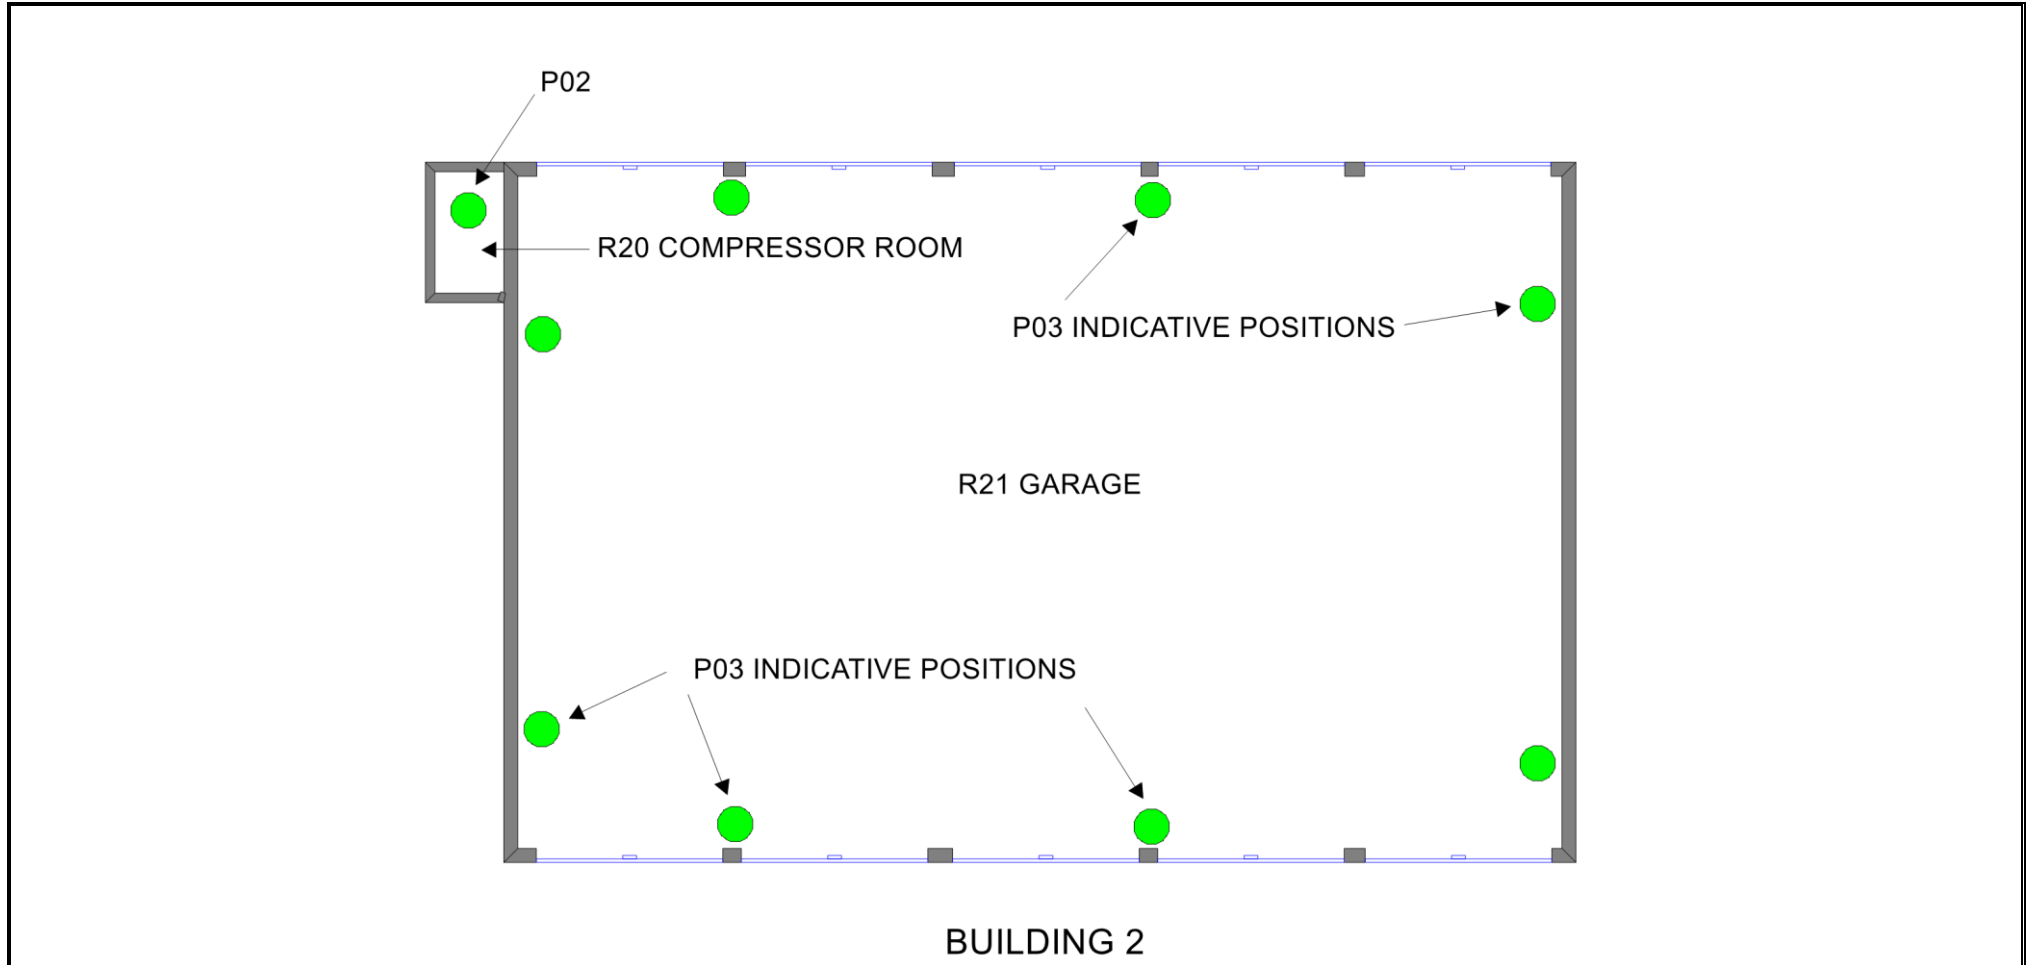
BUILDING 2

NOTATION KEY			PROJECT	Blackmoorfoot Road Huddersfield,
		Negative Sample		DRAWING No	7168/3
		Presumed Asbestos to safe		SCALE	nts
		Presumed textile flashguards to Electrical Switchgear		DATE	15/06/21

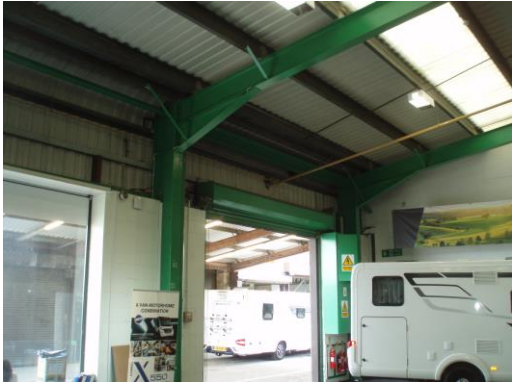
Level of ID:	Visually inspected	Ref:	c
	<p>Building / Floor: 1 / Ground</p> <p>Area: R01 Reception/Showroom</p> <p>Location: Ceiling</p> <p>Description: Steel portal frame,insulated cladding, modern heater</p> <p>Asbestos Type: No suspect material</p> <p>Amount:</p>			
Recommendations:				
No action required

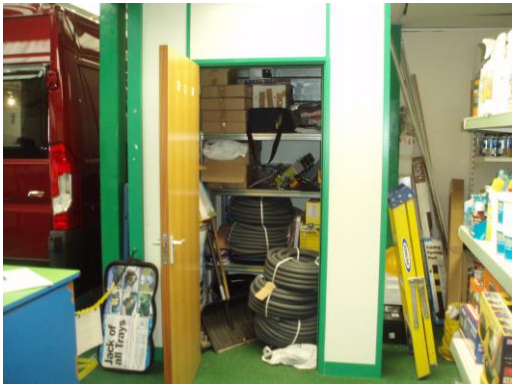
Level of ID:	Visually inspected	Ref:	c
	<p>Building / Floor: 1 / Ground</p> <p>Area: R02 Under stairs cupboard</p> <p>Location: Ceiling</p> <p>Description: Metal stairs above</p> <p>Asbestos Type: No suspect material</p> <p>Amount:</p>			
Recommendations:				
No action required

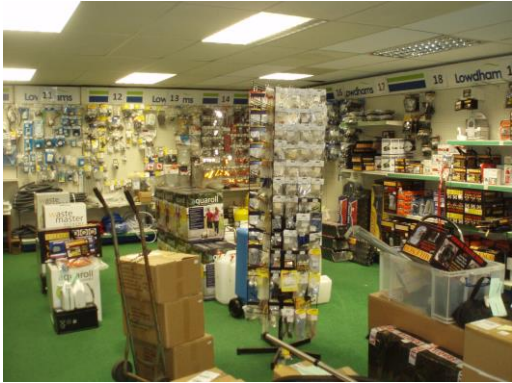
Level of ID:	Visually inspected	Ref:	c
	<p>Building / Floor: 1 / Ground</p> <p>Area: R03 Stores</p> <p>Location: Ceiling</p> <p>Description: Suspended ceiling, metal mezzanine floor above</p> <p>Asbestos Type: No suspect material</p> <p>Amount:</p>			
Recommendations:				
No action required

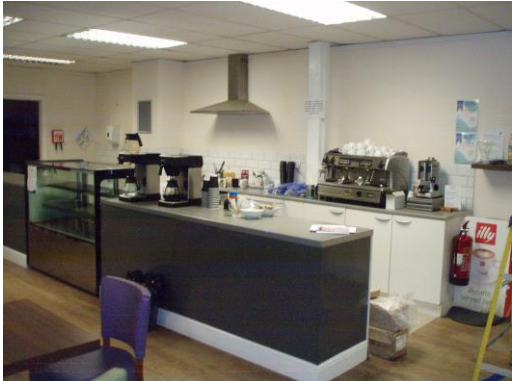
Level of ID:	Visually inspected	Ref:	c
	<p>Building / Floor: 1 / Ground</p> <p>Area: R04 Kitchen area</p> <p>Location: Ceiling</p> <p>Description: Suspended ceiling, metal mezzanine floor above</p> <p>Asbestos Type: No suspect material</p> <p>Amount:</p>			
Recommendations:				
No action required

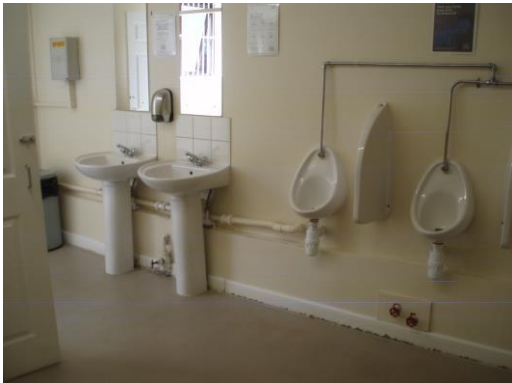
Level of ID:	Visually inspected	Ref:	c
	<p>Building / Floor: 1 / Ground</p> <p>Area: R06 Gents toilet</p> <p>Location: Wall</p> <p>Description: Masonry & stud walls, modern sanitaryware</p> <p>Asbestos Type: No suspect material</p> <p>Amount:</p>			
Recommendations:				
No action required

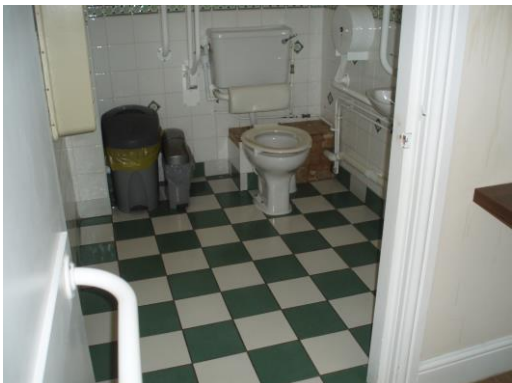
Level of ID:	Visually inspected	Ref:	c
	Building / Floor: 1 / Ground Area: R09 Disabled toilet Location: Floor Description: Ceramic tiles on concrete Asbestos Type: No suspect material Amount:			
Recommendations:				
No action required

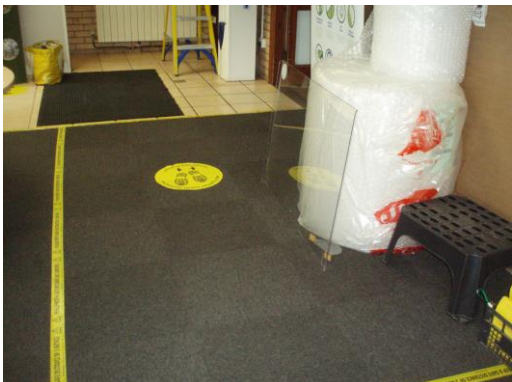
Level of ID:	Visually inspected	Ref:	c
	Building / Floor: 1 / Ground Area: R12 Main office Location: Floor Description: Carpet & ceramic tiles on concrete Asbestos Type: No suspect material Amount:			
Recommendations:				
No action required

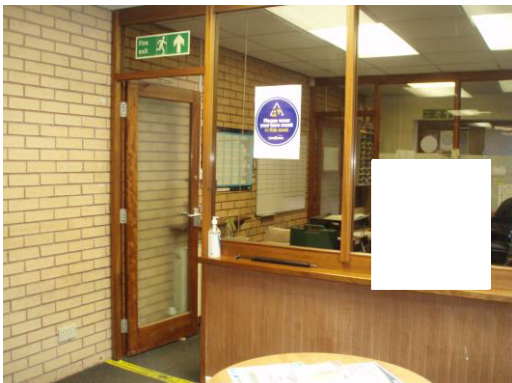
Level of ID:	Visually inspected	Ref:	c
	Building / Floor: 1 / Ground Area: R14 Offices Location: Wall Description: Masonry & timber glazed screens Asbestos Type: No suspect material Amount:			
Recommendations:				
No action required

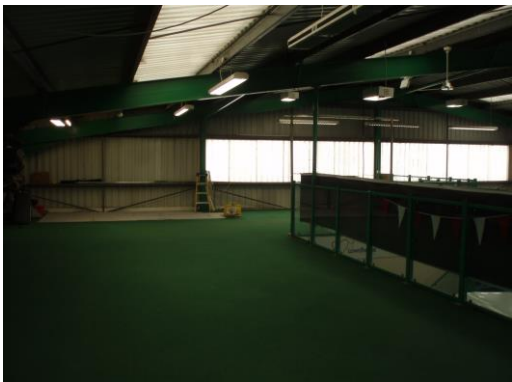
Level of ID:	Visually inspected	Ref:	c
	Building / Floor: 1 / First Area: R15 Mezzanine showroom Location: Ceiling Description: Open to clad roof Asbestos Type: No suspect material Amount:			
Recommendations:				
No action required

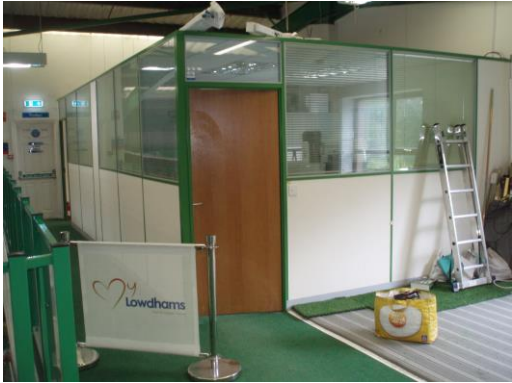
Level of ID:	Visually inspected	Ref:	c
	Building / Floor: 1 / First Area: R16 Office Location: Wall Description: Masonry & de-mountable partitions Asbestos Type: No suspect material Amount:			
Recommendations:				
No action required

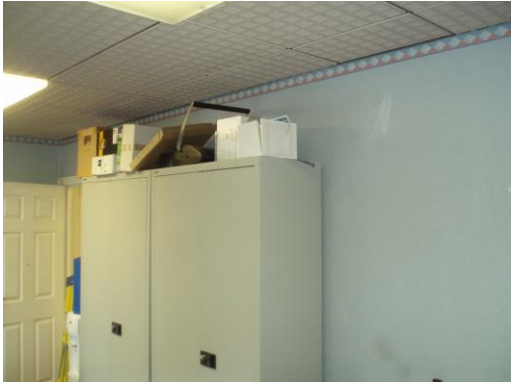
Level of ID:	Visually inspected	Ref:	c
	Building / Floor: 1 / First Area: R19 Office & store Location: Wall Description: Masonry & stud wall at first floor level Asbestos Type: No suspect material Amount:			
Recommendations:				
No action required

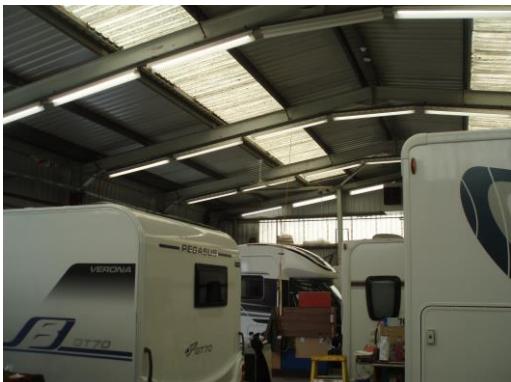
Level of ID:	Visually inspected	Ref:	c
	Building / Floor: 2 / First Area: R21 Garage Location: Ceiling Description: Steel portal frame with insulated cladding Asbestos Type: No suspect material Amount:			
Recommendations:				
No action required

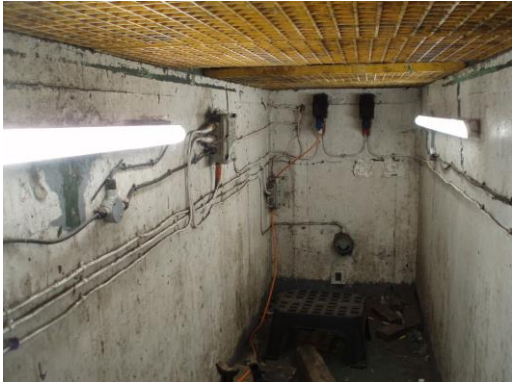
Level of ID:	Visually inspected	Ref:	c
	<p>Building / Floor: 2 / First</p> <p>Area: R21 Garage</p> <p>Location: Floor</p> <p>Description: Concrete, with masonry pits in the bays</p> <p>Asbestos Type: No suspect material</p> <p>Amount:</p>			
Recommendations:				
No action required

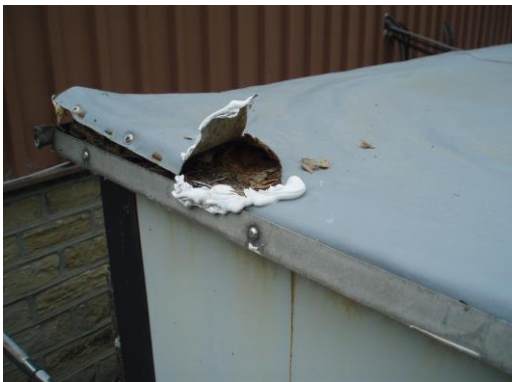
Level of ID:	Visually inspected	Ref:	c
	<p>Building / Floor: 3 / Ground</p> <p>Area: R22 Prefabricated cabin</p> <p>Location: Ceiling</p> <p>Description: Felt on a timber construction</p> <p>Asbestos Type: No suspect material</p> <p>Amount:</p>			
Recommendations:				
No action required

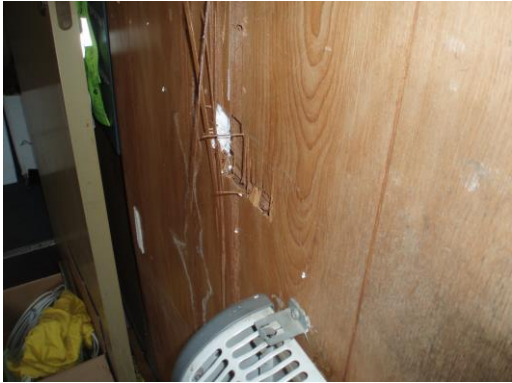
Level of ID:	Visually inspected	Ref:	c
	<p>Building / Floor: 3 / Ground</p> <p>Area: R22 Prefabricated cabin</p> <p>Location: Wall</p> <p>Description: External panel, Insulated timber</p> <p>Asbestos Type: No suspect material</p> <p>Amount:</p>			
Recommendations:				
No action required

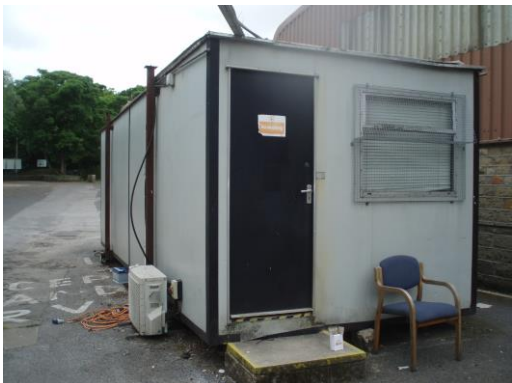
Level of ID:	Visually inspected	Ref:	c
	<p>Building / Floor: 3 / Ground</p> <p>Area: R22 Prefabricated cabin</p> <p>Location: Floor</p> <p>Description: Carpet on timber</p> <p>Asbestos Type: No suspect material</p> <p>Amount:</p>			
Recommendations:				
No action required

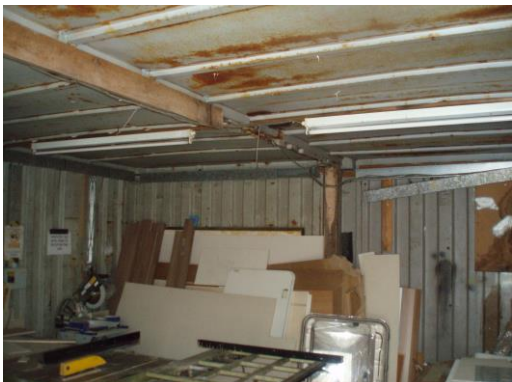
Level of ID:	Visually inspected	Ref:	c
	<p>Building / Floor: 4 / Ground</p> <p>Area: R23 Metal container</p> <p>Location: General</p> <p>Description: Metal construction, assumed Lowdams will be removing contents.</p> <p>Asbestos Type: No suspect material</p> <p>Amount:</p>			
Recommendations:				
No action required

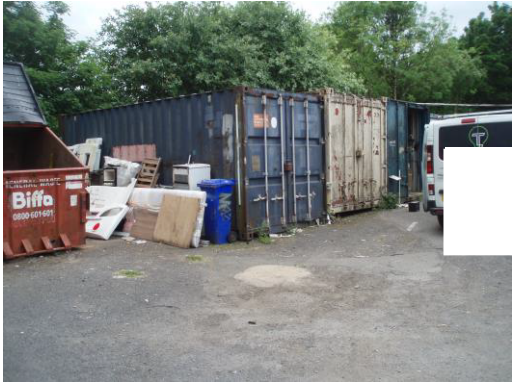
Level of ID:	Visually inspected	Ref:	c
	<p>Building / Floor: 4 / Ground</p> <p>Area: R24 Metal container</p> <p>Location: General</p> <p>Description: Metal construction, assumed Lowdams will be removing contents.</p> <p>Asbestos Type: No suspect material</p> <p>Amount:</p>			
Recommendations:				
No action required

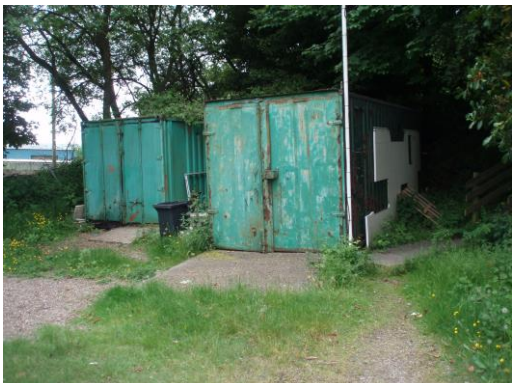
Level of ID:	Visually inspected	Ref:	c
	<p>Building / Floor: 5 / Ground</p> <p>Area: R26 Metal container</p> <p>Location: General</p> <p>Description: Metal construction, no access, assumed Lowdams will be removing contents</p> <p>Asbestos Type: No suspect material</p> <p>Amount:</p>			
Recommendations:				
No action required

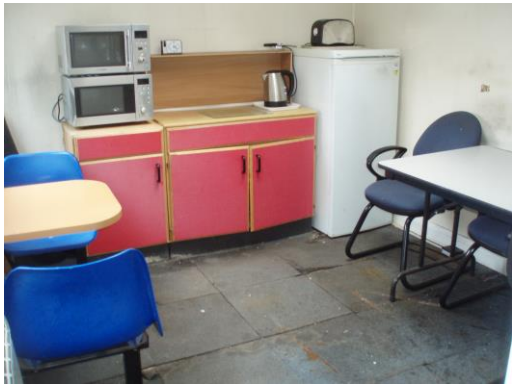
Level of ID:	Visually inspected	Ref:	c
	<p>Building / Floor: 6 / Ground</p> <p>Area: R28 Prefabricated cabin (Canteen)</p> <p>Location: Floor</p> <p>Description: Carpet on timber, modern kitchen units</p> <p>Asbestos Type: No suspect material</p> <p>Amount:</p>			
Recommendations:				
No action required

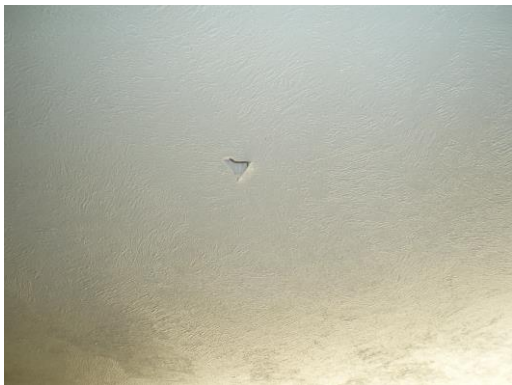
Level of ID:	Visually inspected	Ref:	c
	<p>Building / Floor: 7 / Ground</p> <p>Area: R29 Prefabricated cabin(Parts)</p> <p>Location: Ceiling</p> <p>Description: Felt on a timber construction, plasterboard ceiling</p> <p>Asbestos Type: No suspect material</p> <p>Amount:</p>			
Recommendations:				
No action required

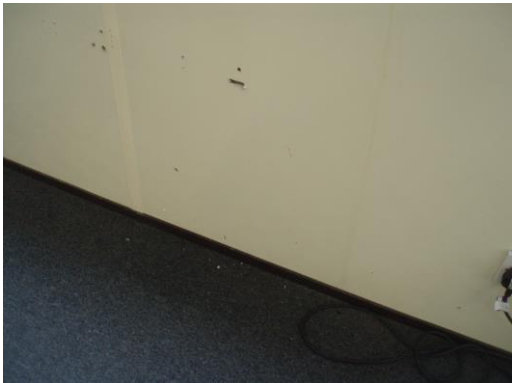
Level of ID:	Visually inspected	Ref:	c
	<p>Building / Floor: 8 / Ground</p> <p>Area: R30 Prefabricated cabin</p> <p>Location: Wall</p> <p>Description: External panel, Insulated timber, internal plasterboard</p> <p>Asbestos Type: No suspect material</p> <p>Amount:</p>			
Recommendations:				
<p>No action required</p>

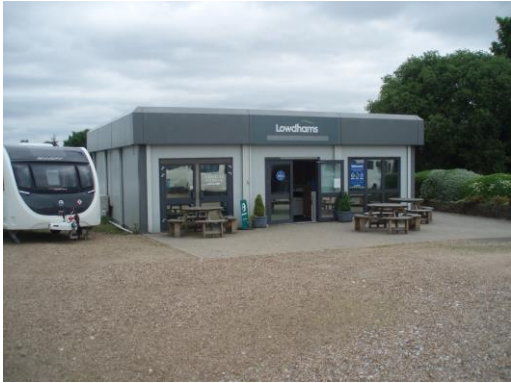
Level of ID:	Visually inspected	Ref:	c
	<p>Building / Floor: 9 / Ground</p> <p>Area: Modern modular cabin</p> <p>Location: General</p> <p>Description: Erected post 2015.</p> <p>Asbestos Type: No suspect material</p> <p>Amount:</p>			
Recommendations:				
No action required

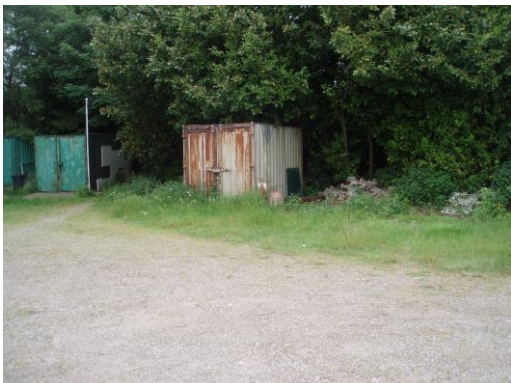
Level of ID:	Visually inspected	Ref:	c
	<p>Building / Floor: 10 / Ground</p> <p>Area: Metal container</p> <p>Location: General</p> <p>Description: Metal construction, no access, assumed Lowdams will be removing contents</p> <p>Asbestos Type: No suspect material</p> <p>Amount:</p>			
Recommendations:				
No action required

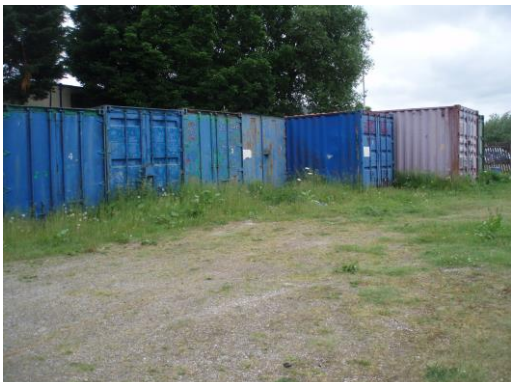
Level of ID:	Visually inspected	Ref:	c
	<p>Building / Floor: 11 / Ground</p> <p>Area: Metal containers (Several)</p> <p>Location: General</p> <p>Description: Metal construction, no access, assumed Lowdams will be removing contents</p> <p>Asbestos Type: No suspect material</p> <p>Amount:</p>			
Recommendations:				
No action required

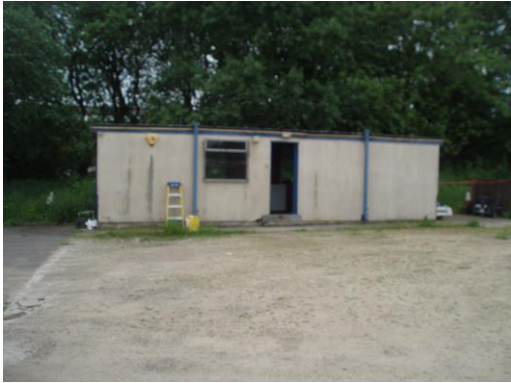
Level of ID:	Visually inspected	Ref:	As S04
	<p>Building / Floor: 12 / Ground</p> <p>Area: R31 Prefabricated cabin</p> <p>Location: Wall</p> <p>Description: Insulated timber, external textured coating (As S04)</p> <p>Asbestos Type: No asbestos detected</p> <p>Amount:</p>			
Recommendations:				
No action required

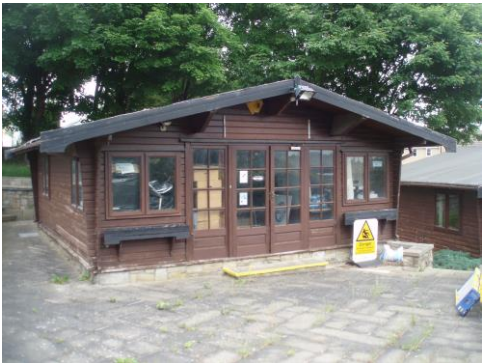
Level of ID:	Visually inspected	Ref:	c
	<p>Building / Floor: 13 / Ground</p> <p>Area: R32 Timber chalet style cabin</p> <p>Location: Ceiling</p> <p>Description: Timber structure with felt covering, internal timber</p> <p>Asbestos Type: No suspect material</p> <p>Amount:</p>			
Recommendations:				
No action required

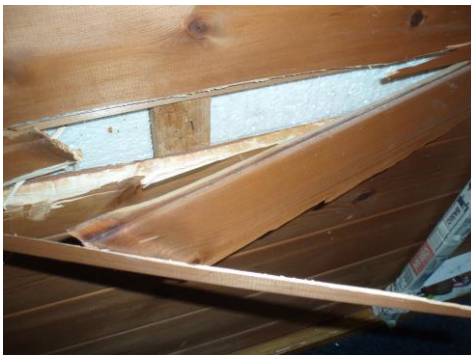
Level of ID:	Visually inspected	Ref:	c
	<p>Building / Floor: 13 / Ground</p> <p>Area: R32 Timber chalet style cabin</p> <p>Location: Wall</p> <p>Description: Insulated timber, timber partitions, modern kitchen units</p> <p>Asbestos Type: No suspect material</p> <p>Amount:</p>			
Recommendations:				
No action required

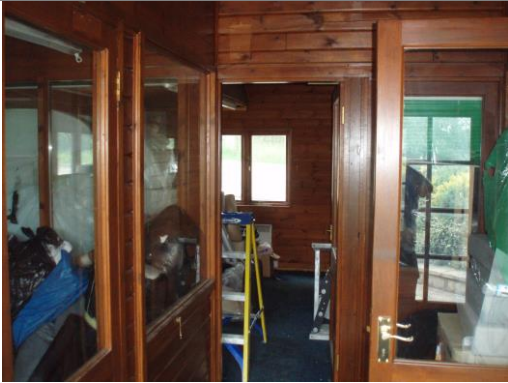
Level of ID:	Visually inspected	Ref:	c
	<p>Building / Floor: 13 / Ground</p> <p>Area: R32 Timber chalet style cabin</p> <p>Location: Wall</p> <p>Description: Insulated timber, timber partitions, modern kitchen units</p> <p>Asbestos Type: No suspect material</p> <p>Amount:</p>			
Recommendations:				
No action required

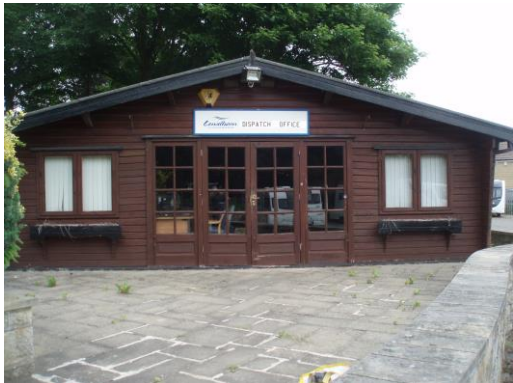
Level of ID:	Visually inspected	Ref:	c
	<p>Building / Floor: 14 / Ground</p> <p>Area: R33 Timber chalet style cabin</p> <p>Location: Ceiling</p> <p>Description: Timber structure with felt covering, internal timber</p> <p>Asbestos Type: No suspect material</p> <p>Amount:</p>			
Recommendations:				
No action required

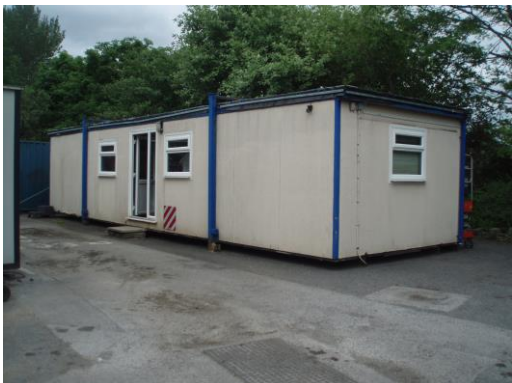
Level of ID:	Visually inspected	Ref:	As S03
	<p>Building / Floor: 15 / Ground</p> <p>Area: R34 Prefabricated cabin</p> <p>Location: Wall</p> <p>Description: Insulated timber, external textured coating (As S03)</p> <p>Asbestos Type: No asbestos detected</p> <p>Amount:</p>			
Recommendations:				
No access due to a Bee's nest, visually the same as building 6

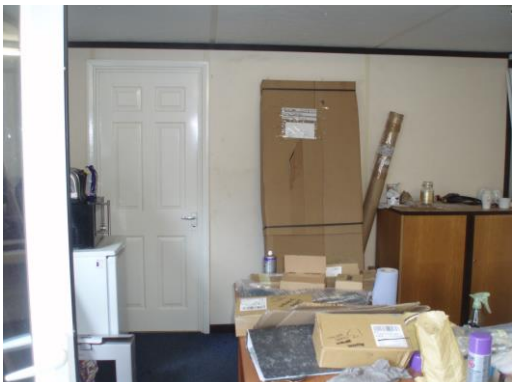
Level of ID:	Visually inspected	Ref:	c
	<p>Building / Floor: 16 / Ground</p> <p>Area: R35 Prefabricated cabin</p> <p>Location: Ceiling</p> <p>Description: Felt on a timber construction</p> <p>Asbestos Type: No suspect material</p> <p>Amount:</p>			
Recommendations:				
No action required
