GEOSHIELD Verification Report

PROJECT REFERENCE: GEO101204

PROJECT: Signature Homes - Holmfirth

PROJECT ADDRESS: New Mill Road

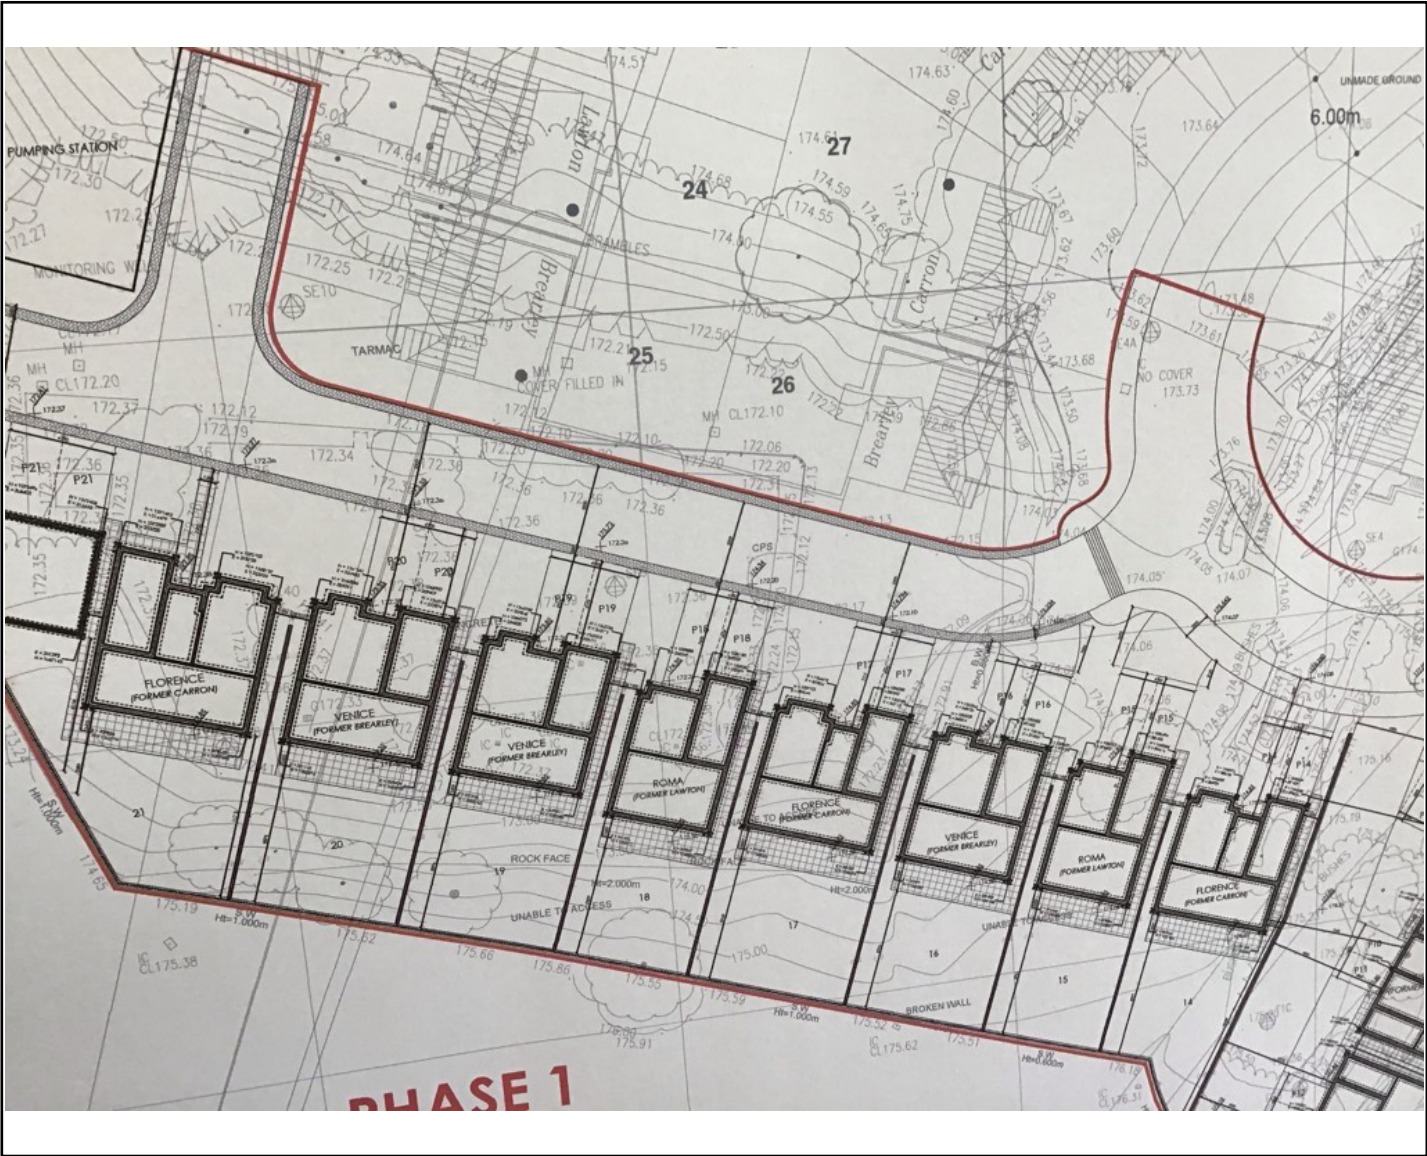
VERIFICATION LAYOUT

This report explains why Plots 14-21 have been signed off and verified.

RESTRICTIONS AND LIMITATIONS: There has been some confusion with regards the sign off of Plots 14-21 perimeters. The verifier was new to the job and expressed some errors in the installation that were not all errors. Butyl tape was missing from the DPC cavity tray and door thresholds were sealed with the floor infill.
