## Heritage, Design & Access Statement

Project: PROPOSED WALL REMEDIATION & REPAIR

Address: Trafford House  
11 Halifax Road  
HUDDERSFIELD  
HD3 3AN

8th FEBRUARY 2022 – Revision 0

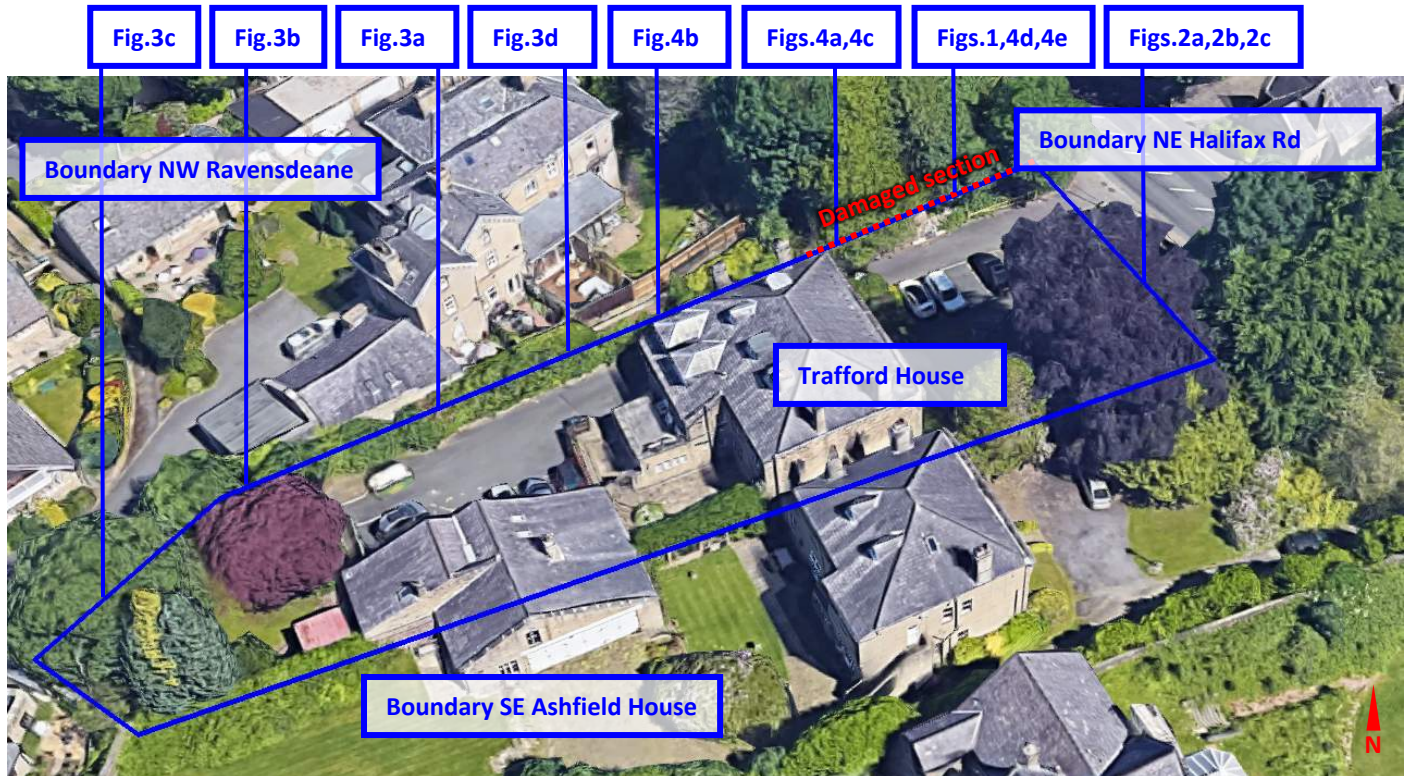
Although the boundary walls and gate piers are not in themselves listed, they are a good example of the quality and workmanship characteristic of the area and are a significant aspect of the designated heritage asset setting (Fig.2) The wall is of 19<sup>th</sup>C red clay brick on its inner leaf and faced with hammer dressed, coursed sandstone on its outer leaf. It is finished with shallow half-round, fine tooled sandstone coping along its length. Ashlar sandstone gate piers with sandstone caps form the entrance. The wall forms a continuation of the boundary with the listed neighbouring properties Ashleigh House and Ravensdeane.

There are areas of blistering and delamination to areas of stone masonry and some loss of mortar on the outer leaf. The brick masonry of the inner leaf shows general weathering, frost damage, some sulphate crystallisation, and a loss of mortar in places. This section of walling is in good, sound condition.
