COAL MINING RISK ASSESSMENT
AT
WINDMILL FARM
1 BUSKER LANE, SKELMANTHORPE
FOR
MRS H HAIGH
REPORT REF: MHH 3492

COAL MINING RISK ASSESSMENT

WINDMILL FARM
1 BUSKER LANE, SKELMANTHORPE

REPORT REF: MHH 3492

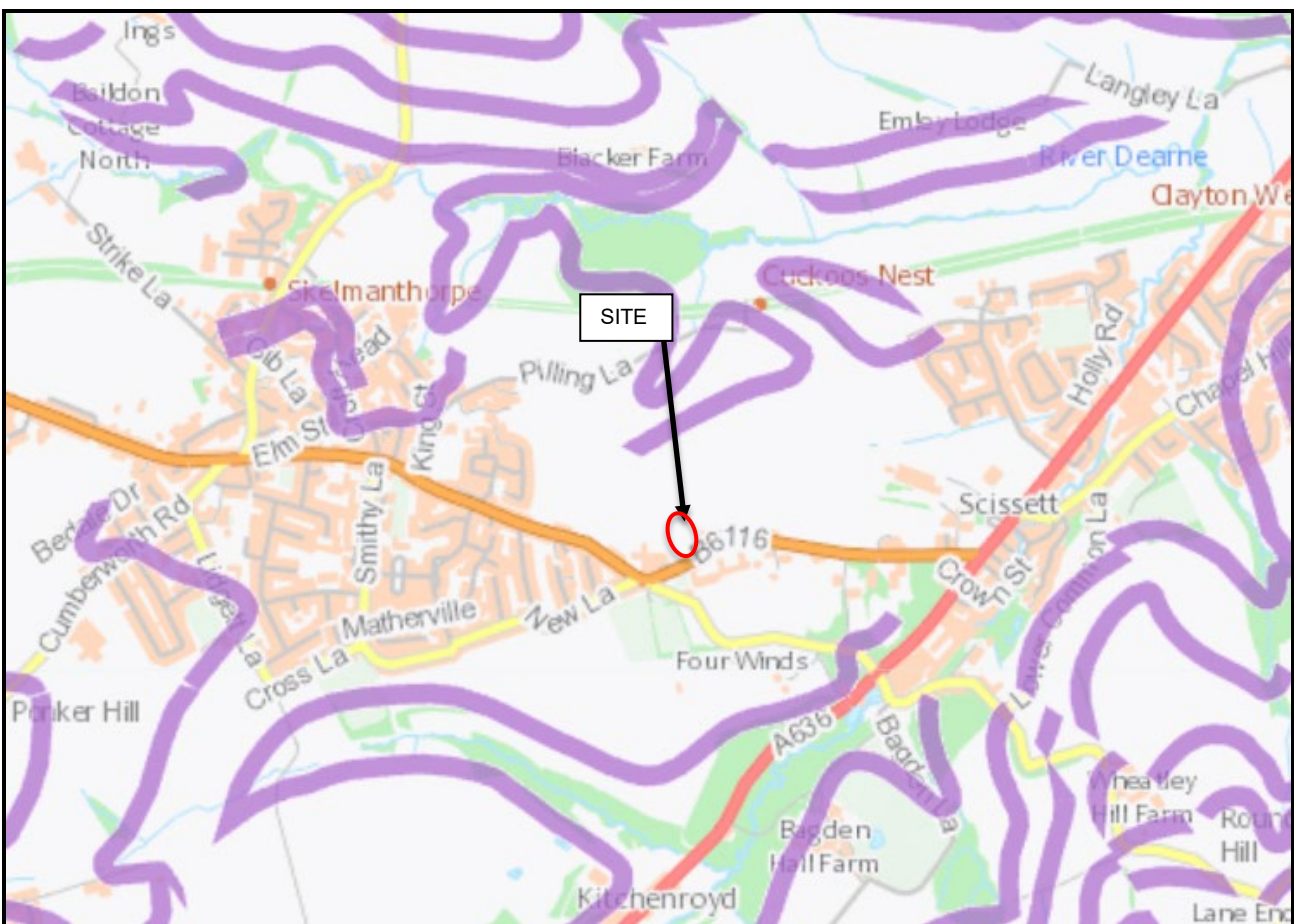
Figure 10 Plan of Coal Seams Outcrop

In summary there is a **medium to high risk** that ground subsidence may occur on the site due to shallow mining in the Black Bed Coal seam. Although the Coal Authority hold no records of such mining, mining may have occurred before the date of 1872.
