## FIELD HOUSE, DEWSBURY

## CONDITION SURVEY

3014/1

December 2020

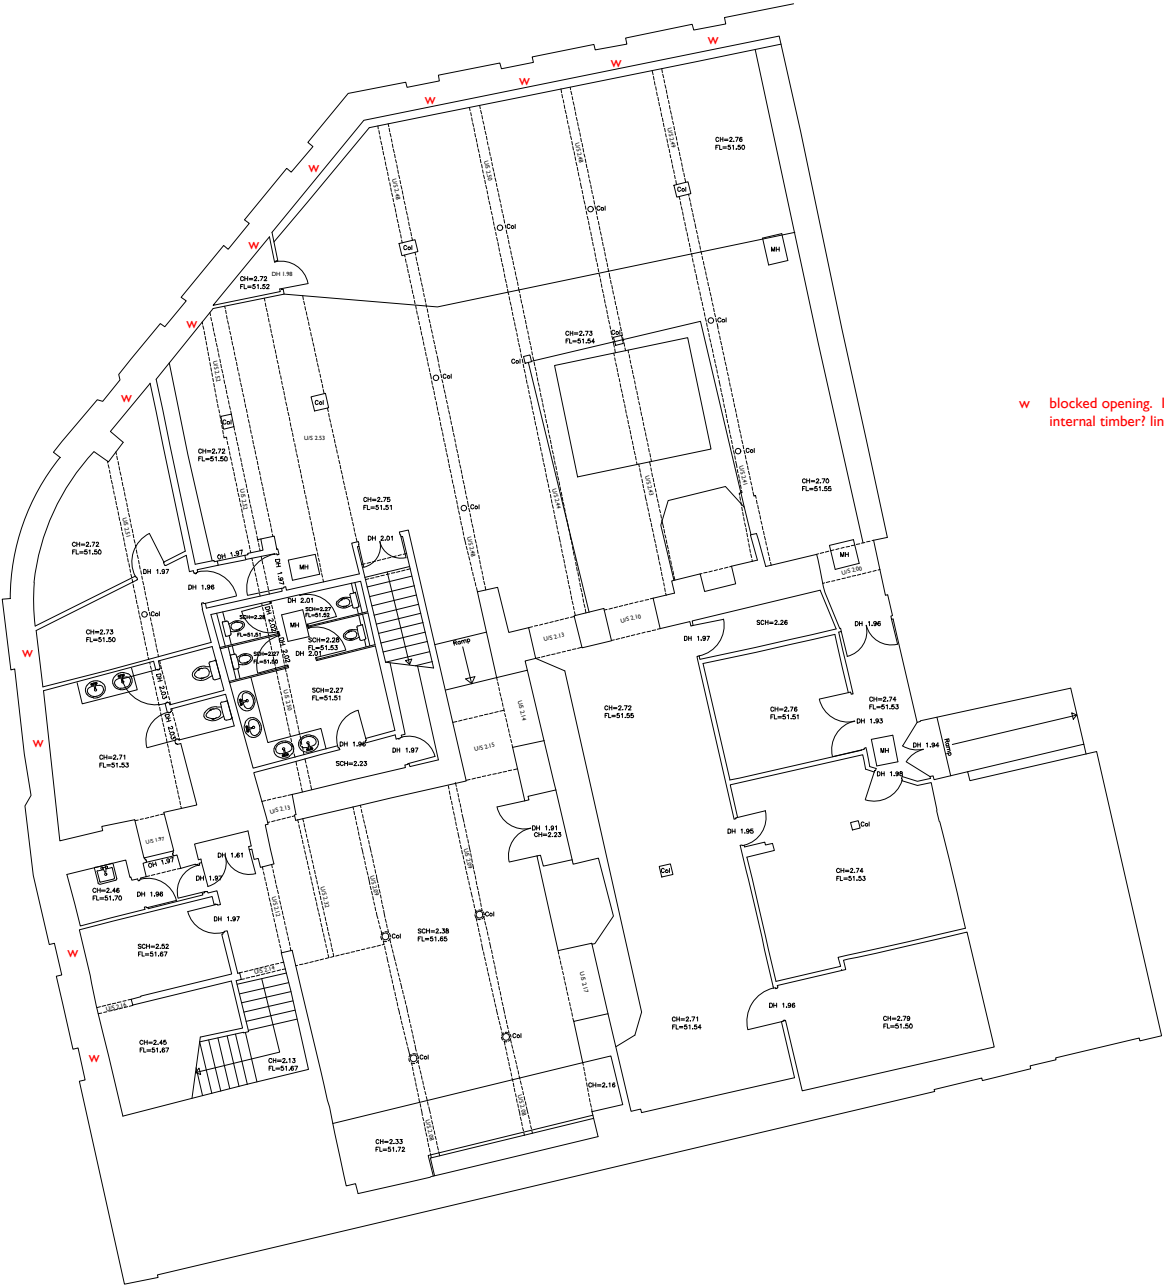
w blocked opening. Investigate condition of internal timber? lintols

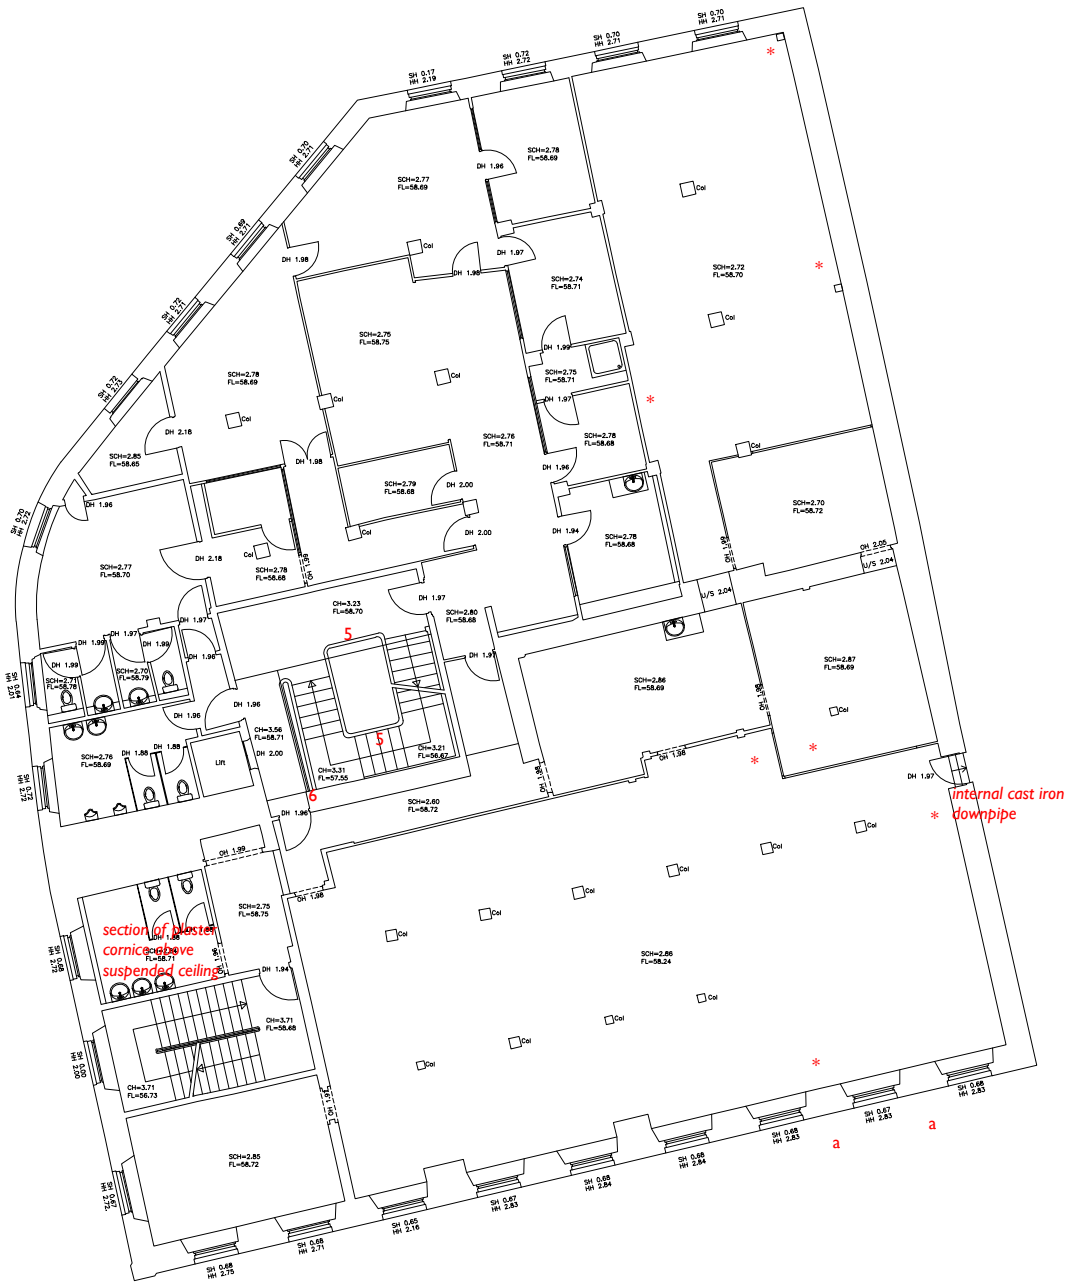
- \* Damp evident/ decayed ceiling and/or floor
- a Moisture penetration evident: check condition of internal timber lintols
- Stair**
  - blocks fitted between base of balusters along landings
  - some balusters are loose
  - some flex/movement on handrails
  - latex screed on some treads suggesting uneven wear pattern
- 1 baluster has failed
- 2 handrail on quarter landing has pulled out of wall and landing appear to have dropped
- 3 landing bows in centre
- 4 metal straps fitted to head of balusters and handrail on landing loose
- 5 balusters lean into stairway
- 6 handrail pulled out of wall

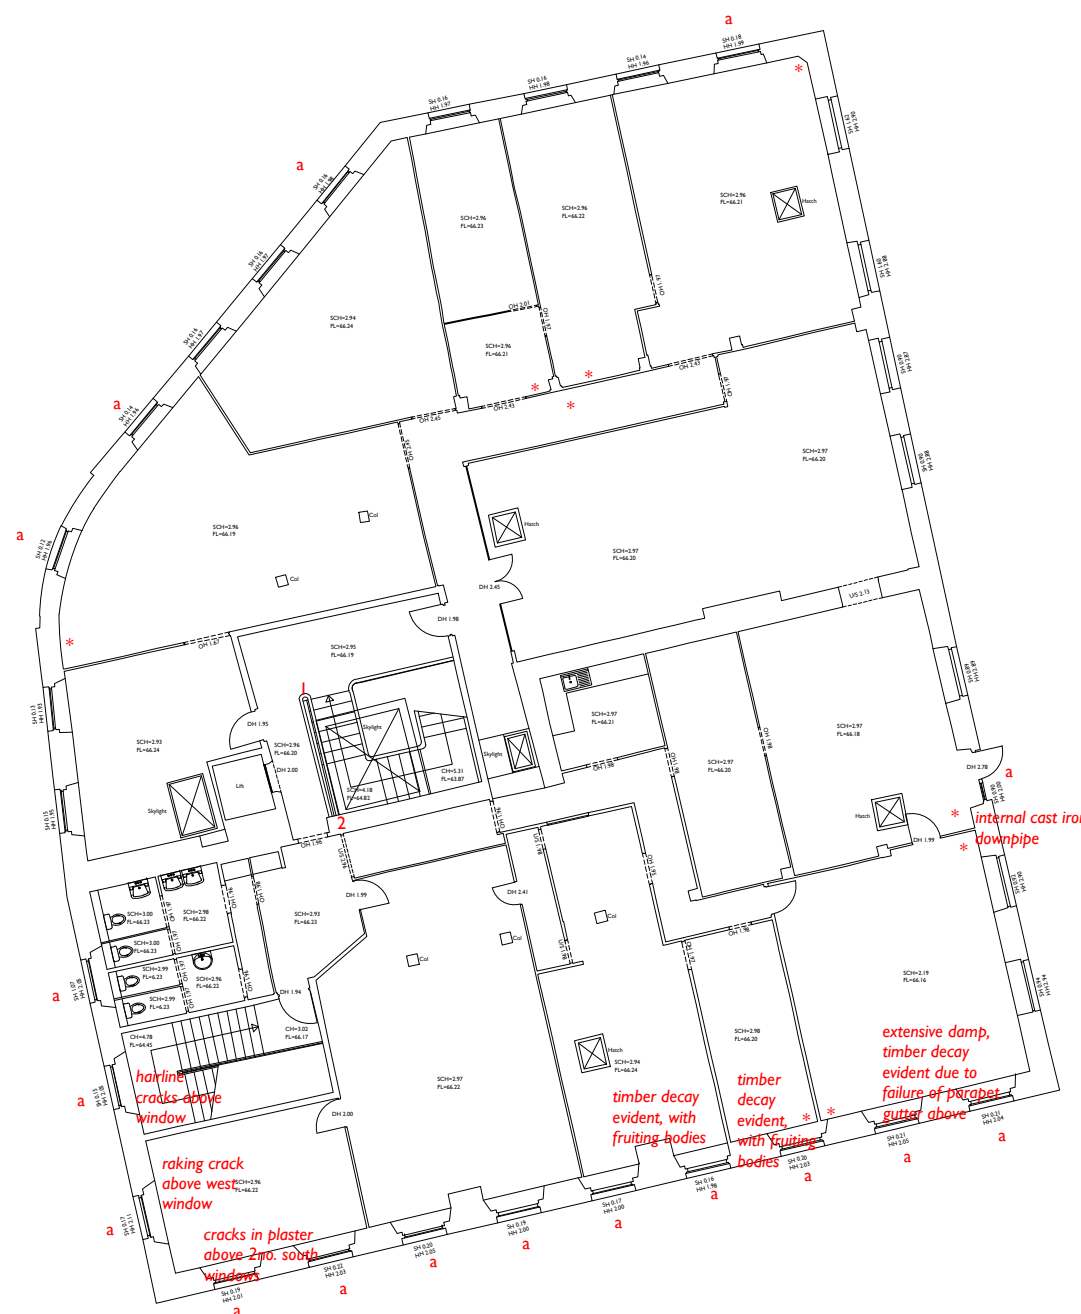
- \* Damp evident. Decayed ceiling and/or floor
- a Moisture penetration evident: check condition of internal timber lintols
