Ceramic Panels – Condition Note and Repair Strategy

Job/Drawing No	Revision
IR430301-FCB-XX-ZZ-DR-A-040955	P01

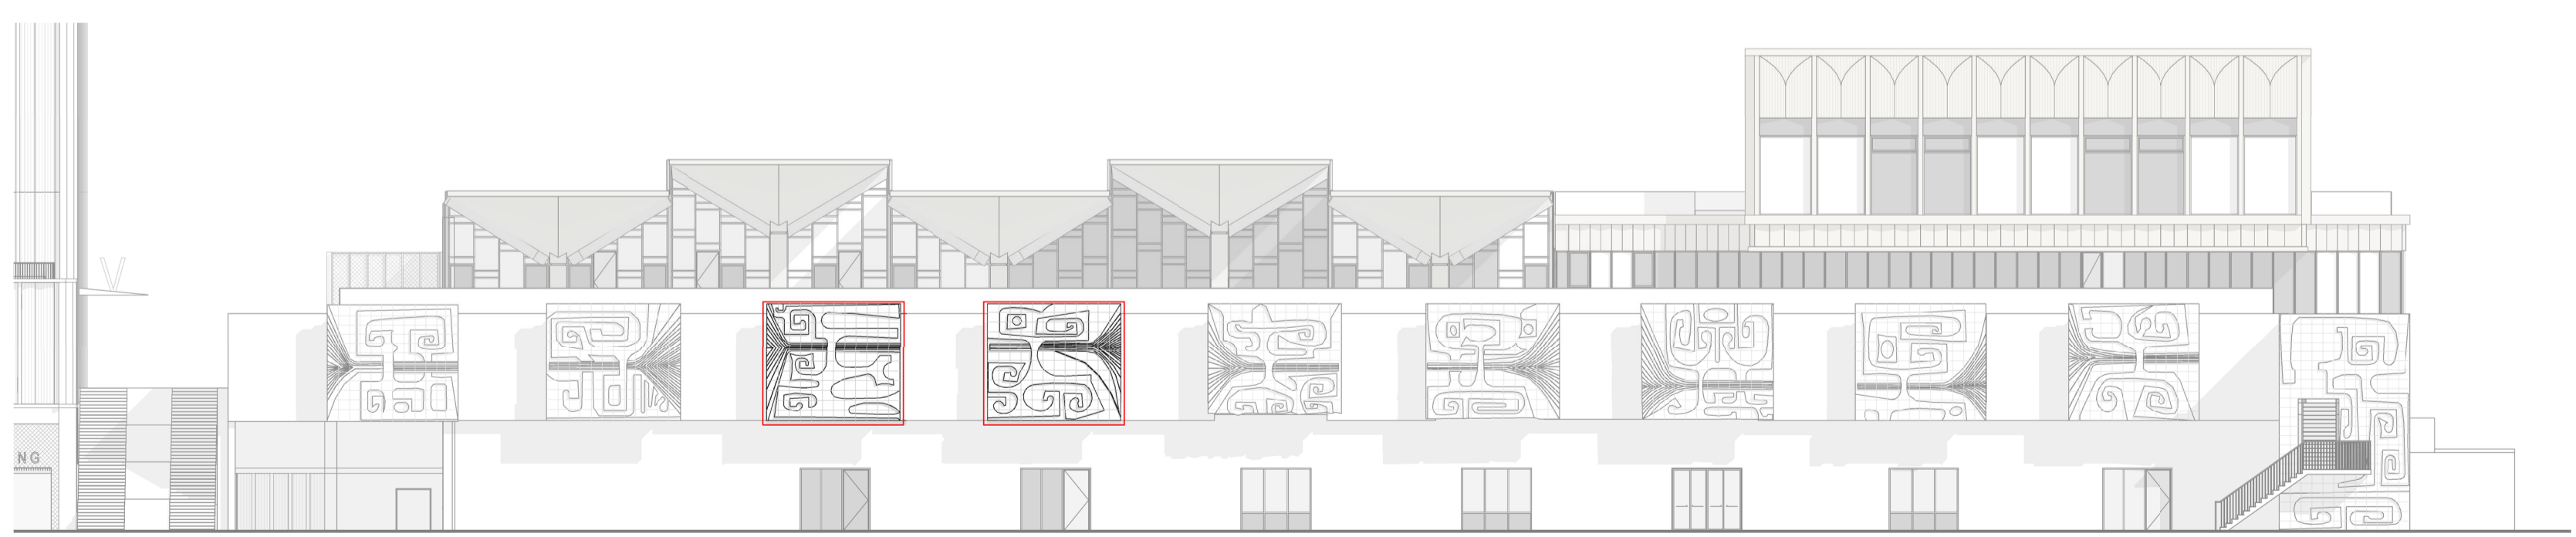
Condition
Visual inspection has confirmed that the ceramic panels are largely in good repair with damage present but in limited volumes. There are a variety of cracks with areas of repair from different times since 1969. Many areas of cracking appear to have occurred in firing. Other cracks or broken units have been reassembled with a dark mortar like that used to bed the units. These may be units that failed in the firing or later and have been reassembled for use. A few units appear to have been mortar repaired with the mortar mixed in an attempt to match the tone of the ceramic. Some degradation in panel 10 is indicative of changes in the mix of the clay and possible lower firing temperatures. The later fabrication of this panel could offer some explanation for the difference in its condition as it is thought the original kiln had been dismantled by the time panel 10 was sculpted.

- Dark Heavy Mortar Repair
- Reconstituted panel - fragments mortared together
- Spalling / impact damage
- Movement crack - repair may be necessary
- Firing Crack

- Removal of non-original fixtures and fittings applied onto the panels
- panels to be cleaned
- failed and loose pointing to be renewed
- damaged units to be mortar renewed
- damaged unit to be mortar repaired (mix to match)
- missing elements to be investigated and where appropriate reinstated
- new lead / hard metal weathering capping to be fitted at the head

- 50% repointing
- 100% doff / thermotech cleaning
- localised mortar repairs
- 12no specialist replacement panels approx 480mm square
- remediation of corroding fixings where damage has been caused to the ceramics
