5 Main Elevation (East) - Ceramic Panel 05
1 : 20

6 Main Elevation (East) - Ceramic Panel 06
1 : 20

Ceramic Panels – Condition Note and Repair Strategy

Job/Drawing No	Revision
IR430301-FCB-XX-ZZ-DR-A-040956	P01

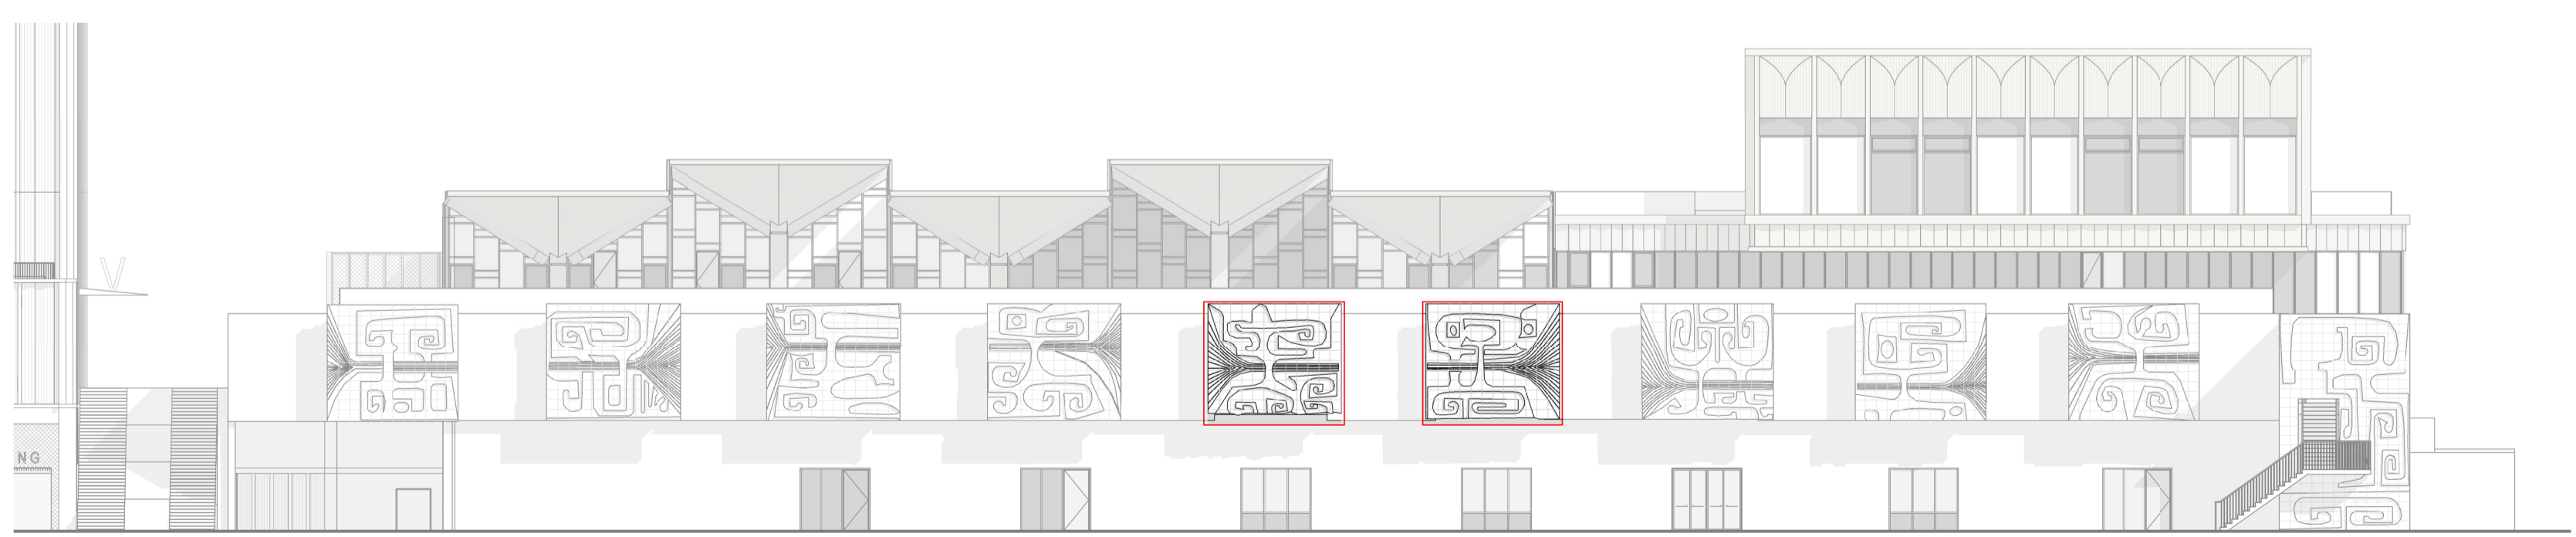
Condition
Visual inspection has confirmed that the ceramic panels are largely in good repair with damage present but in limited volumes. There are a variety of cracks with areas of repair from different times since 1969. Many areas of cracking appear to have occurred in firing. Other cracks or broken units have been reassembled with a dark mortar like that used to bed the units. These may be units that failed in the firing or later and have been reassembled for use. A few units appear to have been mortar repaired with the mortar mixed in an attempt to match the tone of the ceramic. Some degradation in panel 10 is indicative of changes in the mix of the clay and possible lower firing temperatures. The later fabrication of this panel could offer some explanation for the difference in its condition as it is thought the original kiln had been dismantled by the time panel 10 was sculpted.

- Degradation of the fire face
- Impact of past repairs
- Condition of the fixings
- Weathering and areas prone to moss, etc.

- Removal of non-original fixtures and fittings applied onto the panels
- panels to be cleaned
- failed and loose pointing to be renewed
- damaged units to be mortar renewed
- damaged unit to be mortar repaired (mix to match)
- missing elements to be investigated and where appropriate reinstated
- new lead / hard metal weathering capping to be fitted at the head

- 50% repointing
- 100% doff / thermotech cleaning
- localised mortar repairs
- 12no specialist replacement panels approx 480mm square
- remediation of corroding fixings where damage has been caused to the ceramics
