Blake Lea Lane, Marsden

Photographic Record of Condition

Of Blake Lea Lane Highway Retaining walls

Thursday 19th October 2023

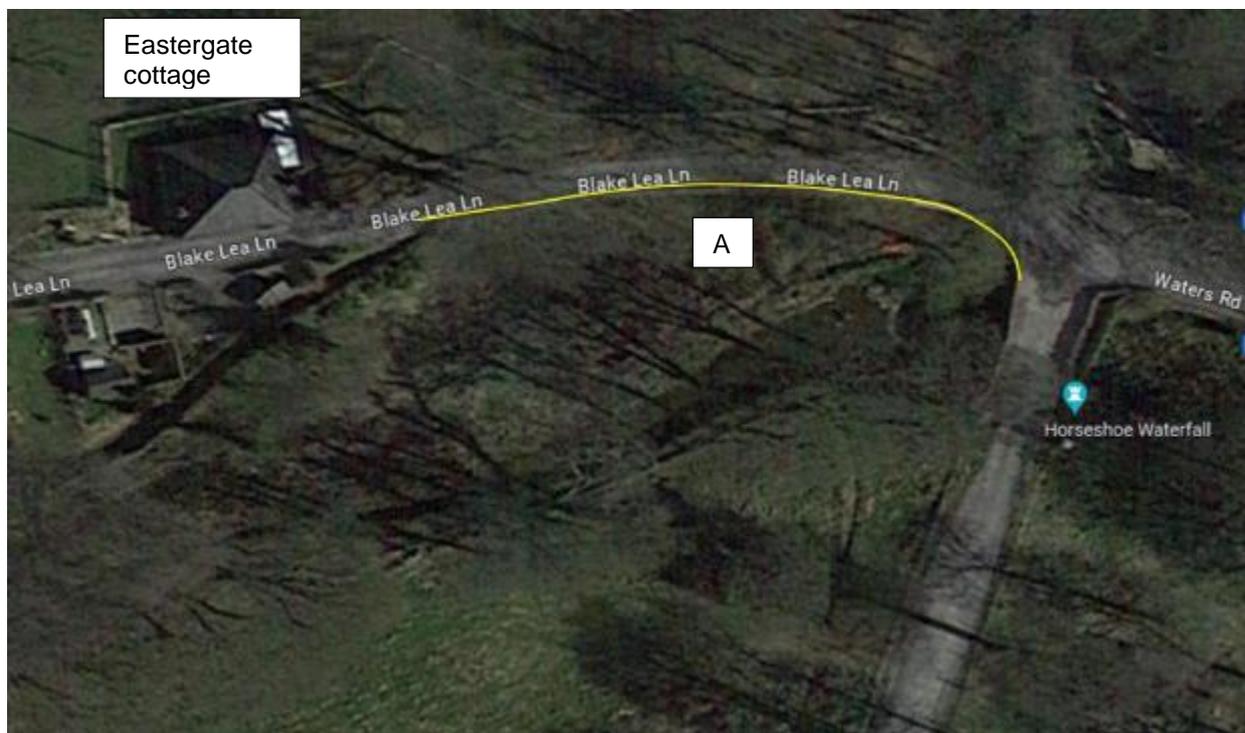
1.5.1 Section A - Start of Blake Lea Lane (junction with Waters Road) up to Eastergate Cottage

At the start of Blake Lea Lane, the road travels parallel to River Colne, with Horseshoe Waterfall just downstream of the bridge crossing.

The road has dry stone walling on both sides. On the LHS (when heading towards the reservoir), the dry stone walling is about 600mm high above road level.

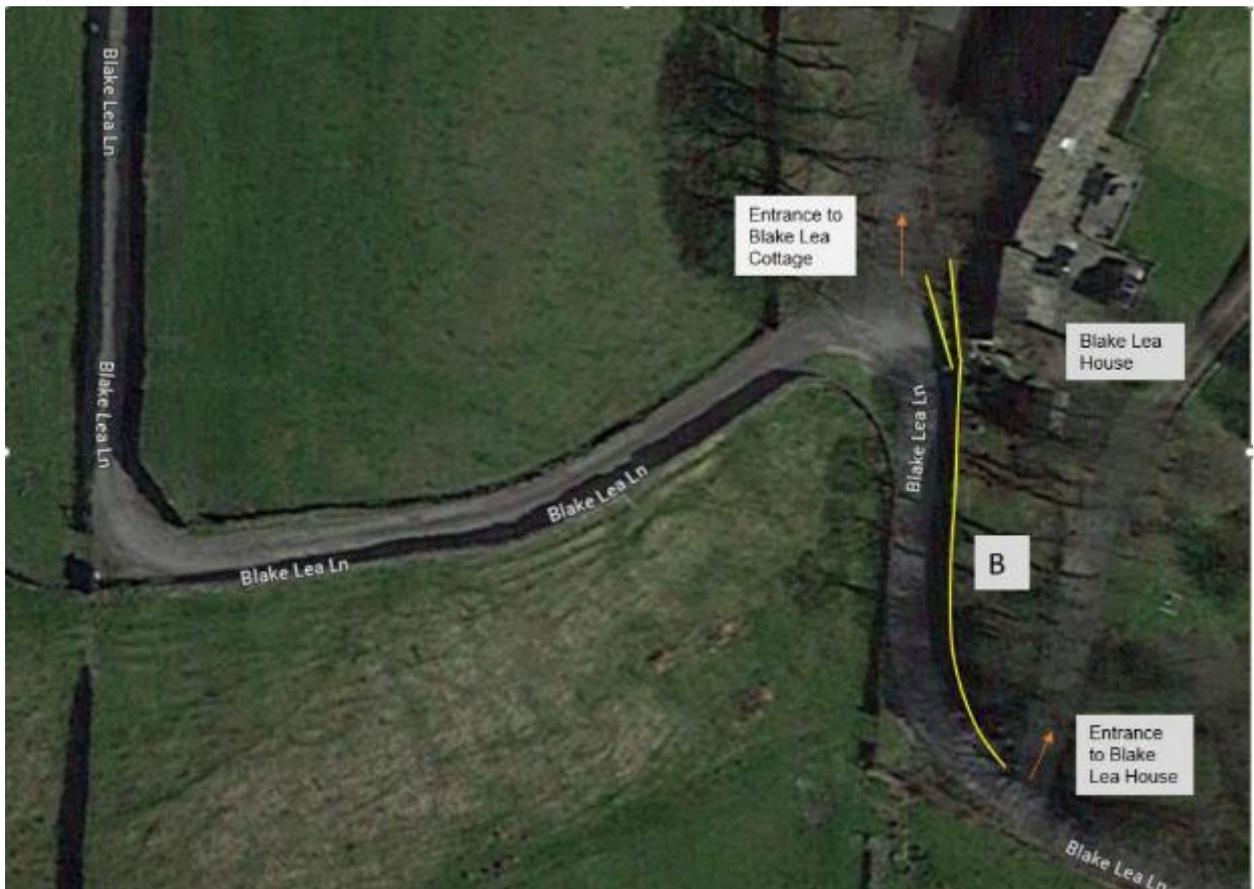
The downhill approach towards the retaining wall is very steep and has a hairpin bend just after the entrance to Blake Lea Cottage. Several concrete block kerbs have been placed in front of the wall, to deflect vehicle impact. Anecdotally, residents informed of vehicles having previously collided with this wall, when travelling downhill under icy conditions.

The dry stone wall where it sits above Blake Lea House, has been rebuilt from road level up, using larger stones, and is now mortared on the back face.

The retaining section of burr wall, is generally a dry stone wall with no mortar. The thickness of the wall, and its foundation construction, is unknown. Limited vegetation is visible growing out of the back face of the wall, with signs of previous vegetation pruning.

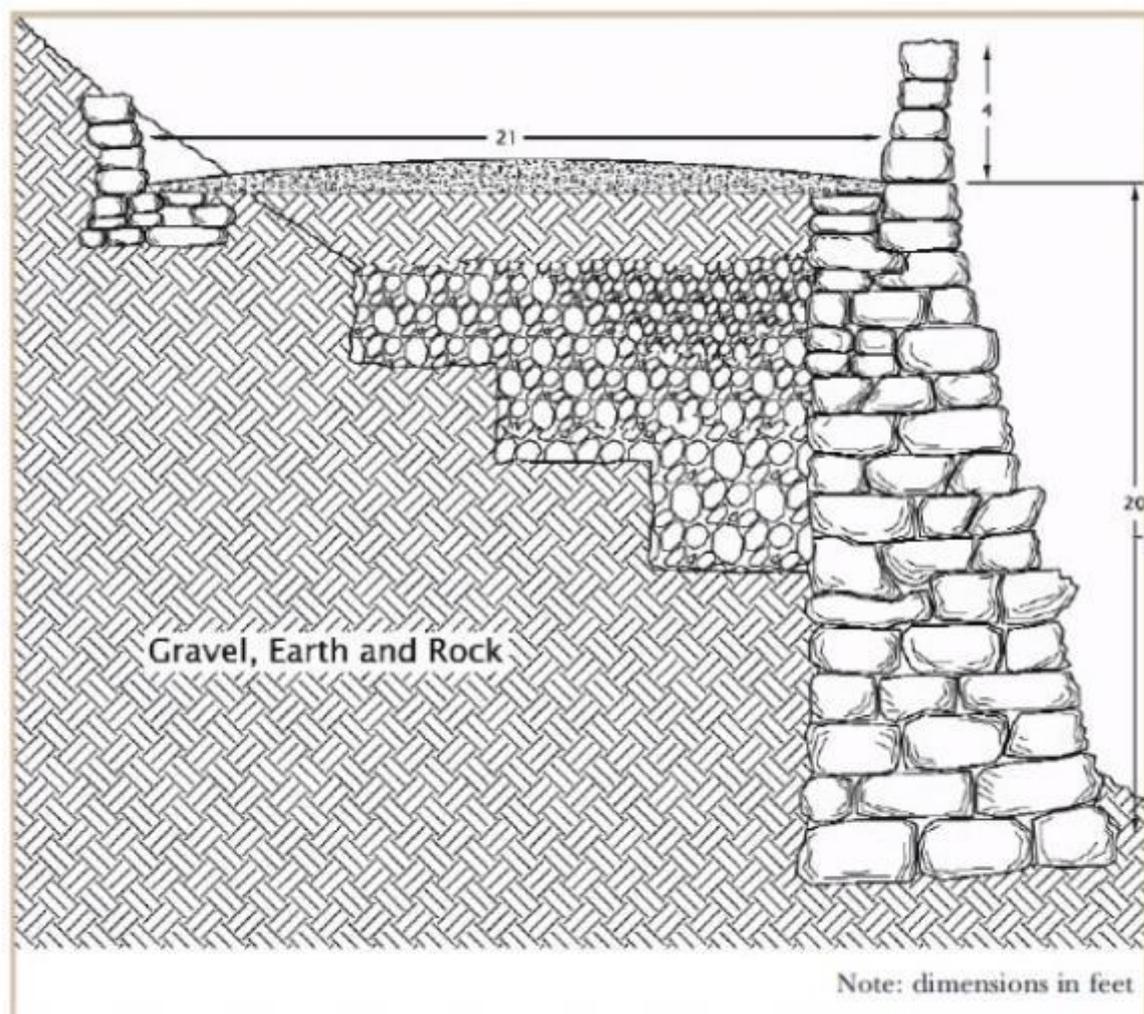
Cross-section of drystone wall at Carey Mountain on the Antrim Coast Road

Included above is an example of burr dry stone wall construction (as depicted in CIRIA C676 Guidance). It is likely that a high retaining wall such as this will extend back into the hillside, reducing the lateral loading experienced by the wall. However, without significant intrusive investigations within the road, the actual construction is not known.

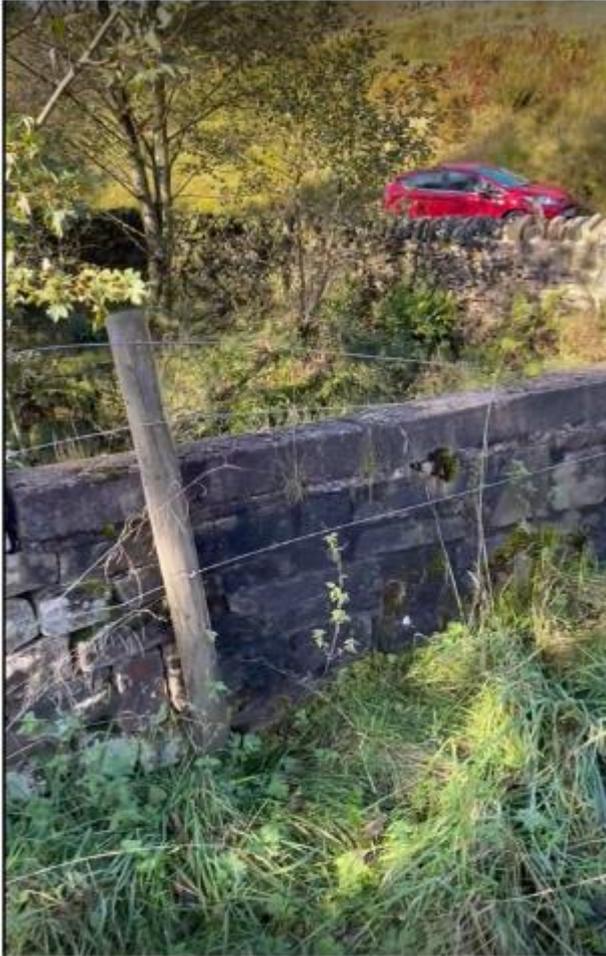
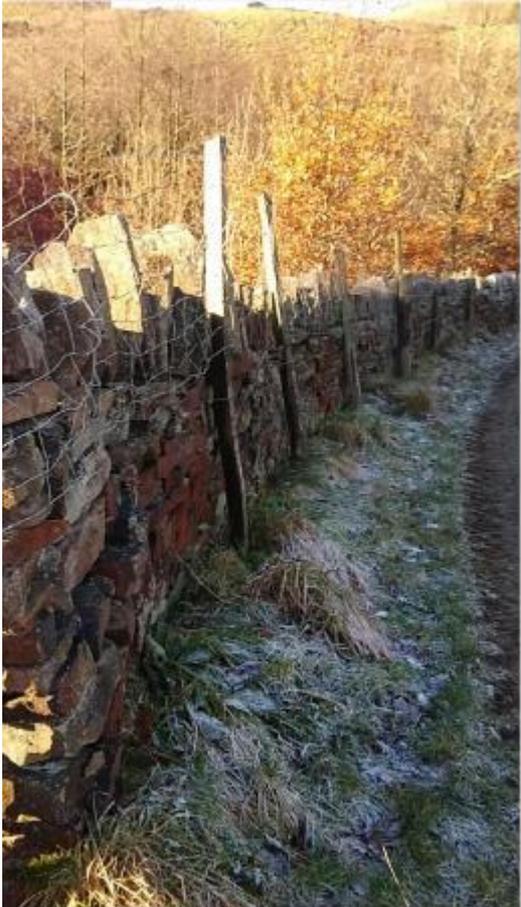
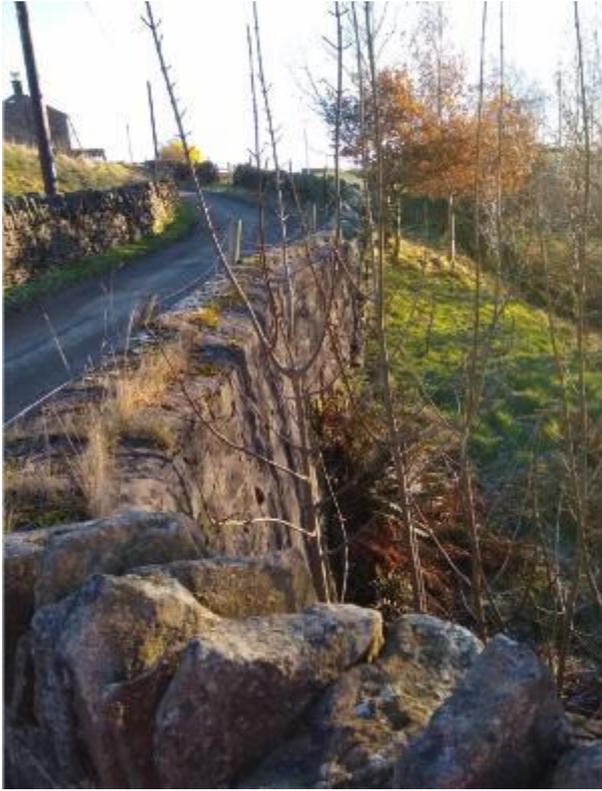
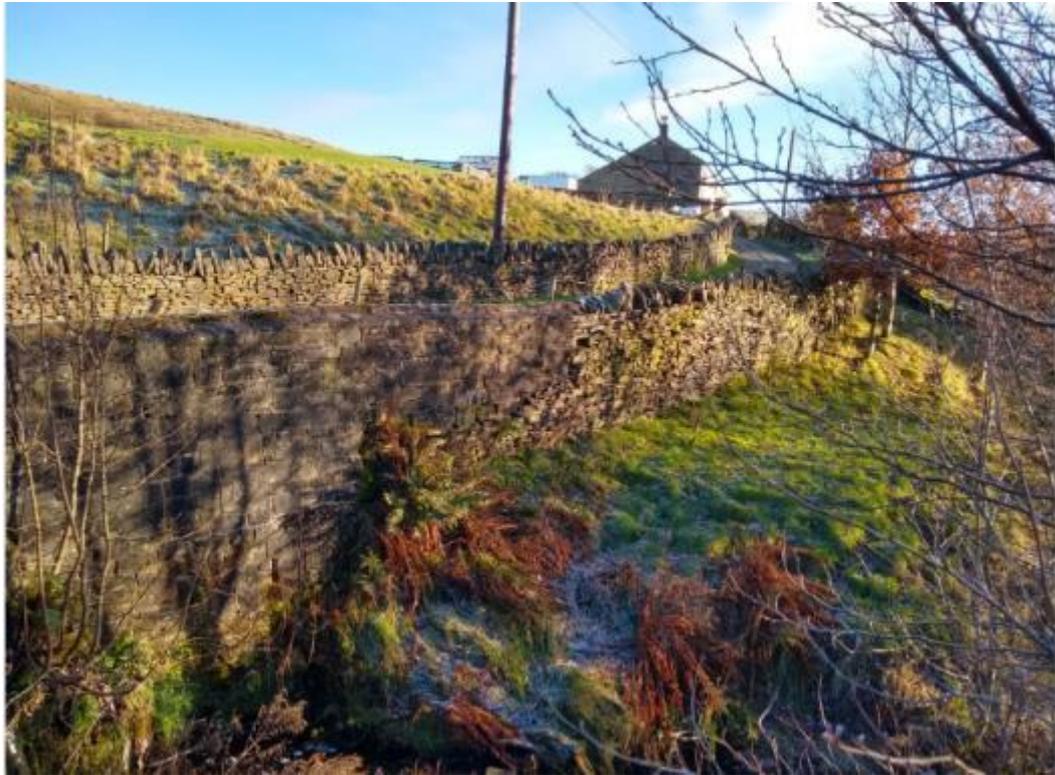
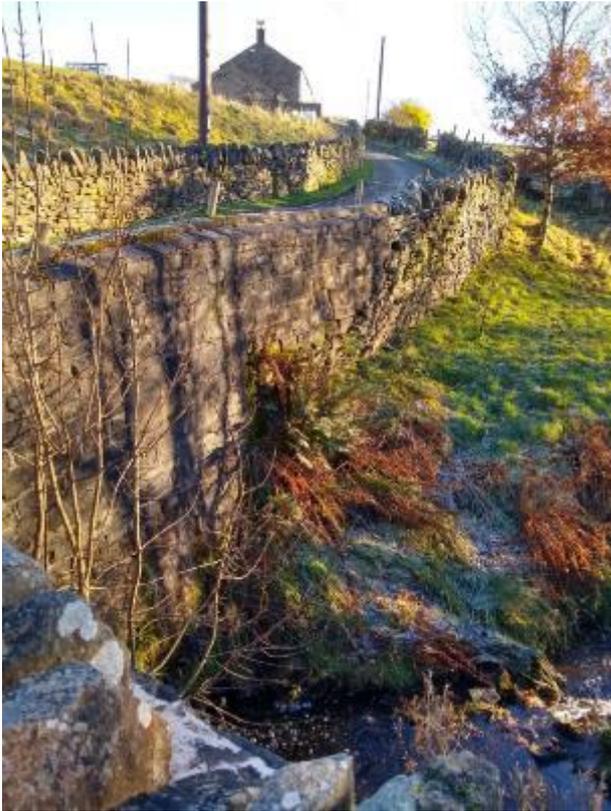
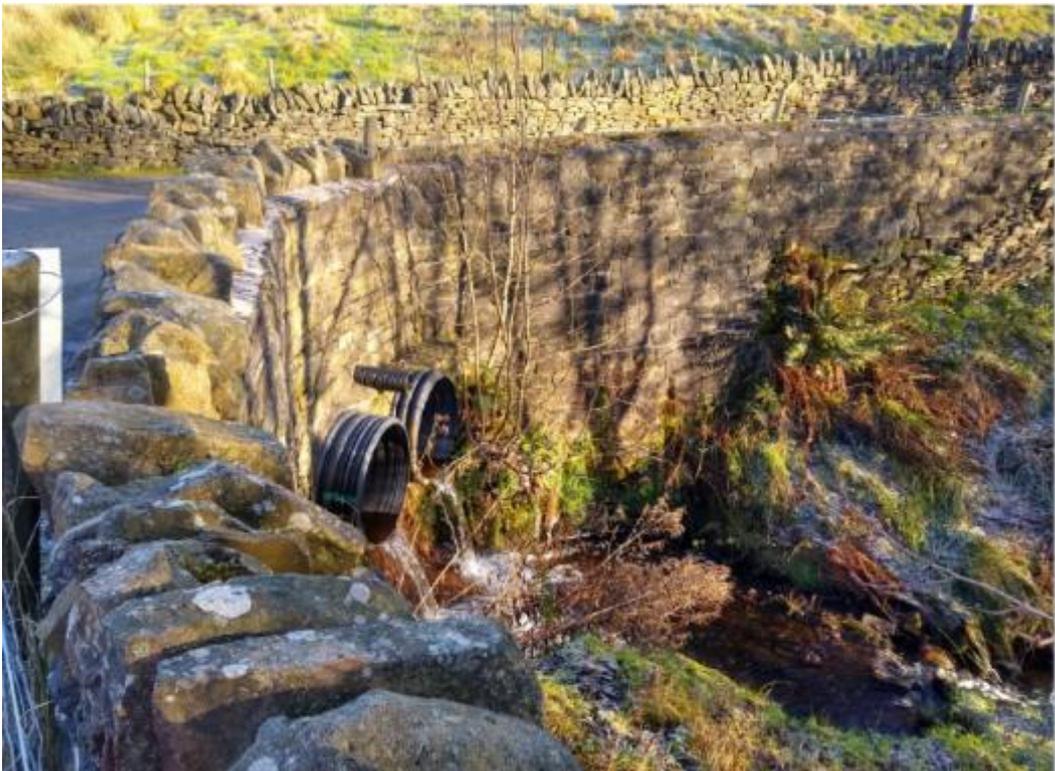
The drystone wall adjacent to the bridge has been rebuilt as a mortared wall using larger size stones. There are some hairline vertical and diagonal cracks through the mortar indicating previous localised ground movement or vehicle impact or freeze/thaw.

Within the mortared section, there is a 25mm wide diagonal crack tracking through the mortar, indicating some horizontal movement has occurred. This coincides with change of ground levels to the rear but may also have been exacerbated by preventing the previous free-draining of the wall.

At the diagonal transition of dry stone to mortared wall, the non-mortared stones below the mortared section look to have loosened slightly - which may be a result of increased susceptibility to freeze/thaw and expansion between the mortared section and the dry stone wall stones. However, the dry stone section has no serious flaws.

The dry stone wall generally looks in good condition, with some coping stone replacement having occurred.
