STRUCTURAL INSPECTION REPORT

Original Mill Offices Building, Newsome
Mills, Ruth Street, Huddersfield
For Connect Housing

Date 23/02/2023
Ref **21197/SIR001**

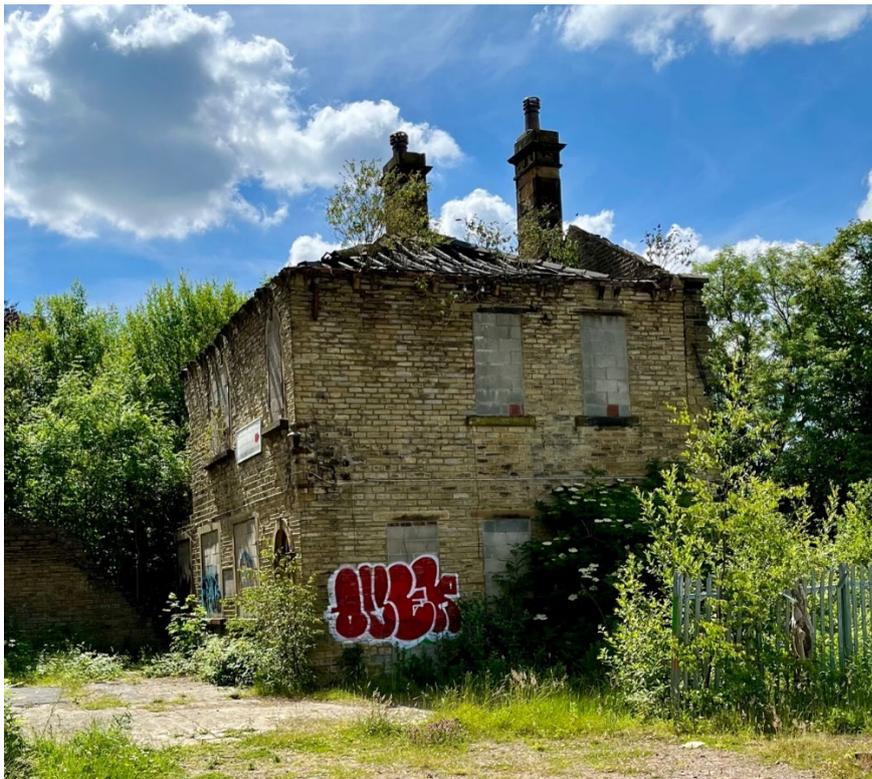
Attached to the rear elevation, is the remnant gable wall construction from the wider mill complex along with an associated chimney stack.
