STRUCTURAL DESIGN CONSULTANTS & SURVEY REPORTS

**STRUCTURAL INSPECTION REPORT
DATE: 03/03/23
REF: MDL - 6813**

Linthwaite Methodist Chapel
31a Chapel Hill
Linthwaite
Huddersfield
HD7 5NJ

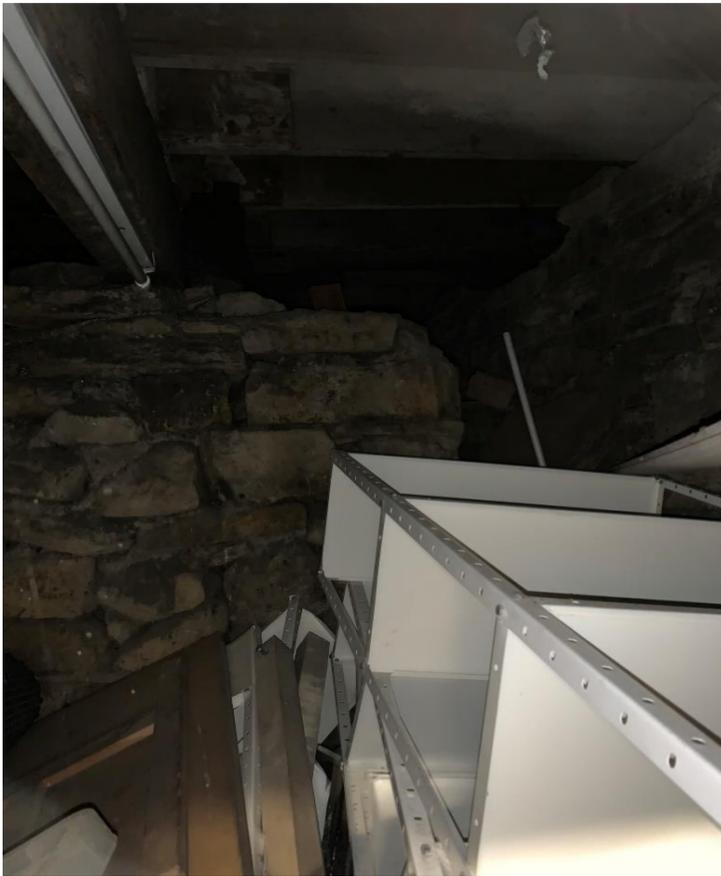
11

The accessible cellar areas to the main building shows no signs of any recent or ongoing movement. The area itself showed no real signs of severe penetrative damp. Minimal cracking noted to all walls deemed historical and not ongoing. All within tolerances. Though further investigation required to ascertain general structural integrity of exposed footing areas during proposed renovations. **Pic Ref: 10-11 Internal Areas**
