## **Phase I / II**

# **Contaminated Land Site Assessment**

103 Heckmondwike Road  
Dewsbury Moor,  
WF13 3PG

03 May 2023  
Report ref. 23/1149.3.1

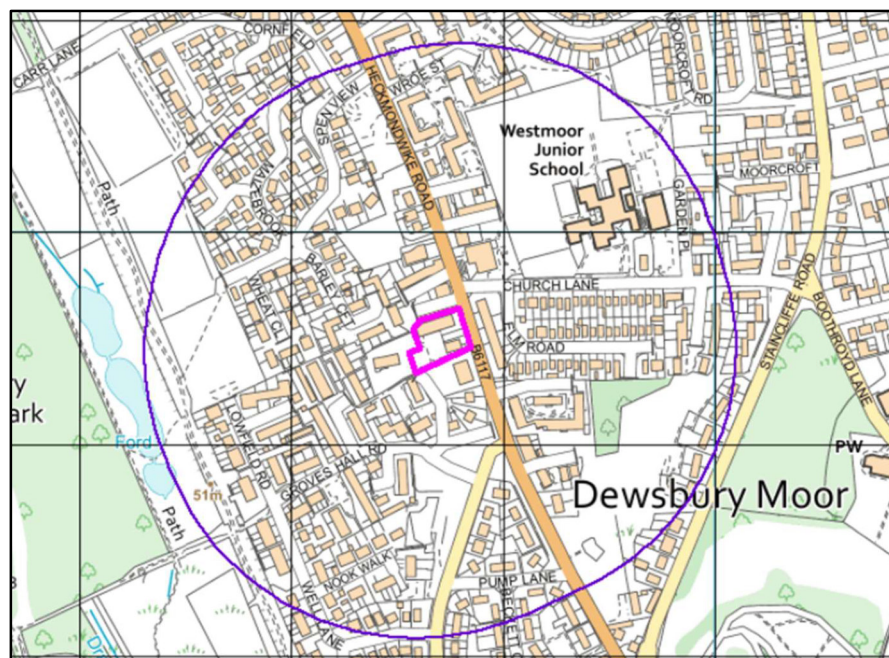
**Figure A:** Site Location Plan. Pink is approximate site boundary and purple is 250m buffer.  
Extract from Report Ref. 21/1149.1.1
