**Appendix A  
Photograph Schedule**

Original School (1868)

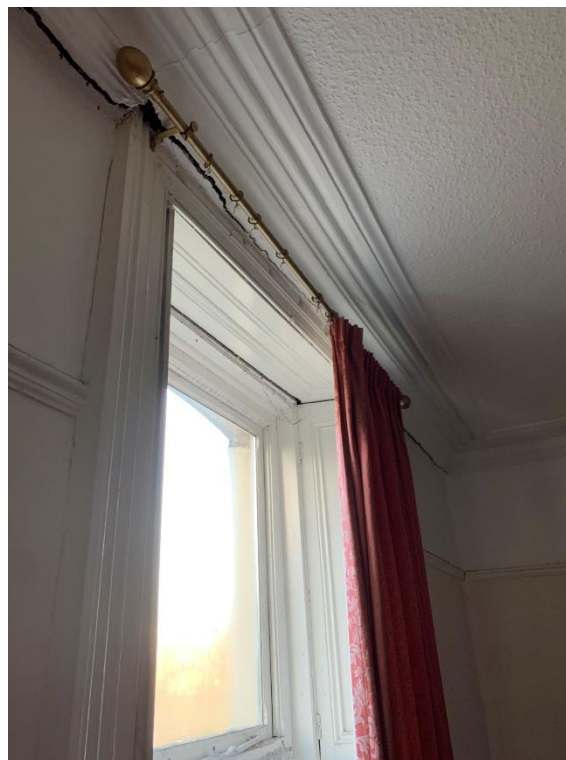
Further GF movement to front elevation

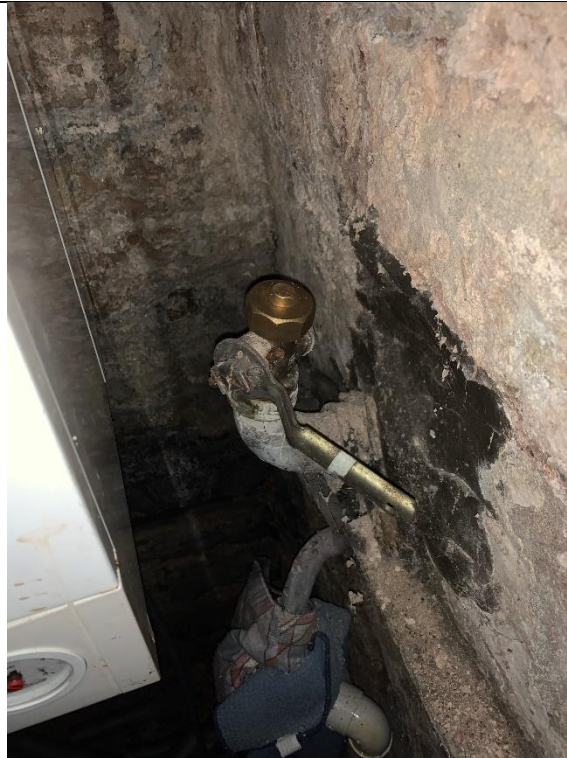
Gas meter removed

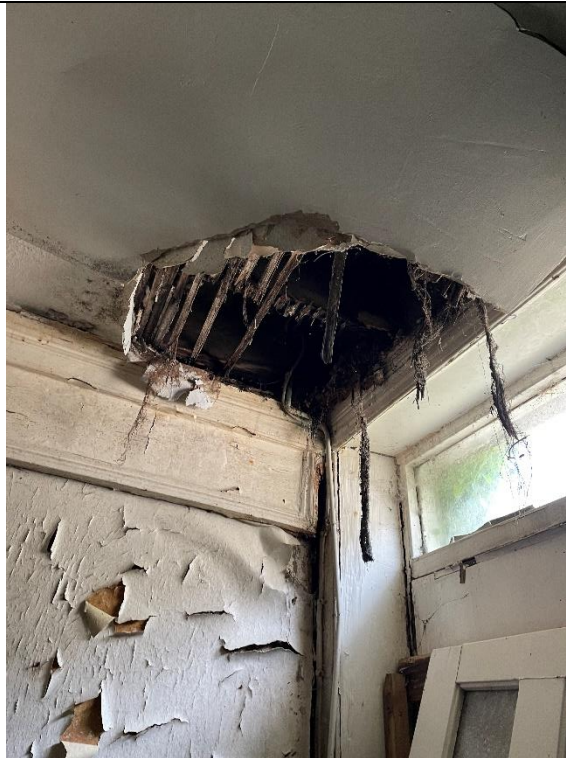
Collapsed ceiling and floor structure above GF main kitchen

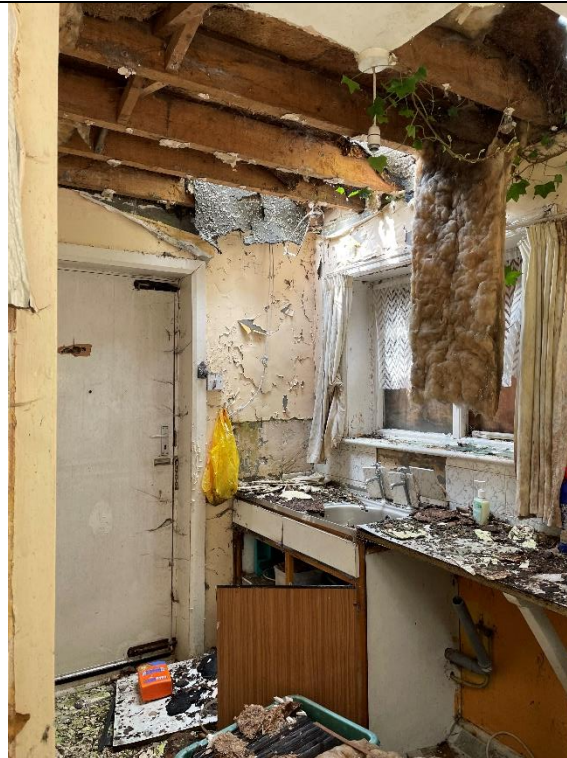
GF side kitchen – roof collapse above

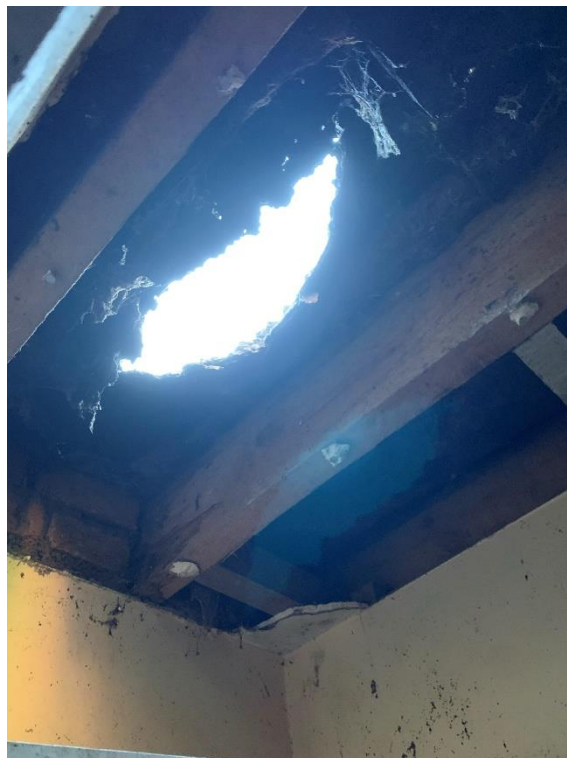
Roof collapse above toilets

Roof collapse above side kitchen

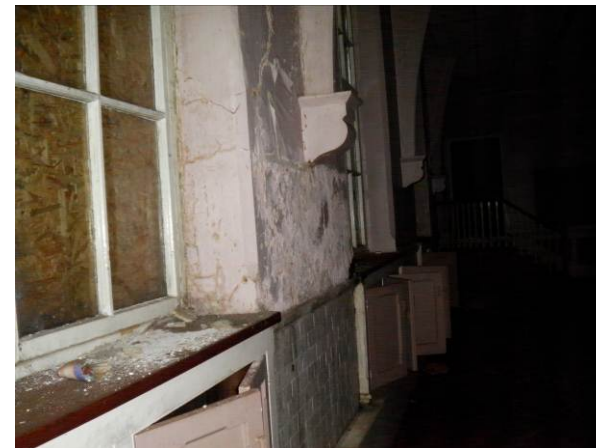
Photo 8  
Extent of dampness to external walls

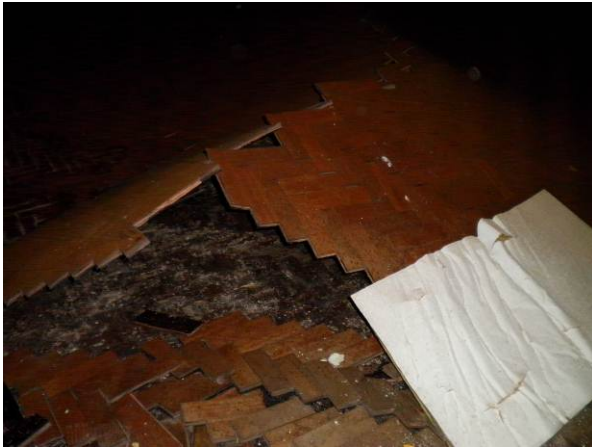
Photo 9  
Swollen parquet flooring to main hall

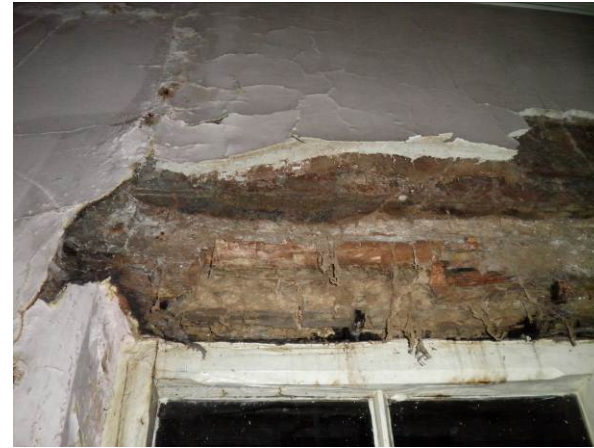
Photo 10  
Rotten timber beam

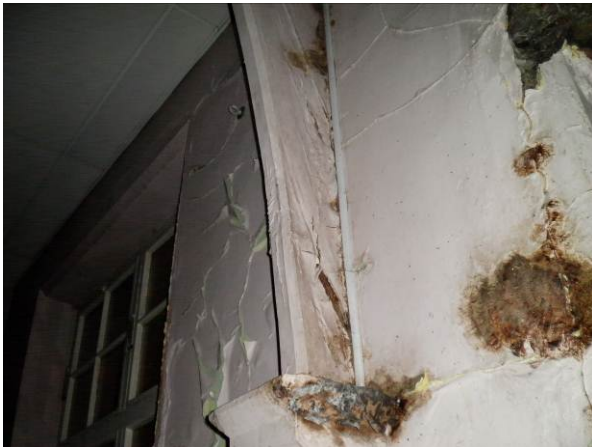
Photo 11  
Rotten timber to truss member

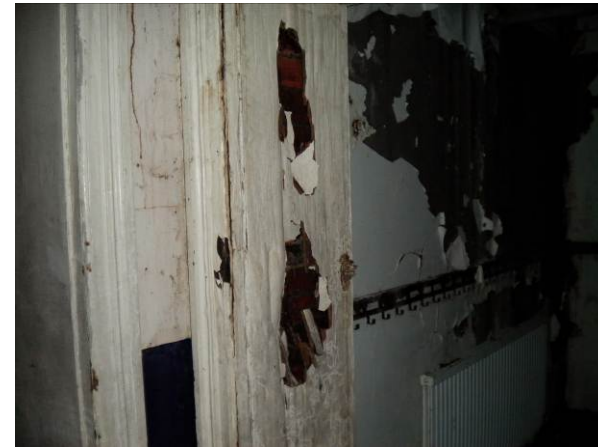
Photo 16  
Rotten door frame and water ingress
