# GEOSHIELD Verification Report

GEO102848

Galiford Try Building

Gas membrane to specification BS8485 2015

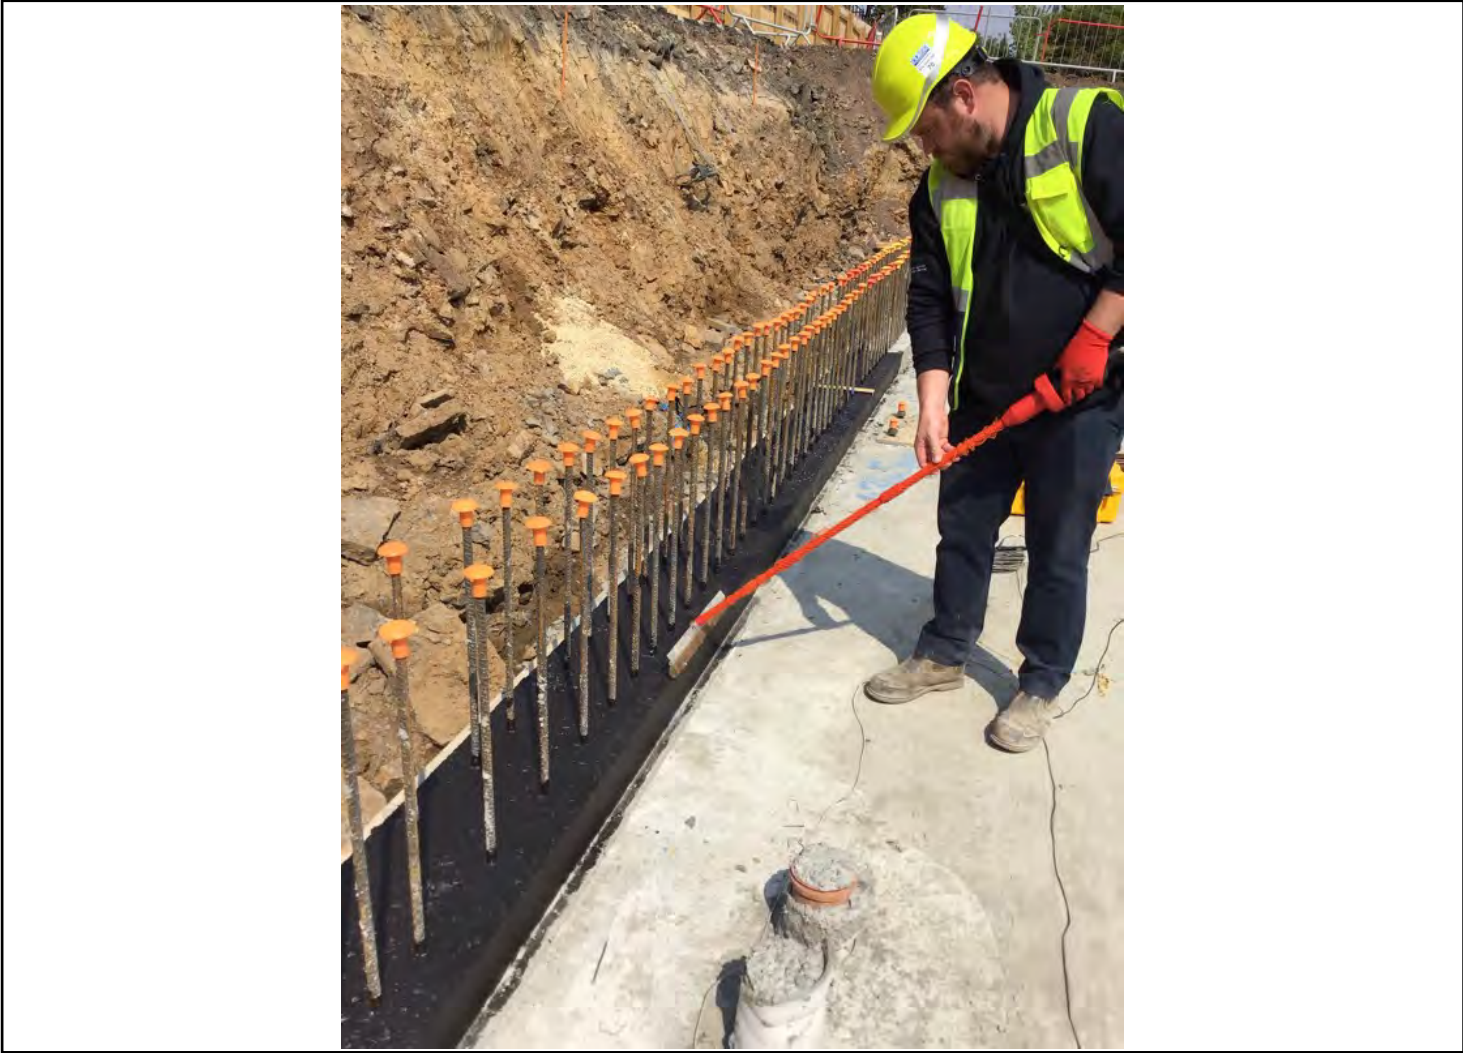
RESTRICTIONS AND LIMITATIONS: Rebar is present in the kicker rising vertically from the concrete. This caused major problems when trying to accurately verify the space between the rebar. All other areas this was not a problem.

A visual inspection was first carried out to make sure a good coverage had been achieved and no water was on the wall. The dielectric test was then carried out on the retaining wall kicker. Some small pinholes were found during the testing, indicated by

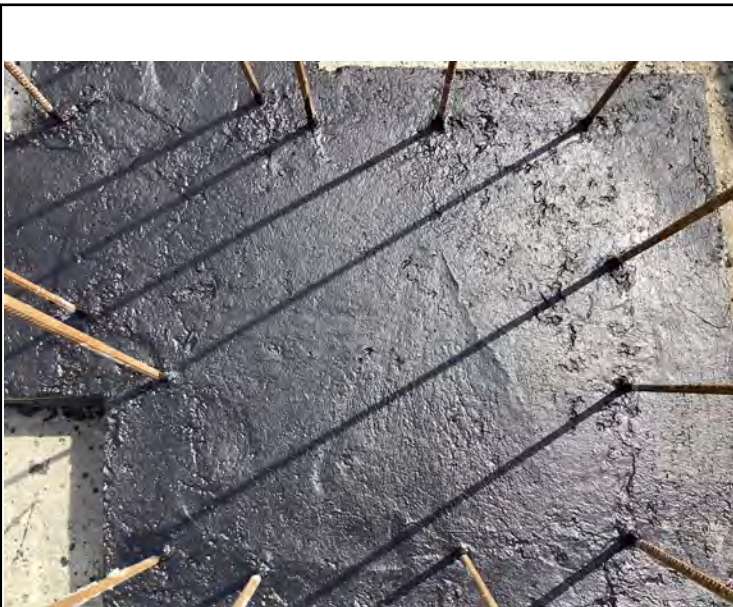
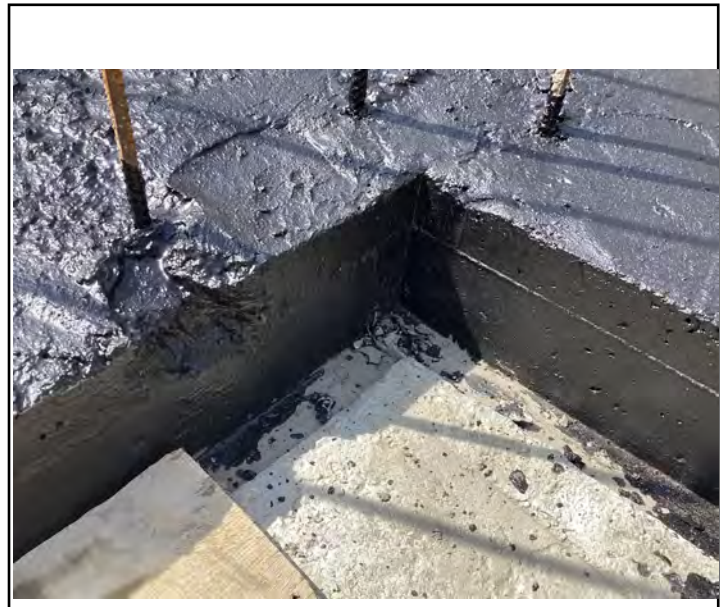
A comprehensive visual inspection was completed of the Lift Pit Kicker where three coats of the Liquid Gas Membrane had been applied. The Dielectric Test revealed no faults upon the smooth areas of the concrete but a visual test had to be completed to the

remaining areas. Any small surface discrepancies had been fully coated and the base of the steel rebar had been coated fully too.

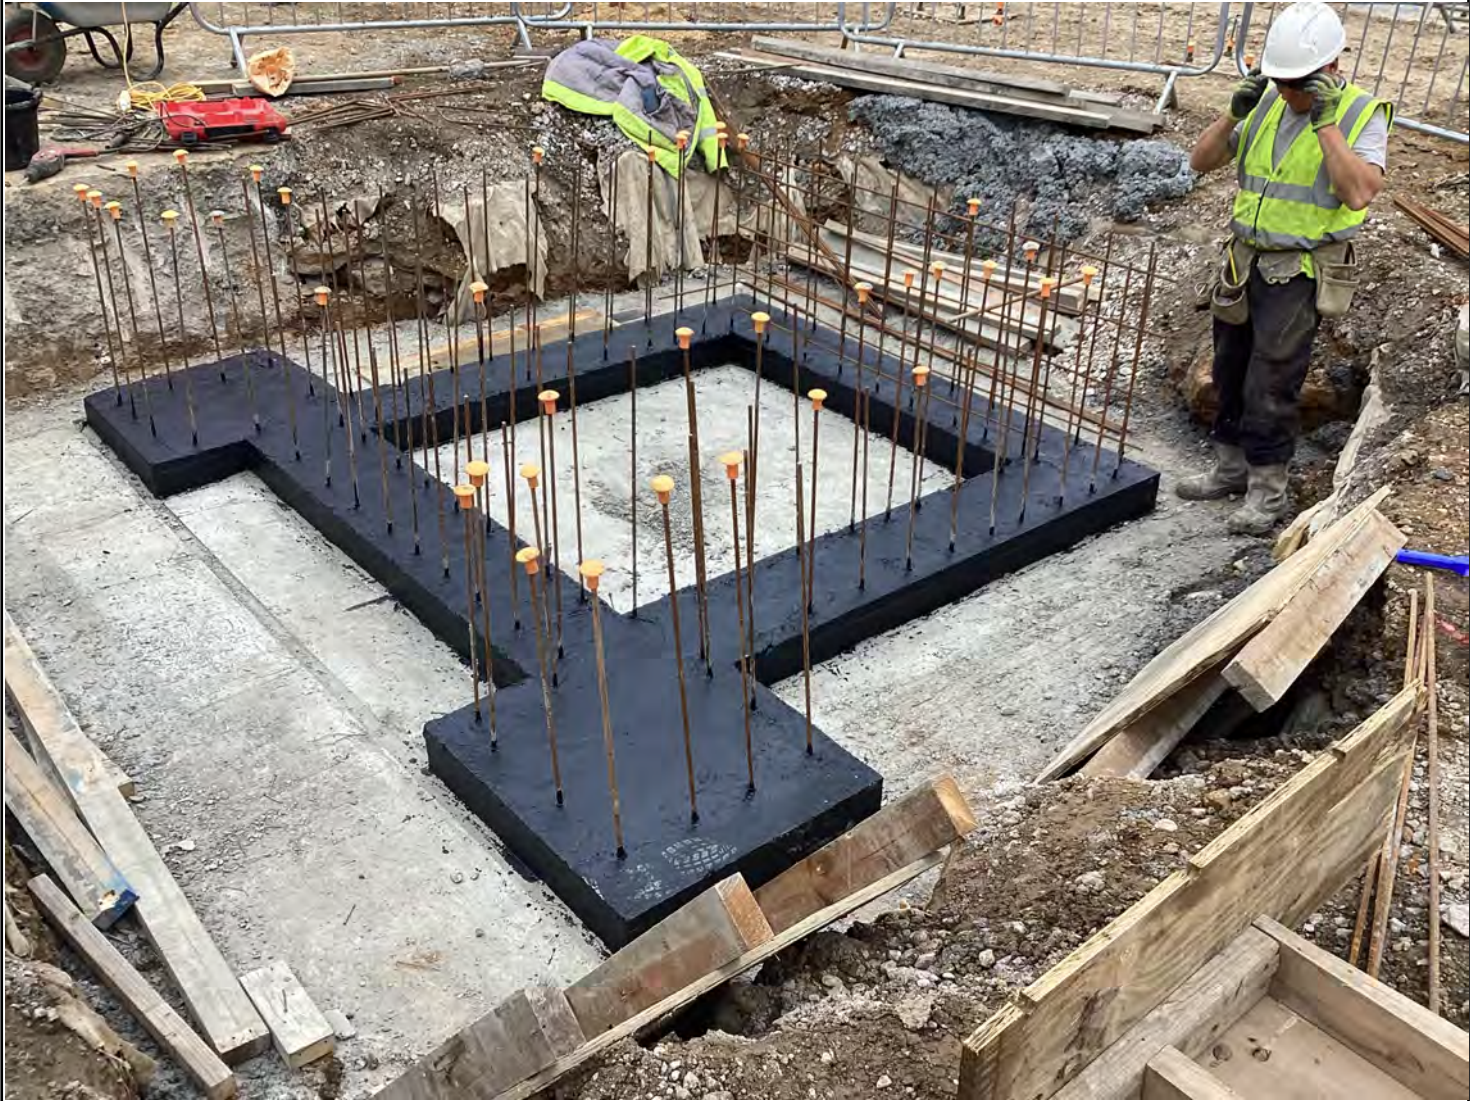
## VERIFICATION ITEM ONE

Overview of the Lift Pit base kicker showing the extent of the Liquid Gas Membrane application. The depth of the Lift Pit kicker had also been completed as these areas will be lapped over when the Gas Resistant Self-Adhesive Membrane is installed to the walls

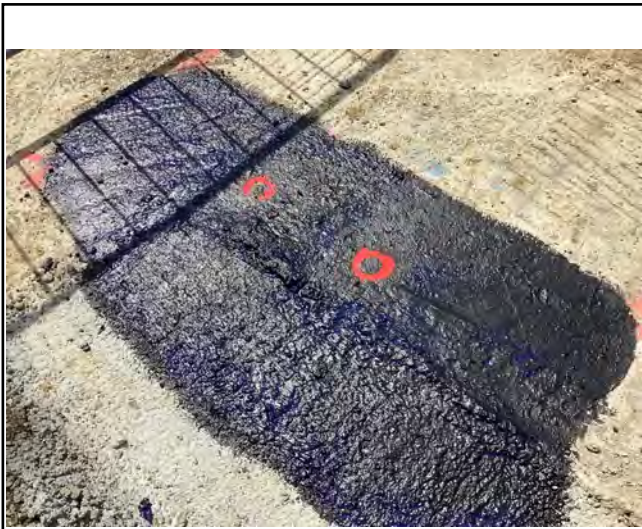
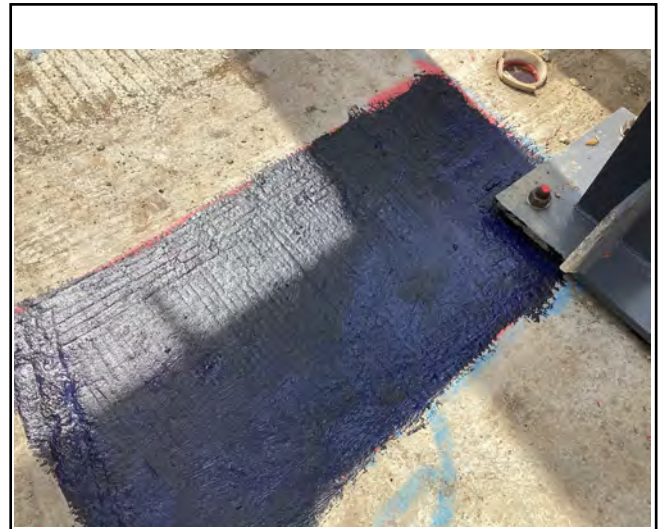
The application of the Liquid Gas Membrane had been applied to three separate areas which form the underside of Stairwell number four. Three coats had been applied and upon close inspection, the areas were fully covered.

Photo 1 - the areas marked with a red circle are where future steel dowels will be installed and therefore holes will penetrate the application. Informed management that evidence will be required to show the Liquid Gas Membrane has been applied forming a new seal to the base of the dowels with the previous application.

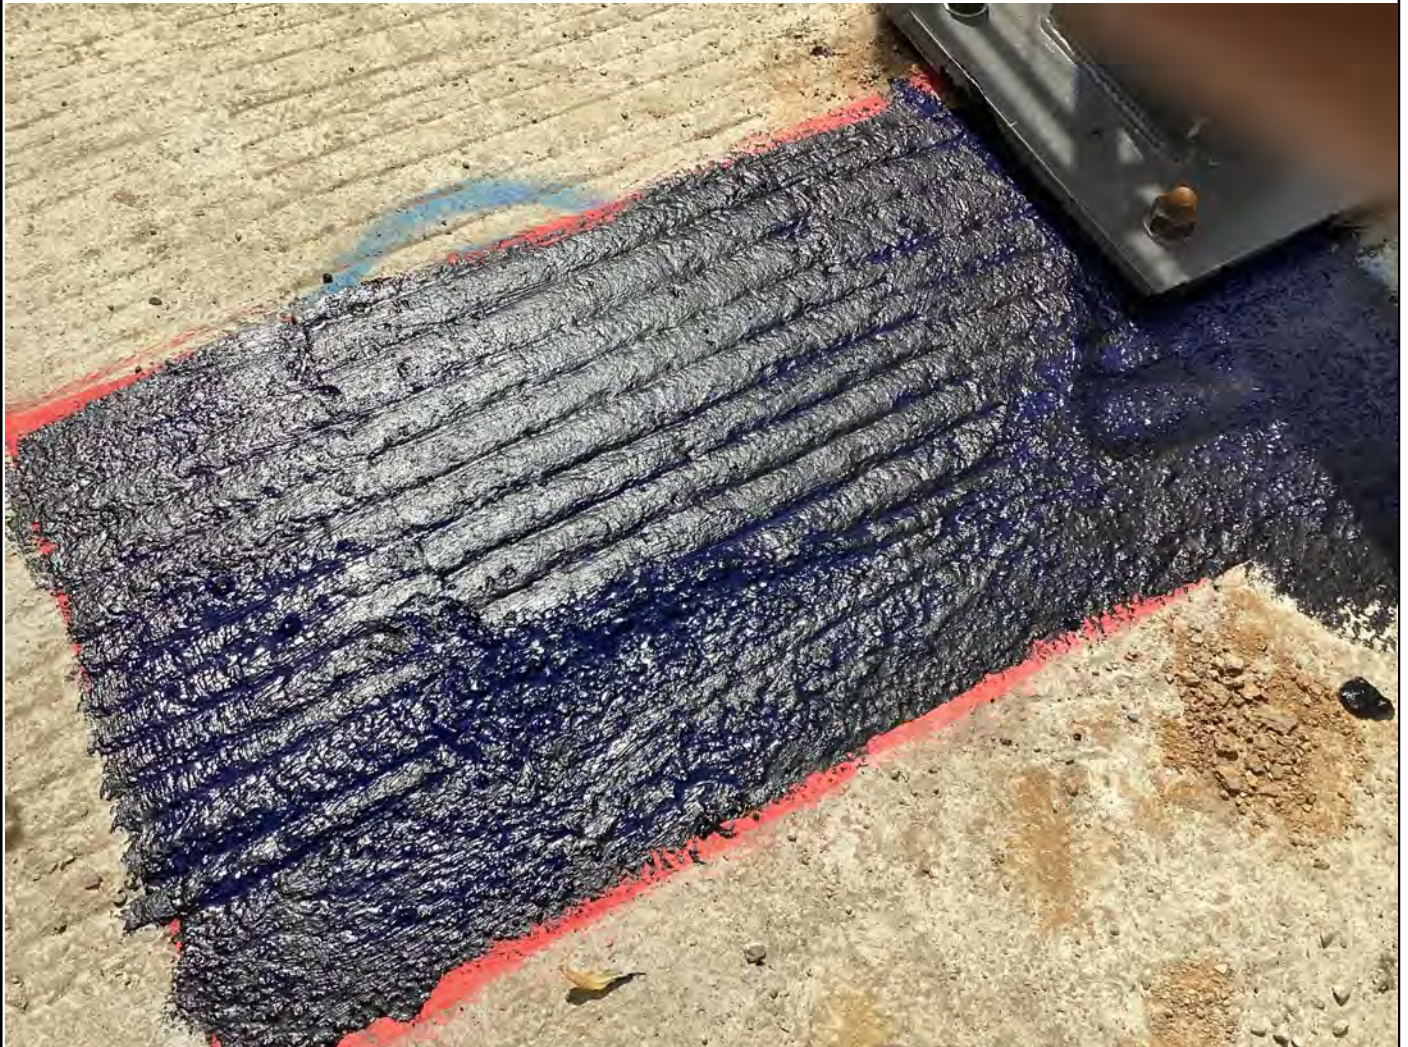
## VERIFICATION ITEM THREE

Overview showing the third coat application of the Liquid Gas Membrane.

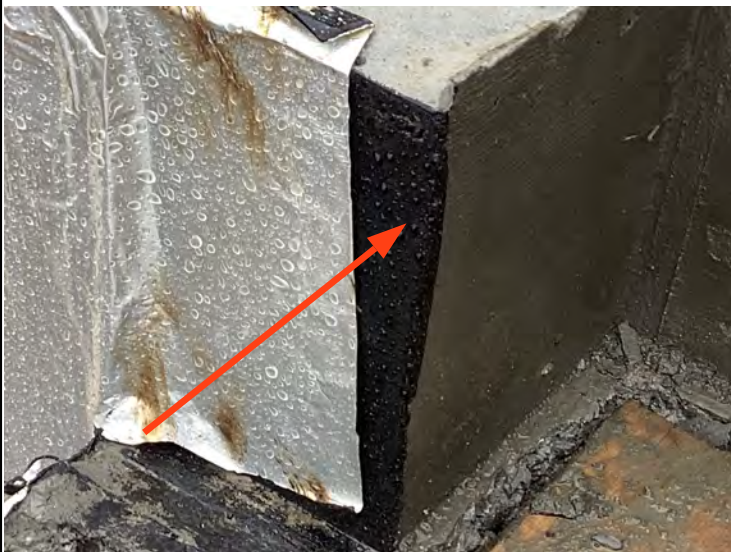
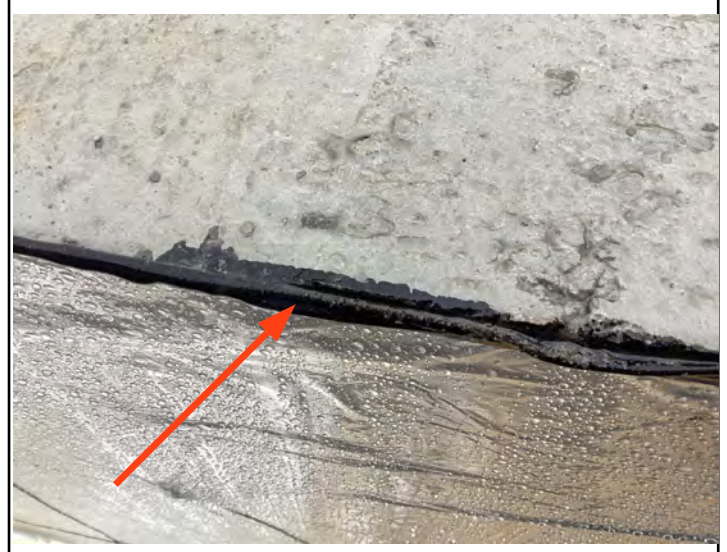
Photos showing that a coat of bitumen primer had been applied to all areas requiring the Visqueen Gas Resistant Self-Adhesive Membrane. This application aided the adhesion ensuring a good bond during installation.

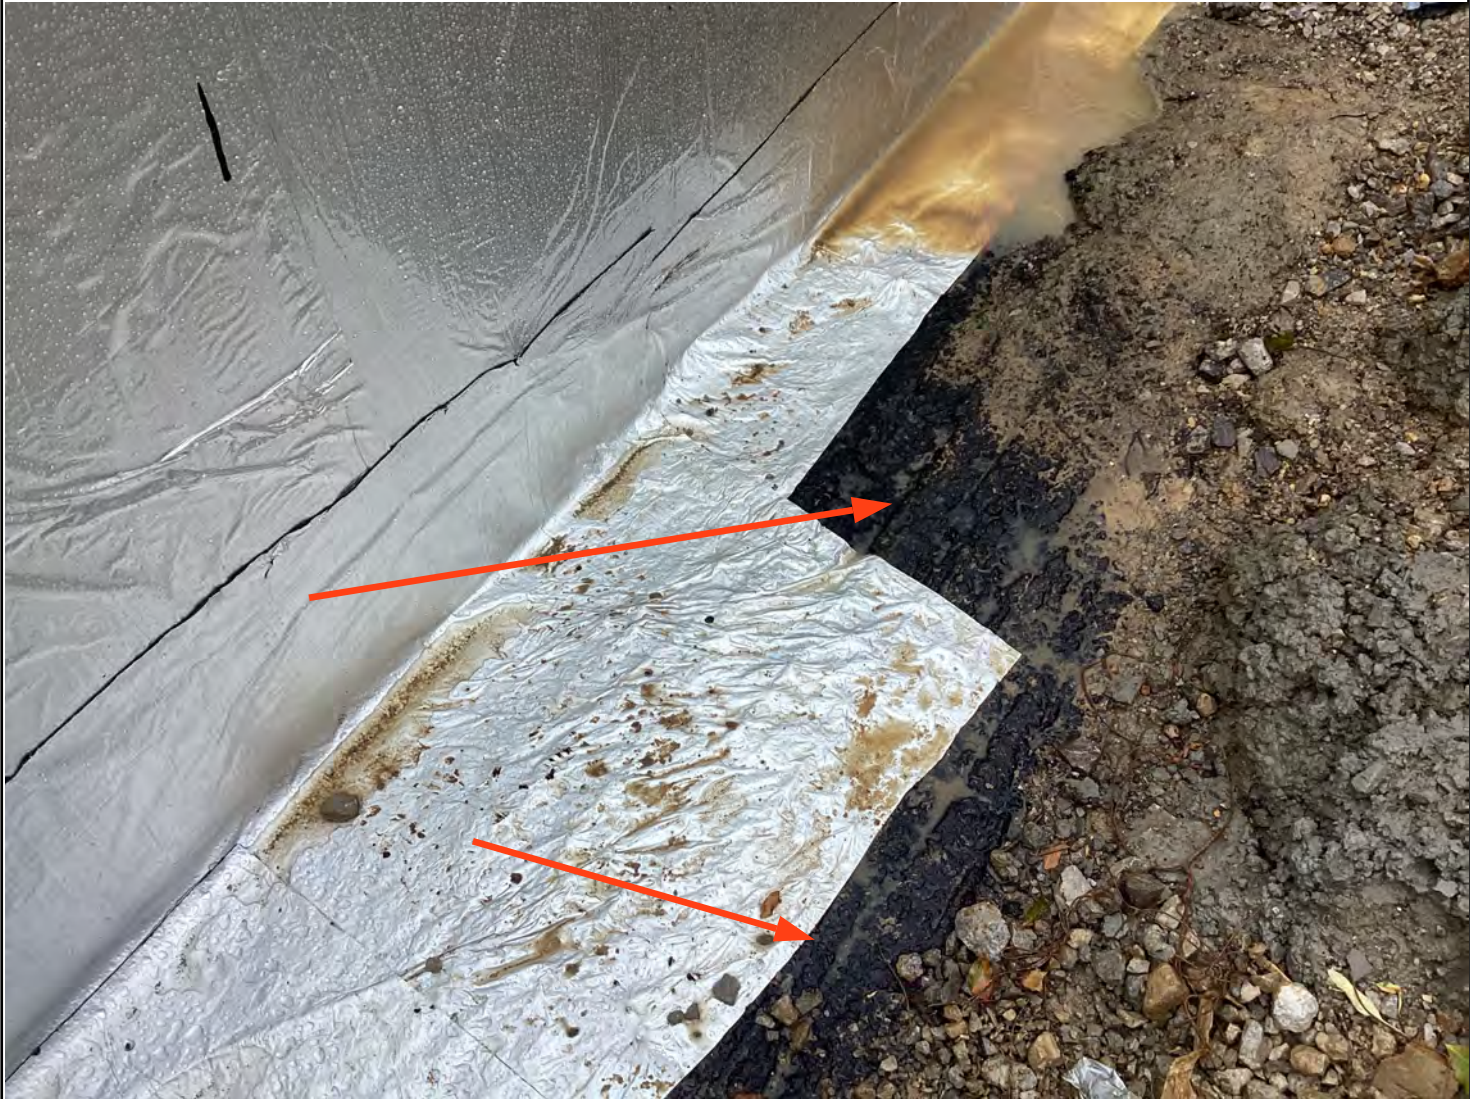
## VERIFICATION ITEM ONE

This photo again shows the extent of the applied bitumen primer which had been applied applied to aid adhesion of the Visqueen Gas Resistant Self-Adhesive Membrane.

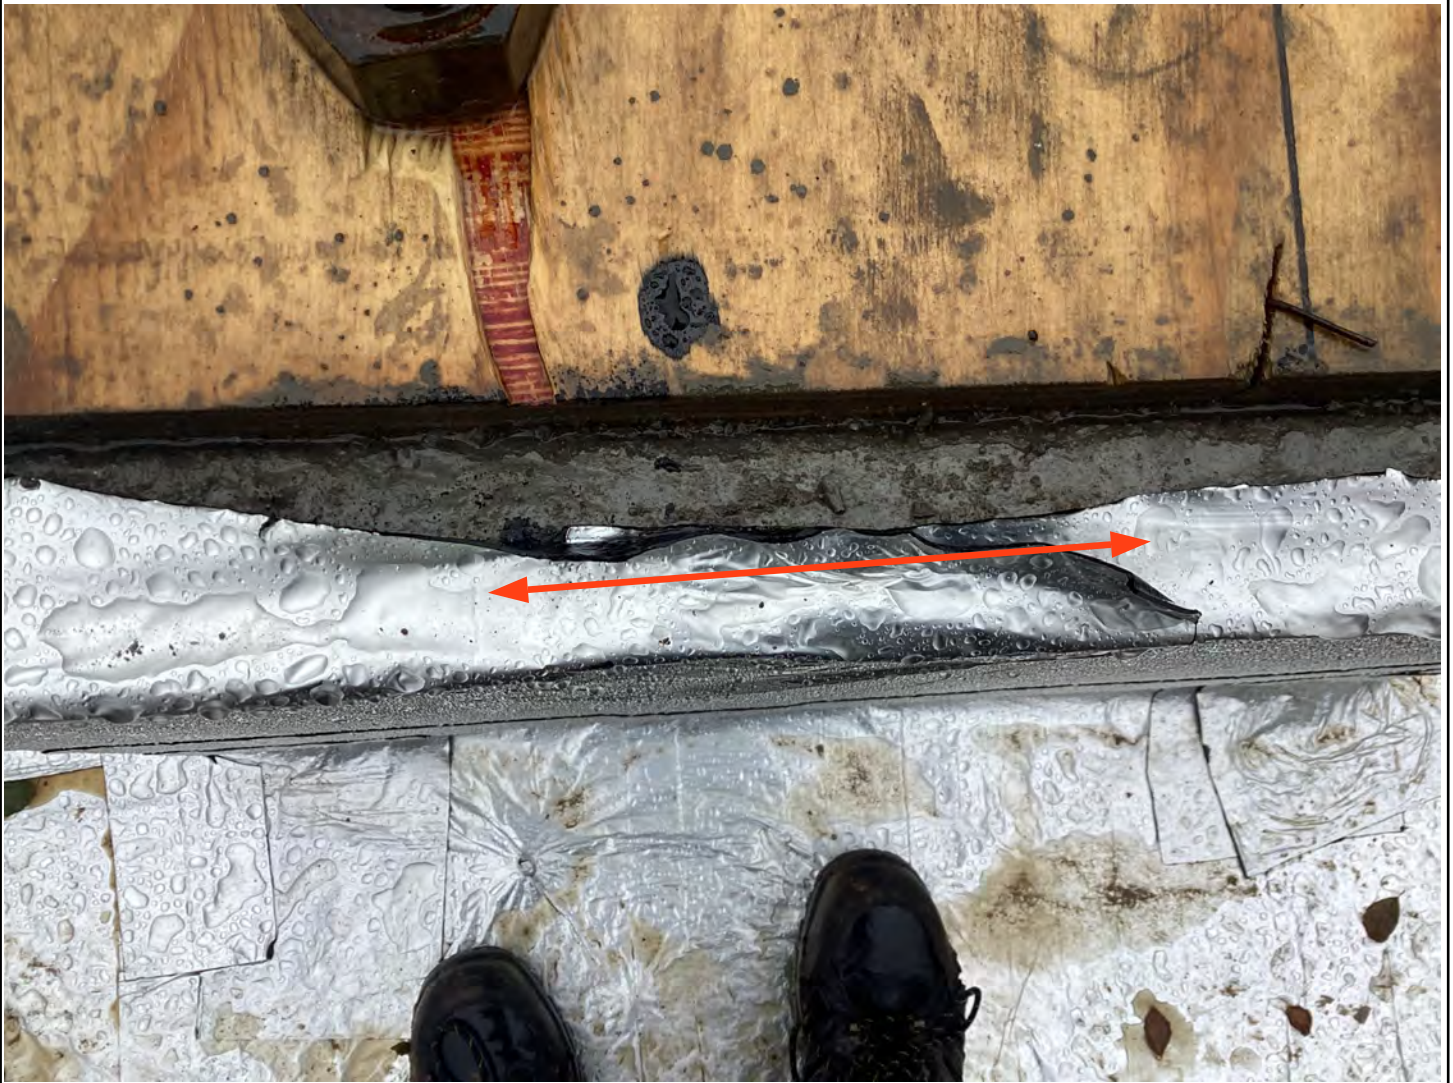
## VERIFICATION ITEM TWO

Overview showing a typical minimum lap of 100mm during the installation of the  
Visqueen Gas Resistant Self-Adhesive Membrane .

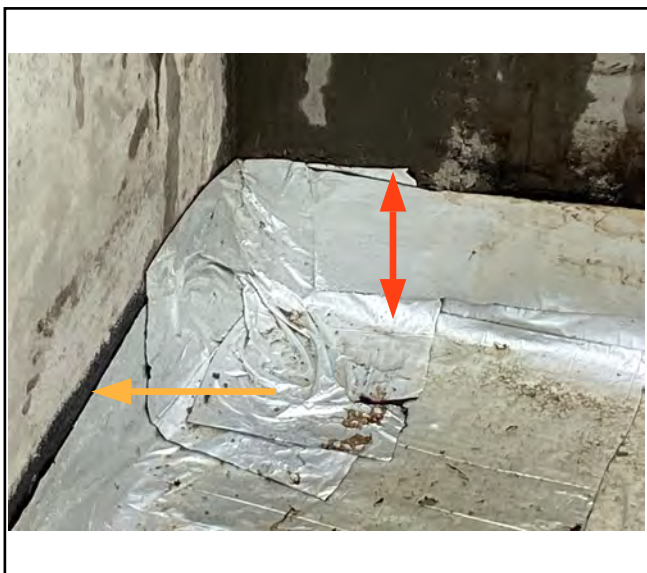
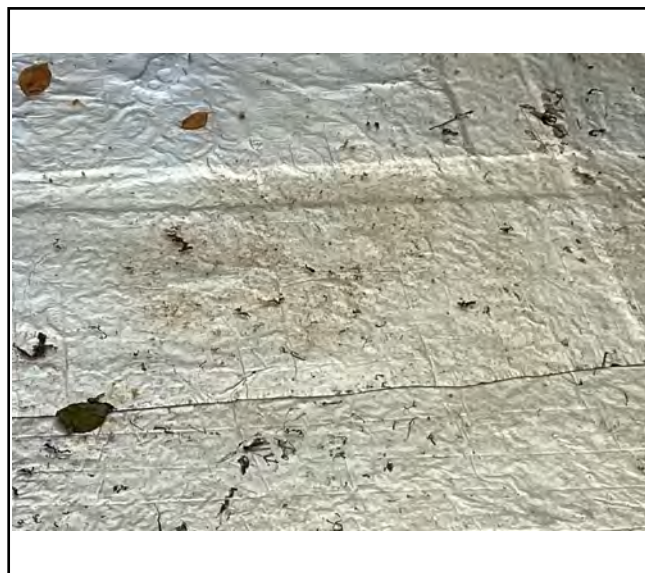
Photos showing the Visqueen Gas Resistant Self-Adhesive Membrane had been installed inside the base internally where on the first photo, the GRSAM has been lapped vertically a minimum of 100mm and above the previously applied Visqueen

Liquid Gas Membrane (Report 2). The edge of the application as seen by the yellow arrow, had peeled away slightly but the remainder was securely bonded.

Photo 2 showing the Visqueen GRSAM was lapped during application.

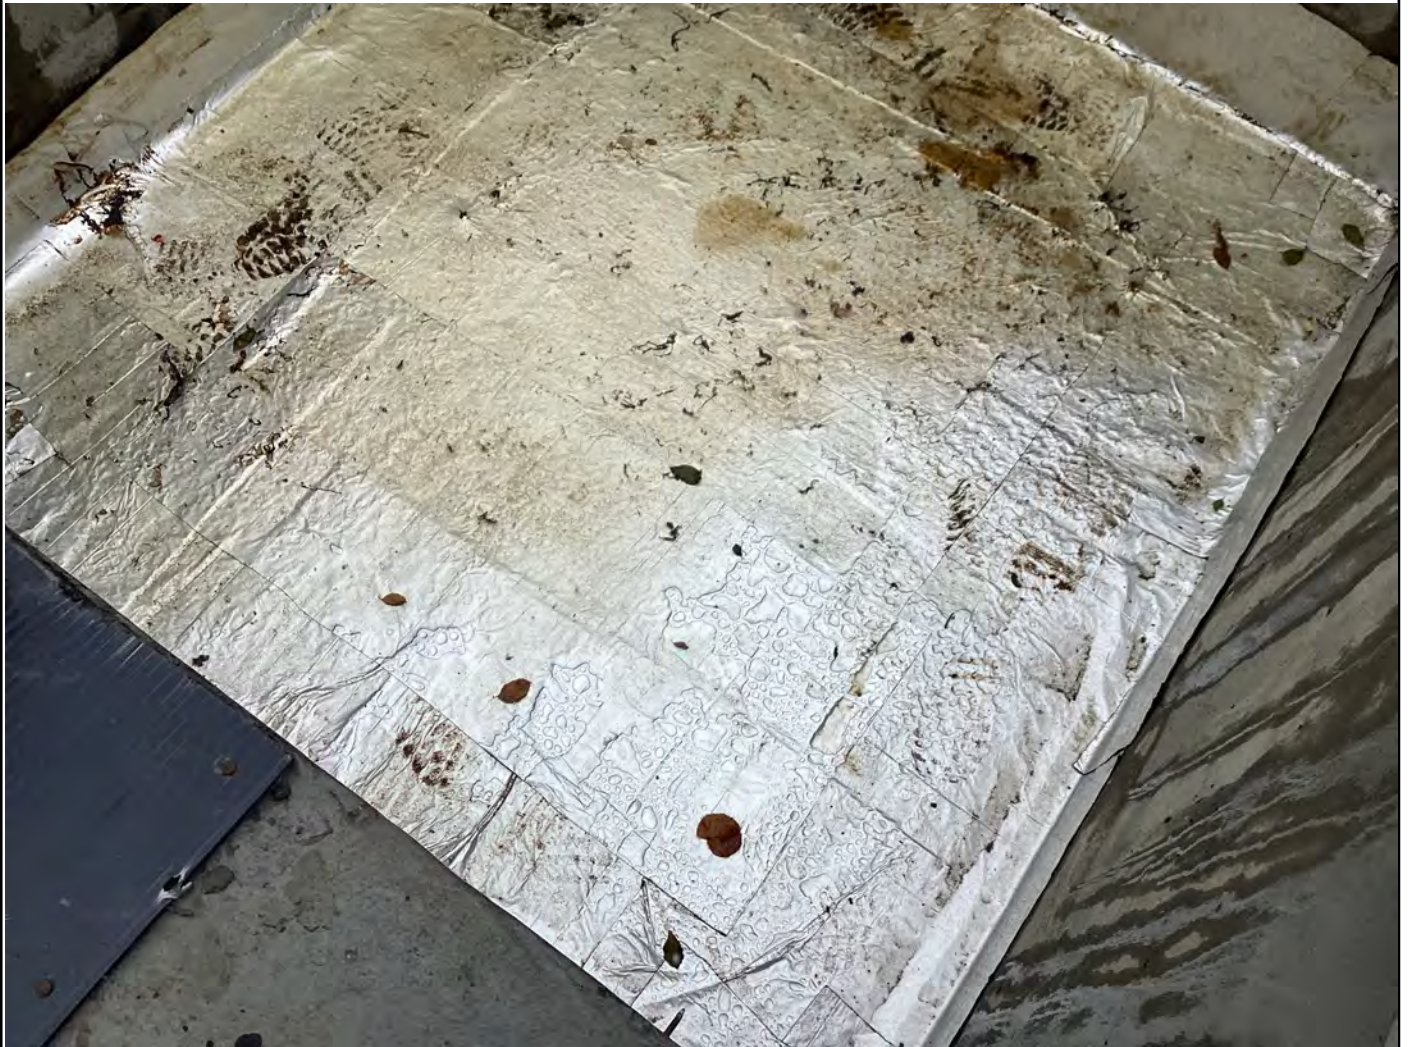
## VERIFICATION ITEM THREE

Overview of the Visqueen Gas Resistant Self-Adhesive Membrane along the  
base within the Lift Pit.

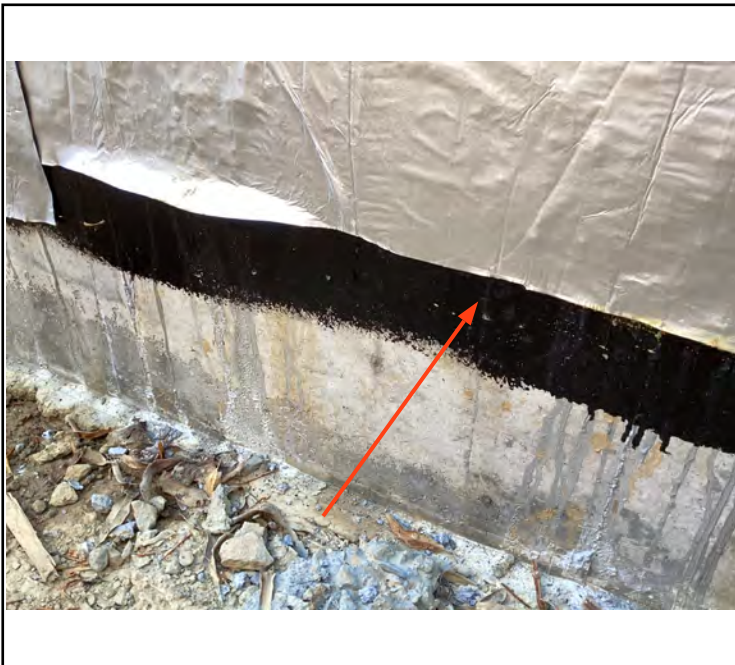
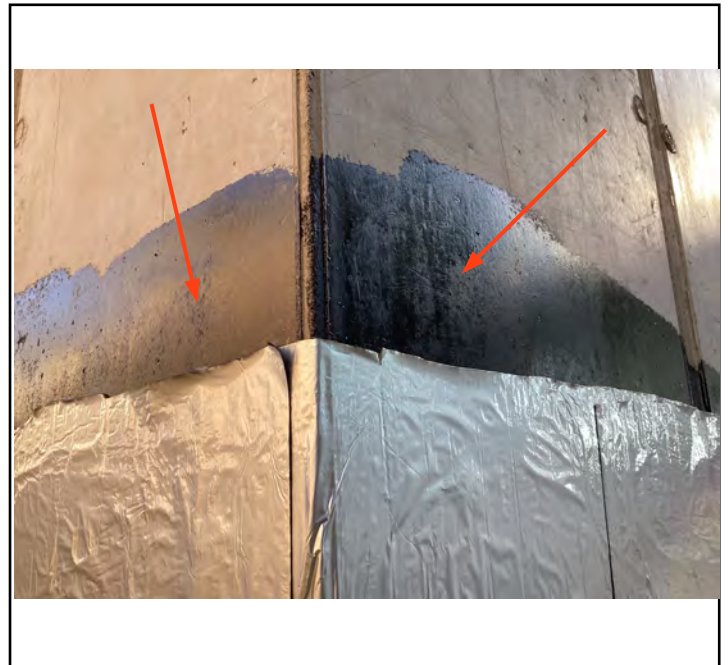
Photos showing that a coat of bitumen primer had been applied to all areas requiring the Visqueen Gas Resistant Self-Adhesive Membrane. This application aided the adhesion ensuring a good bond during installation.

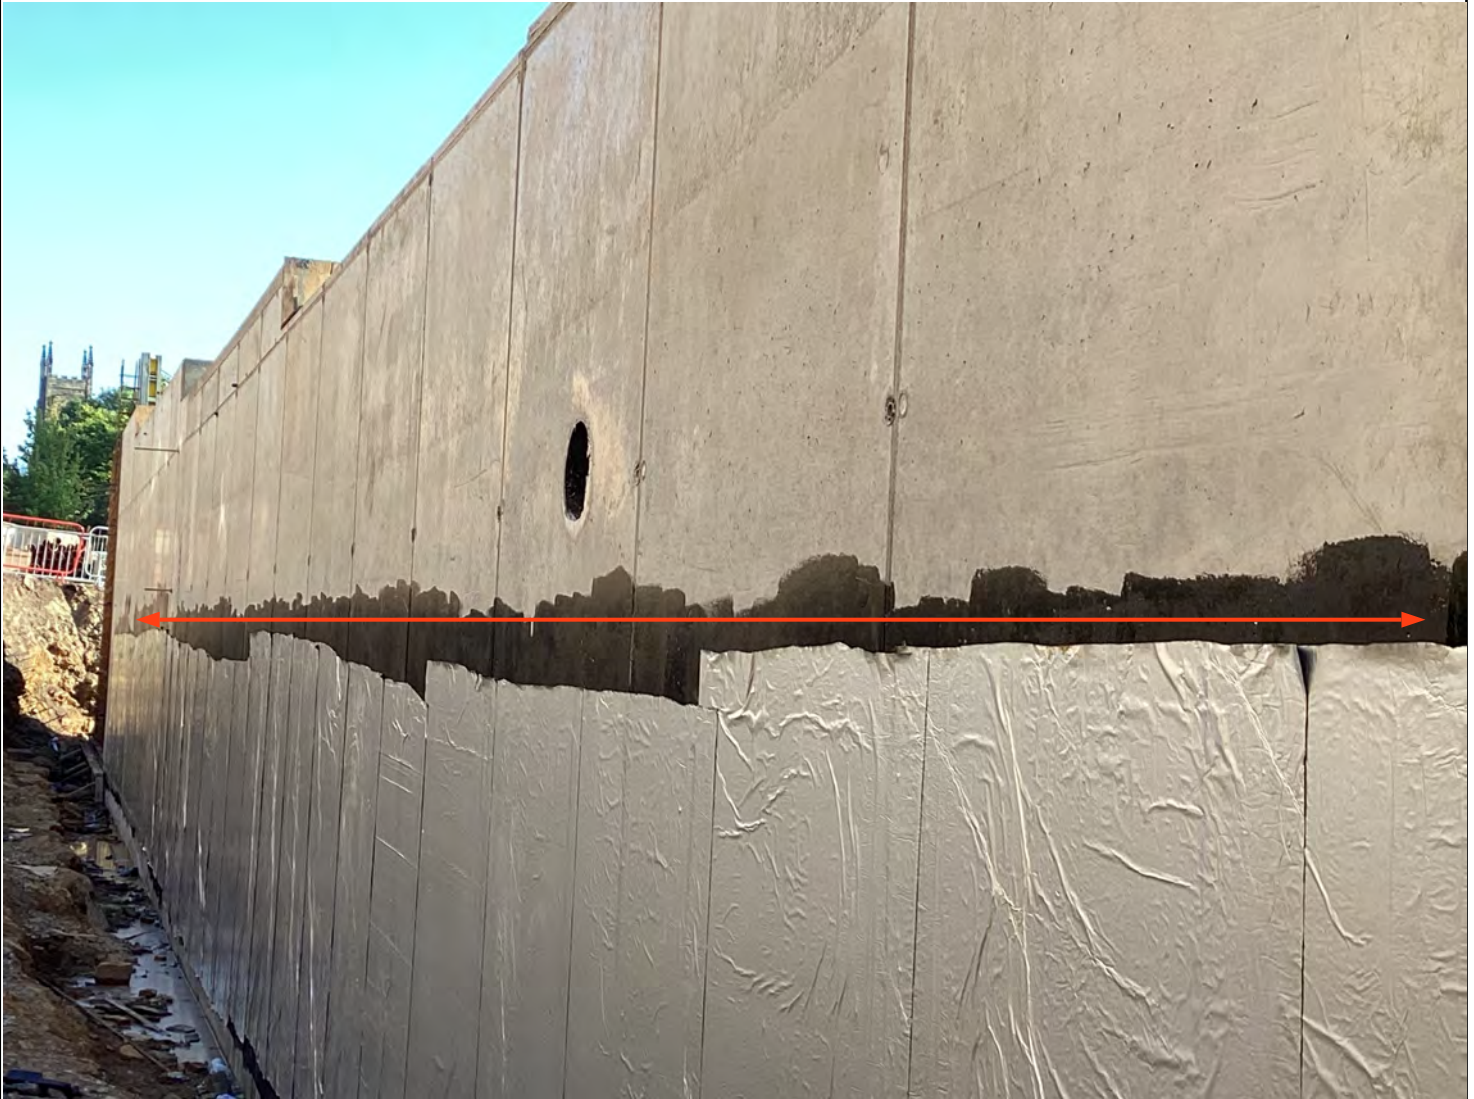
## VERIFICATION ITEM ONE

This photo again shows the extent of the applied bitumen primer which had been

applied to aid adhesion of the Visqueen Gas Resistant Self-Adhesive Membrane.

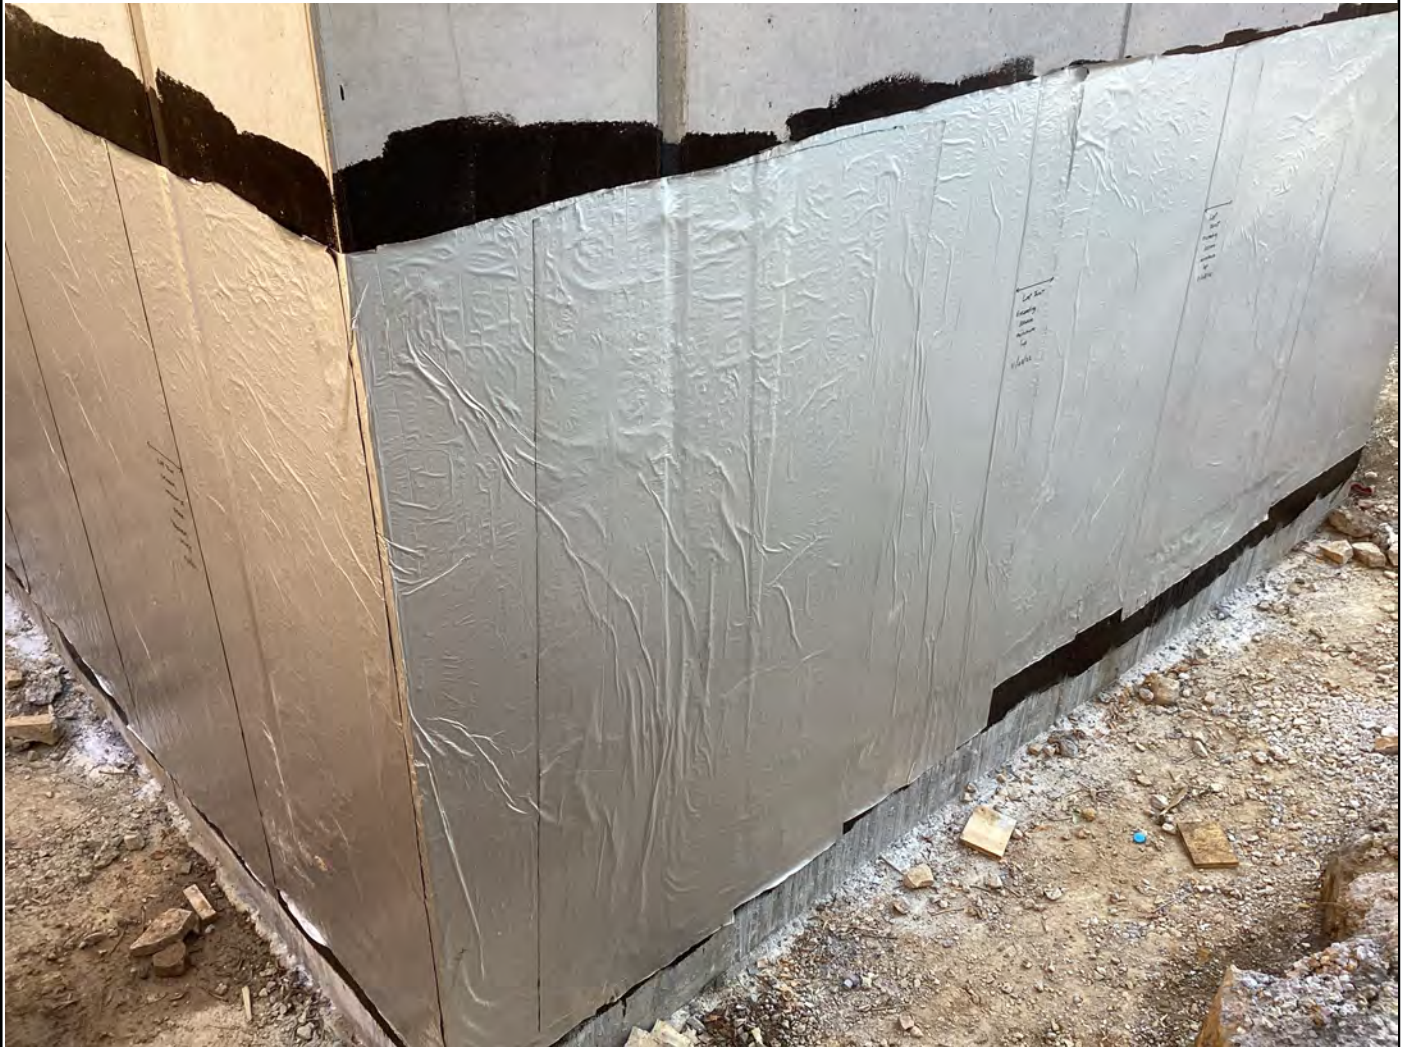
## VERIFICATION ITEM THREE

Overview of the Visqueen Gas Resistant Self-Adhesive Membrane where there are small creases within the Visqueen Gas Resistant Self Adhesive Membrane.

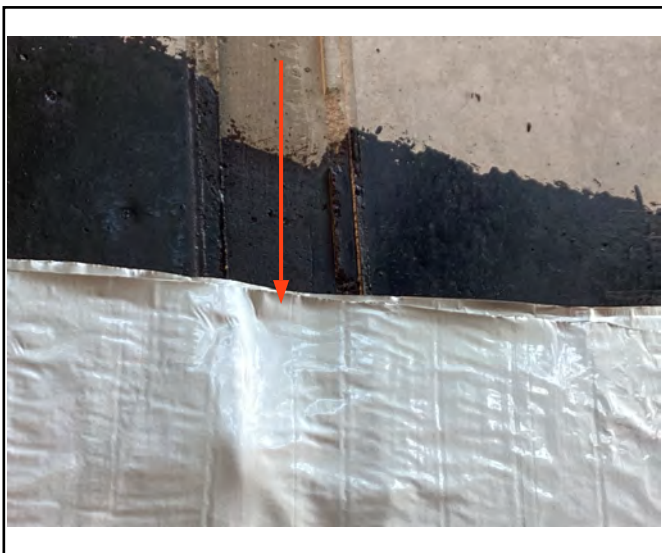
Slight groove within retaining wall to  
be aware of when sealing GRSAM

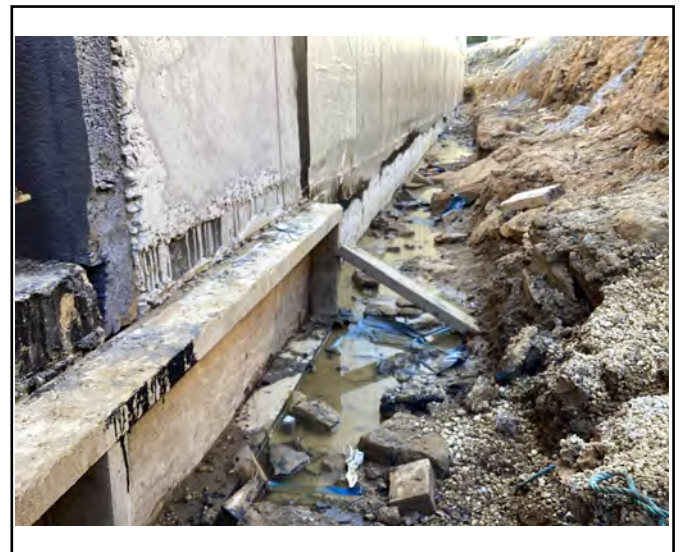
View showing that the GRSAM extends

lower than the Liquid Gas Membrane

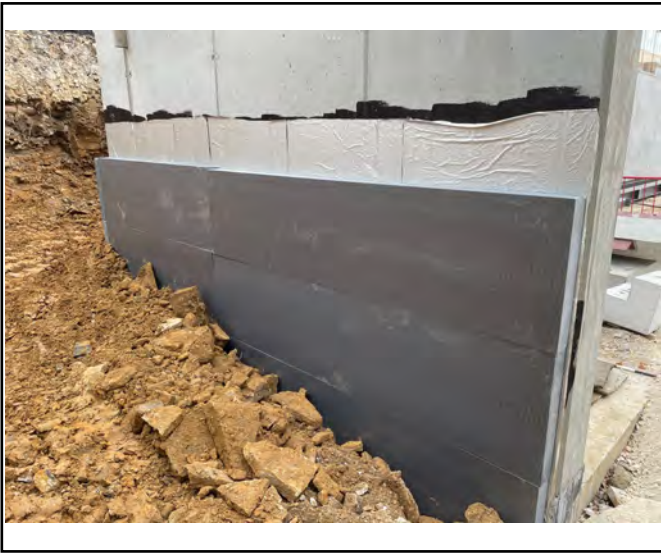
View of insulation protecting the  
GRSAM along rear of retaining wall

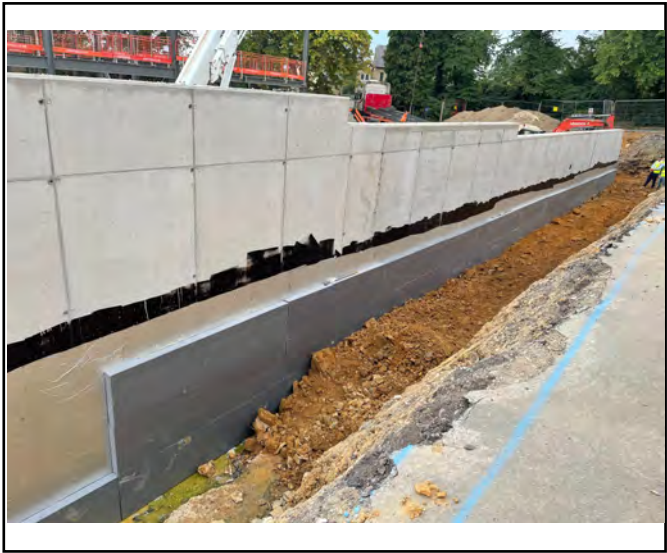
Alternative view of insulation protecting  
GRSAM along rear of retaining wall

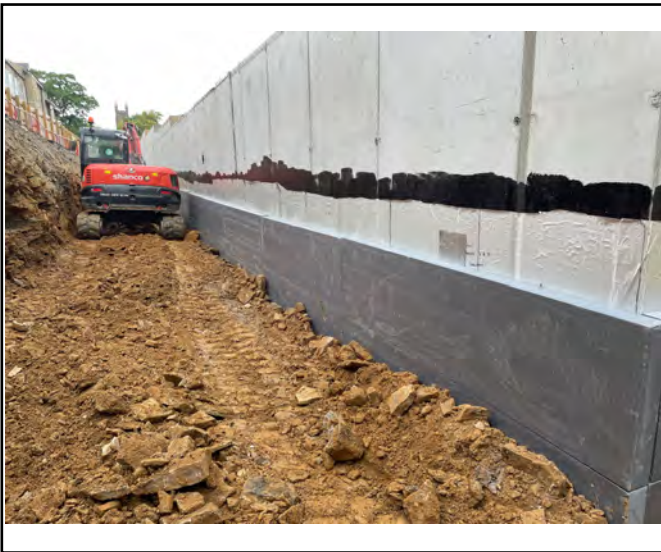
Alternative view of insulation protecting  
GRSAM along rear of retaining wall

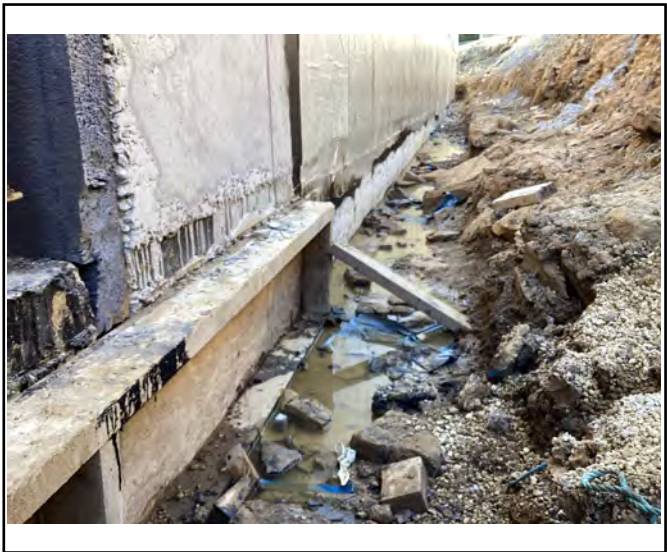
View showing GRSAM exceeding  
beyond the Liquid Gas Membrane

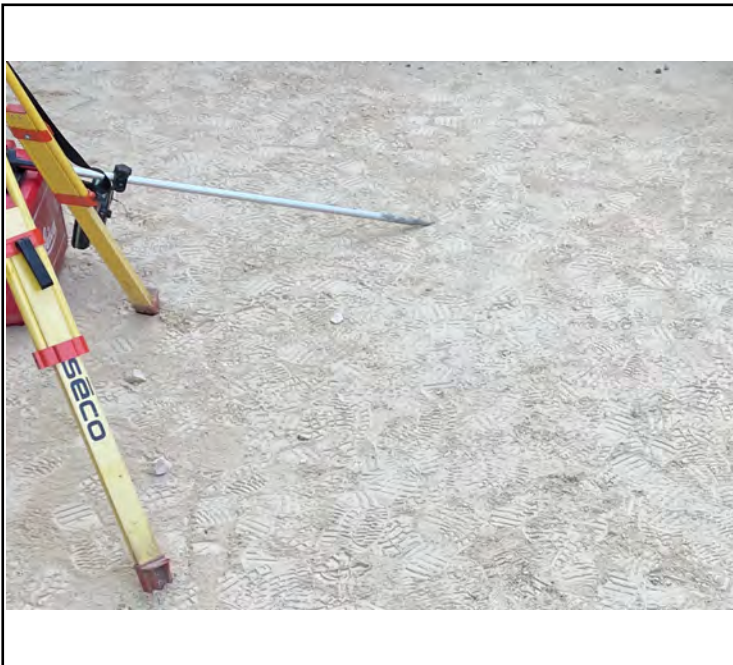
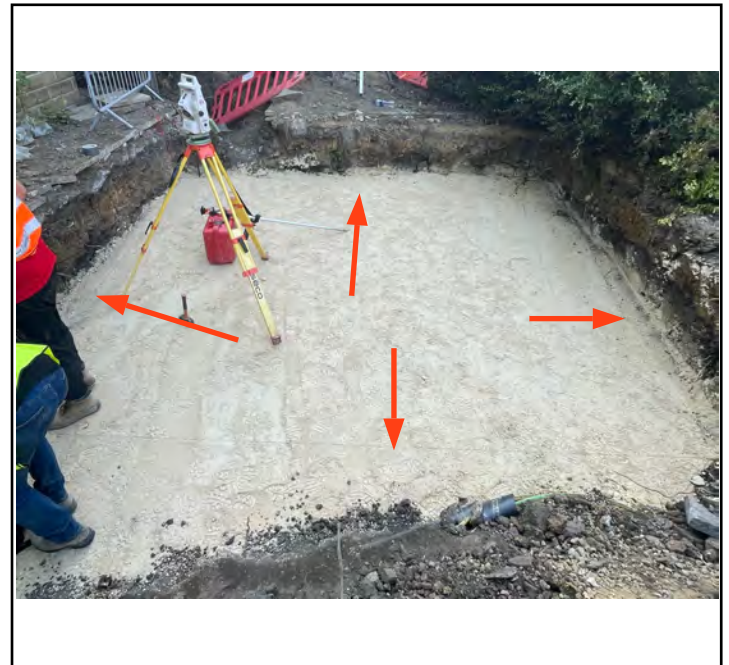
The first stage before the installation of substation base perimeter for work was to prepare the substrate. Photos shows where crushed limestone has been placed ensuring the surface was reasonably flat with minimum larger stones visible.

Photo 2 also shows the correct substrate preparation extends past the proposed position of the formwork - see red arrows which identify the setting out.

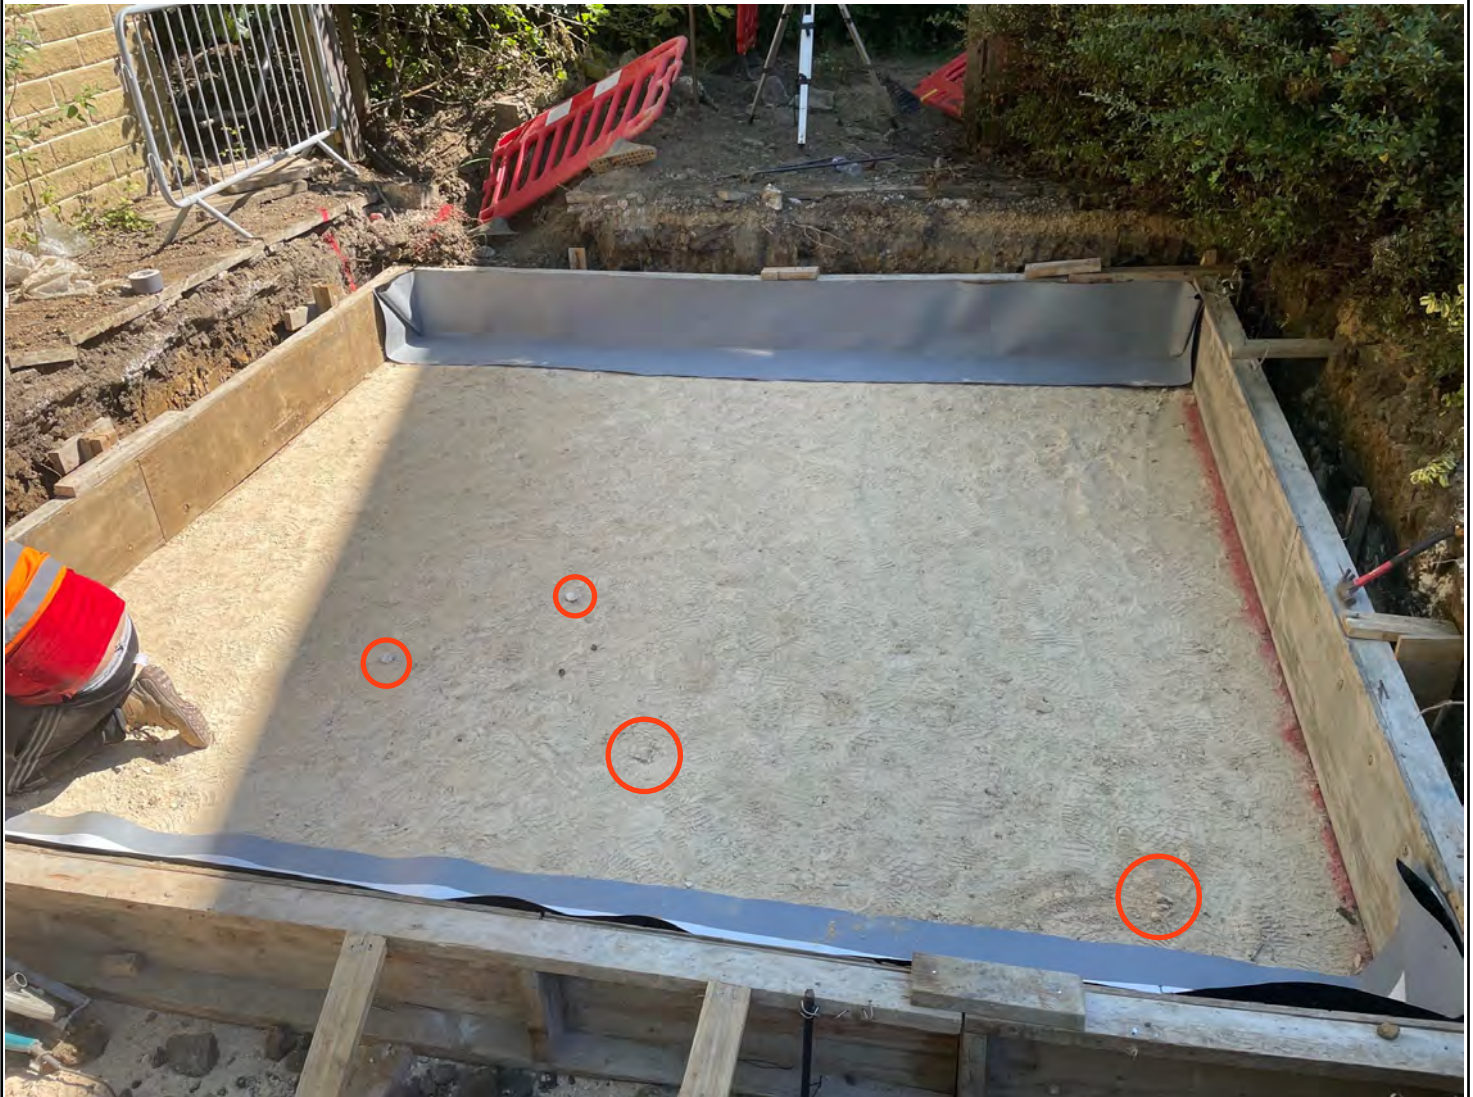
## VERIFICATION ITEM ONE

Overview showing the formwork secured into position upon the previously prepared

substrate. The red circles identify larger stones which were identified during an email
