# GEOSHIELD Verification Report

GEO102848

Galiford Try Building

Gas membrane to specification BS8485 2015

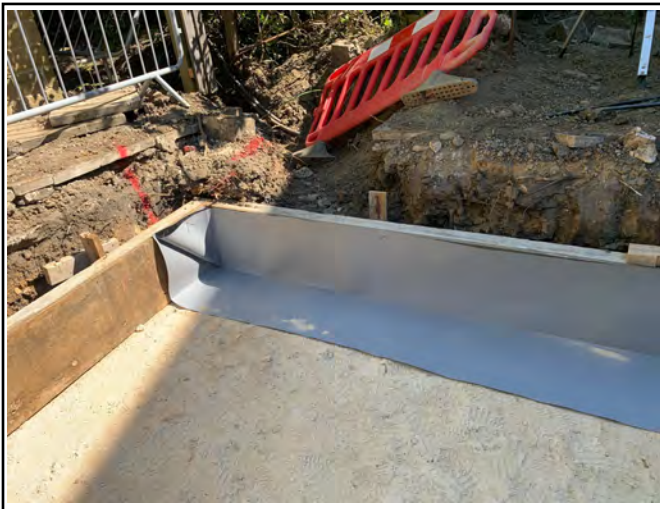
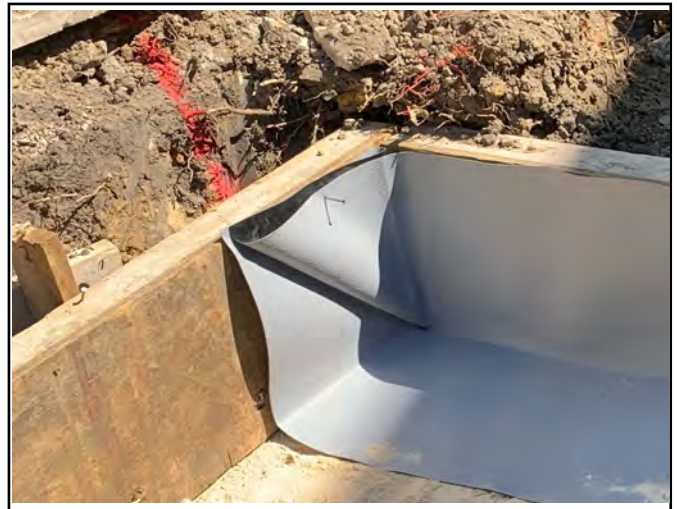
The installation of the Visqueen Ultimate Geoseal was completed in affectively two stages. The first stage was to install a strip of Visqueen Ultimate Geoseal along two opposing sides so that the Visqueen Ultimate Geoseal the base edge and vertically up

the sides of the formwork as per photo 1. There was particular attention when forming the four external corners as these areas are potentially the weakest areas if not completed correctly. Photo 2 shows a close up view of a typically formed internal corner where the Visqueen Ultimate Geoseal has been formed/folded and as there were no signs of any cutting, looked to be a fully sealed corner detail.

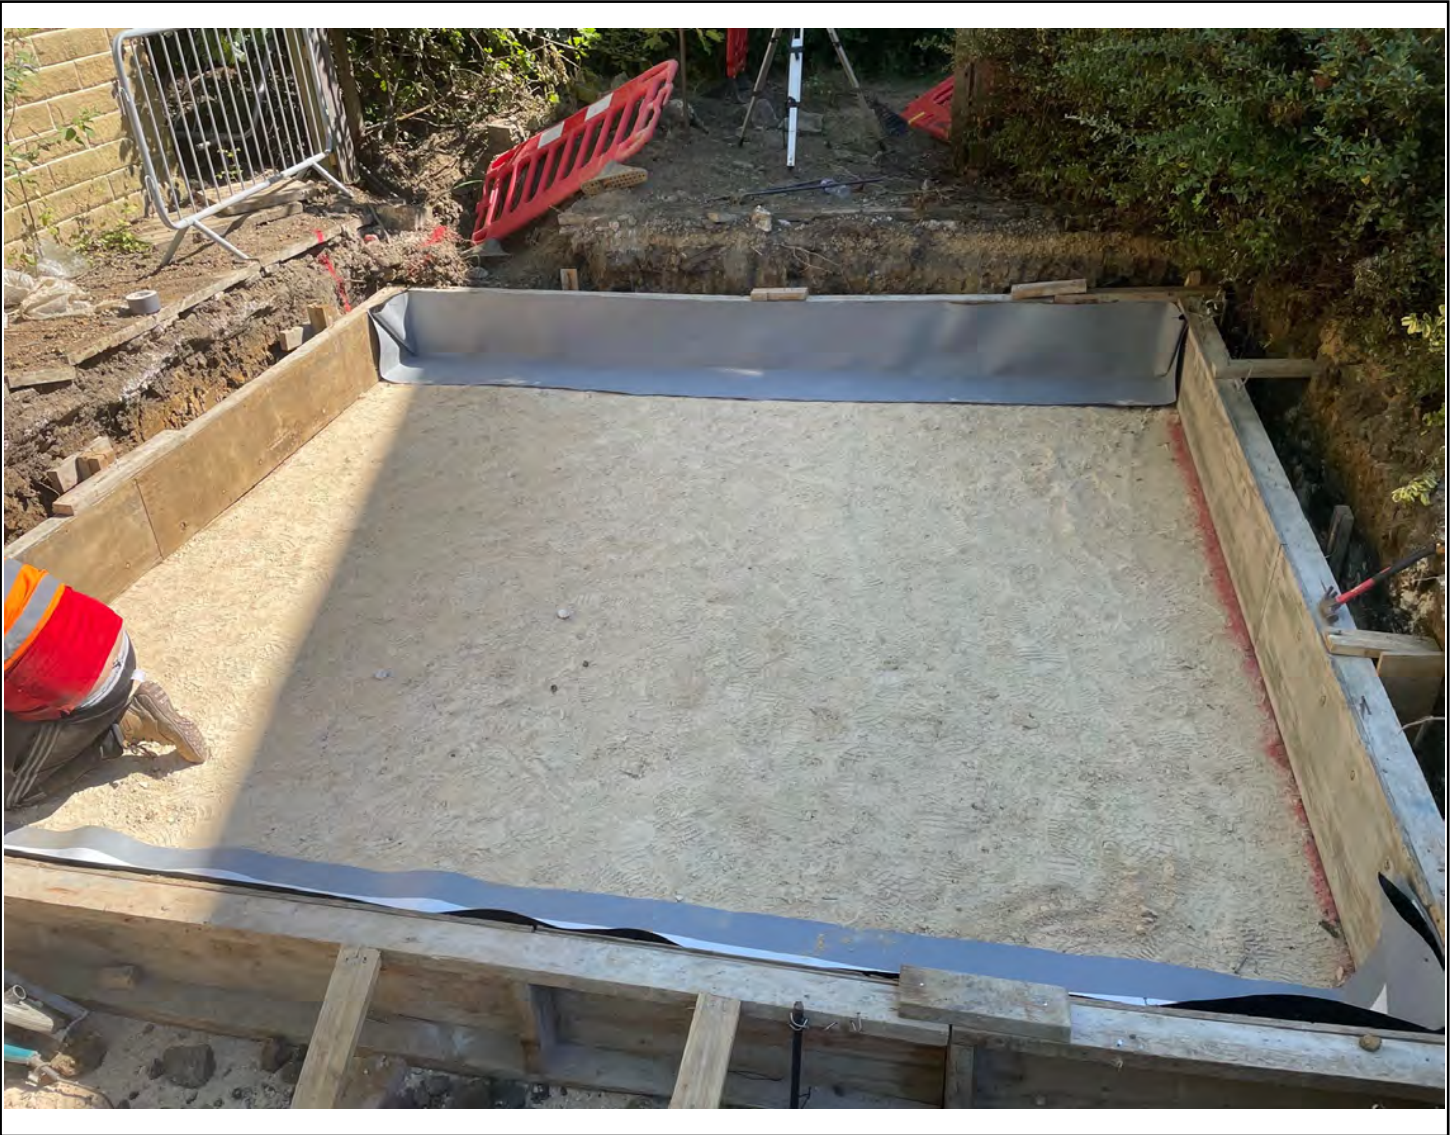
## VERIFICATION ITEM TWO

Overview showing where the Visqueen Ultimate Geoseal has been installed along

two sides of the formwork. The second stage will include the infilling of the

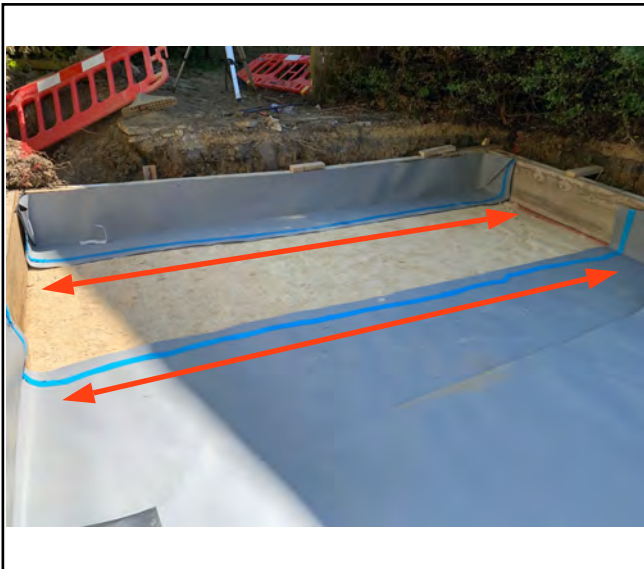
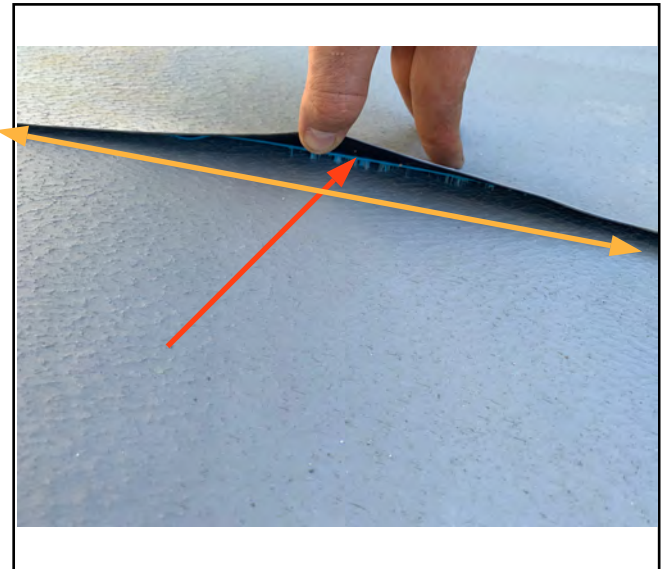
Photos showing the next stage of installing the Visqueen Ultimate Geoseal where any lap joints were lapped a minimum of 150mm according to the one photograph seen in the 'additional photos' section this report. Photo 1 is showing the Visqueen Double

Sided Butyl Tape adhered into position along the edge of the Visqueen Ultimate Geoseal (red arrow).

Photo 2 showing the Visqueen Double Sided Butyl Tape within the lap joint.

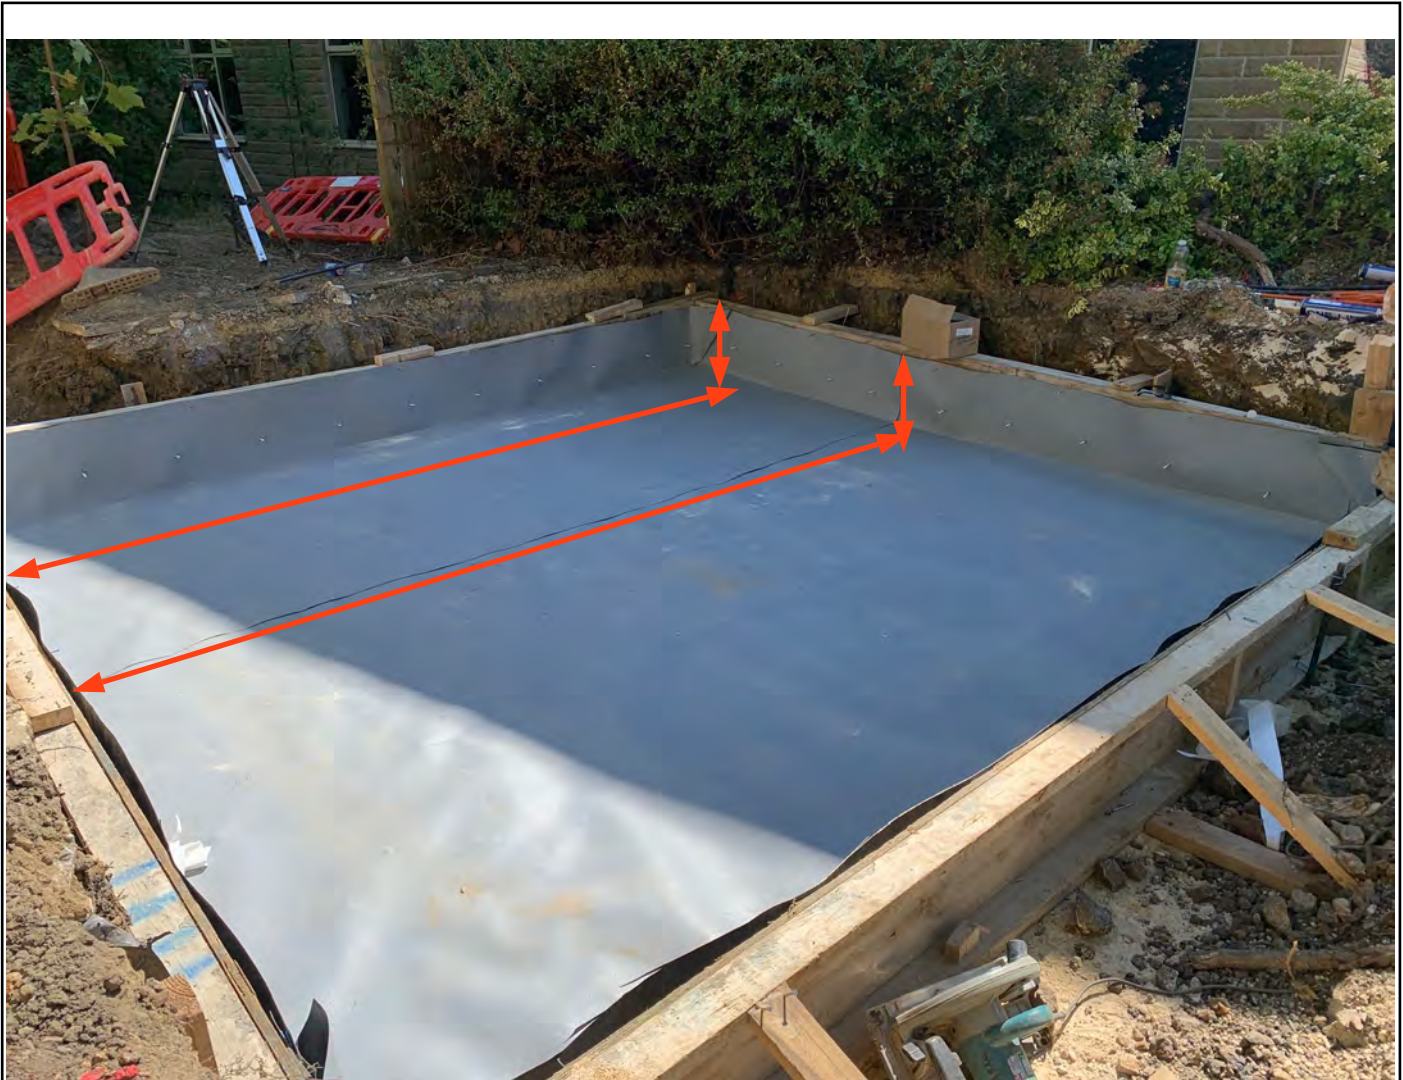
## VERIFICATION ITEM THREE

Overview photo showing the completed installation of the Visqueen Ultimate

Geoseal within the substation base. The red arrows indicate the positions of the two

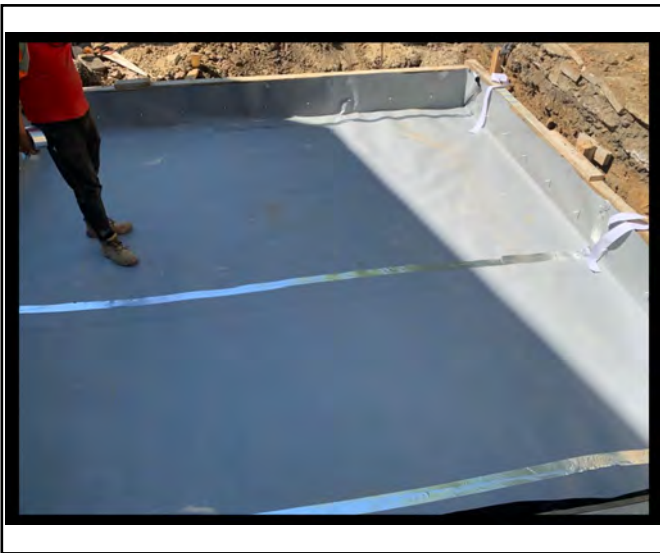
View showing the Visqueen GR Lap

Tape installed to the two lap joints.

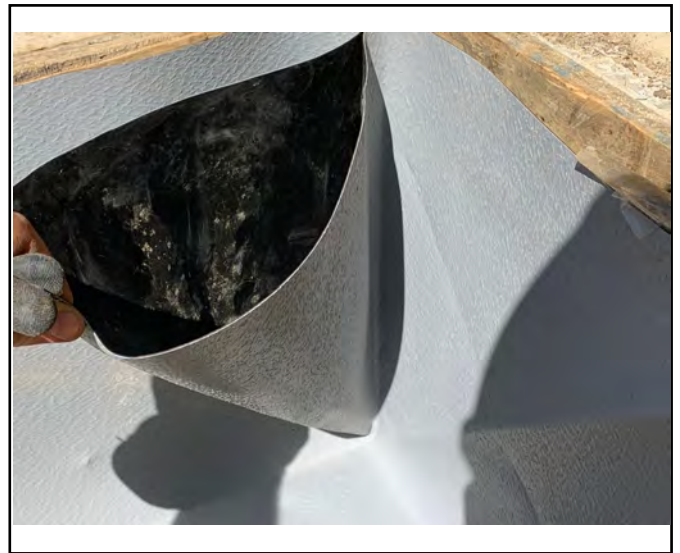
Close up of the the corner formed

without cutting the Geoseal

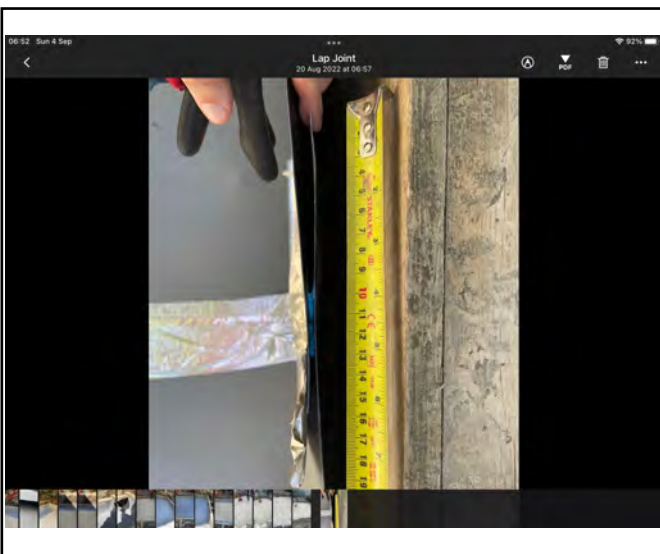
Overview showing the lap joint

lapped at 150mm.

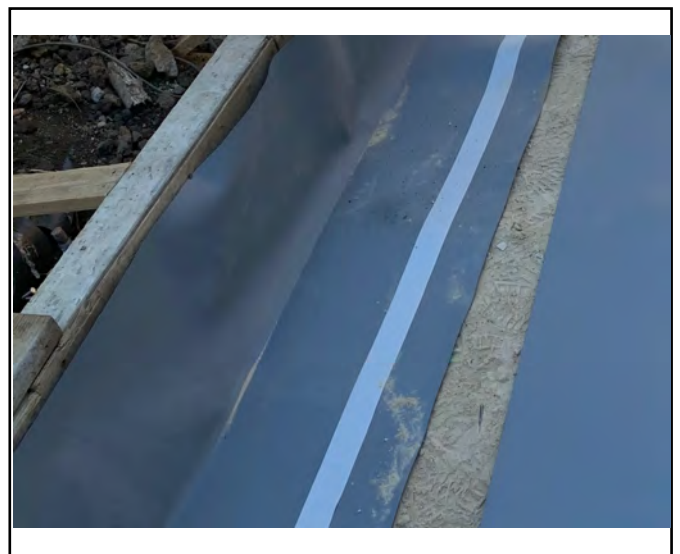
View of the Visqueen Double Sided

Butyl Tape along Ultimate Geoseal

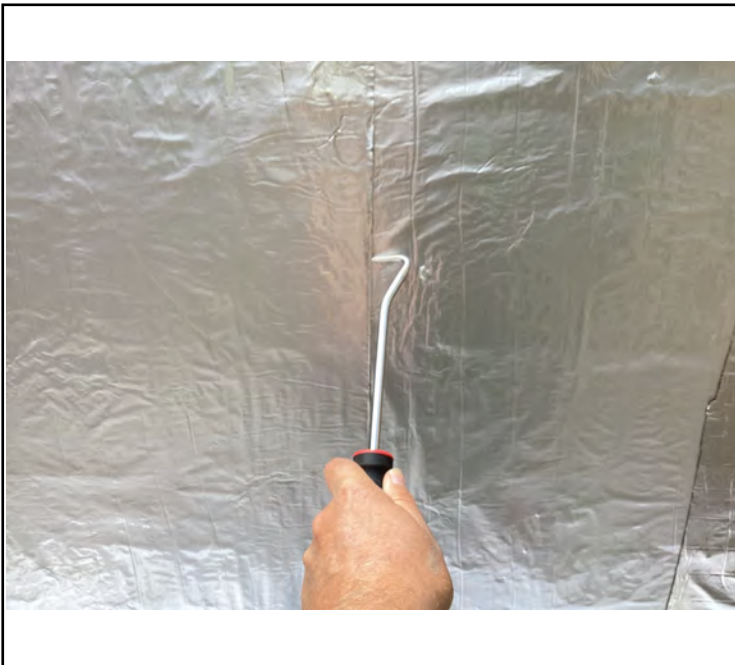
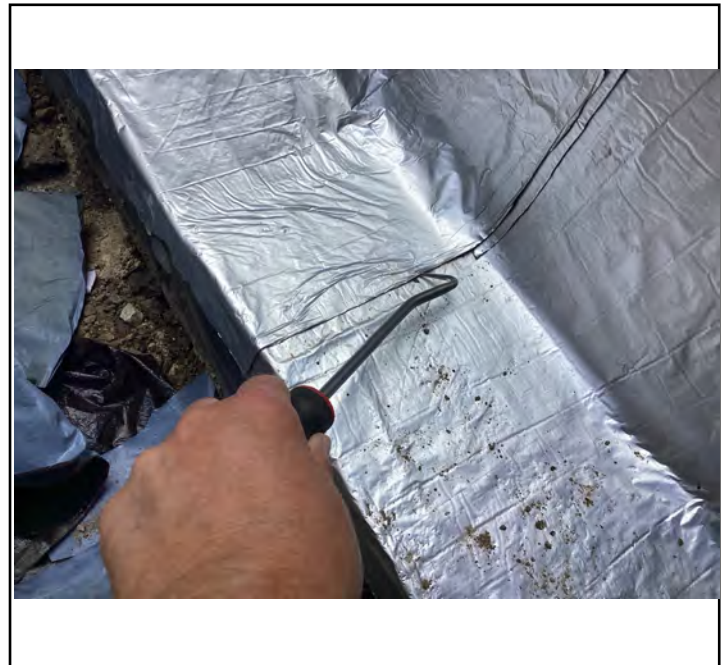
Photos showing the Mechanical Point Stress Test being undertaken along one of the

lap joints to ensure there were no potential capillary leak issues. Verification confirmed

no issues were identified throughout the inspection.

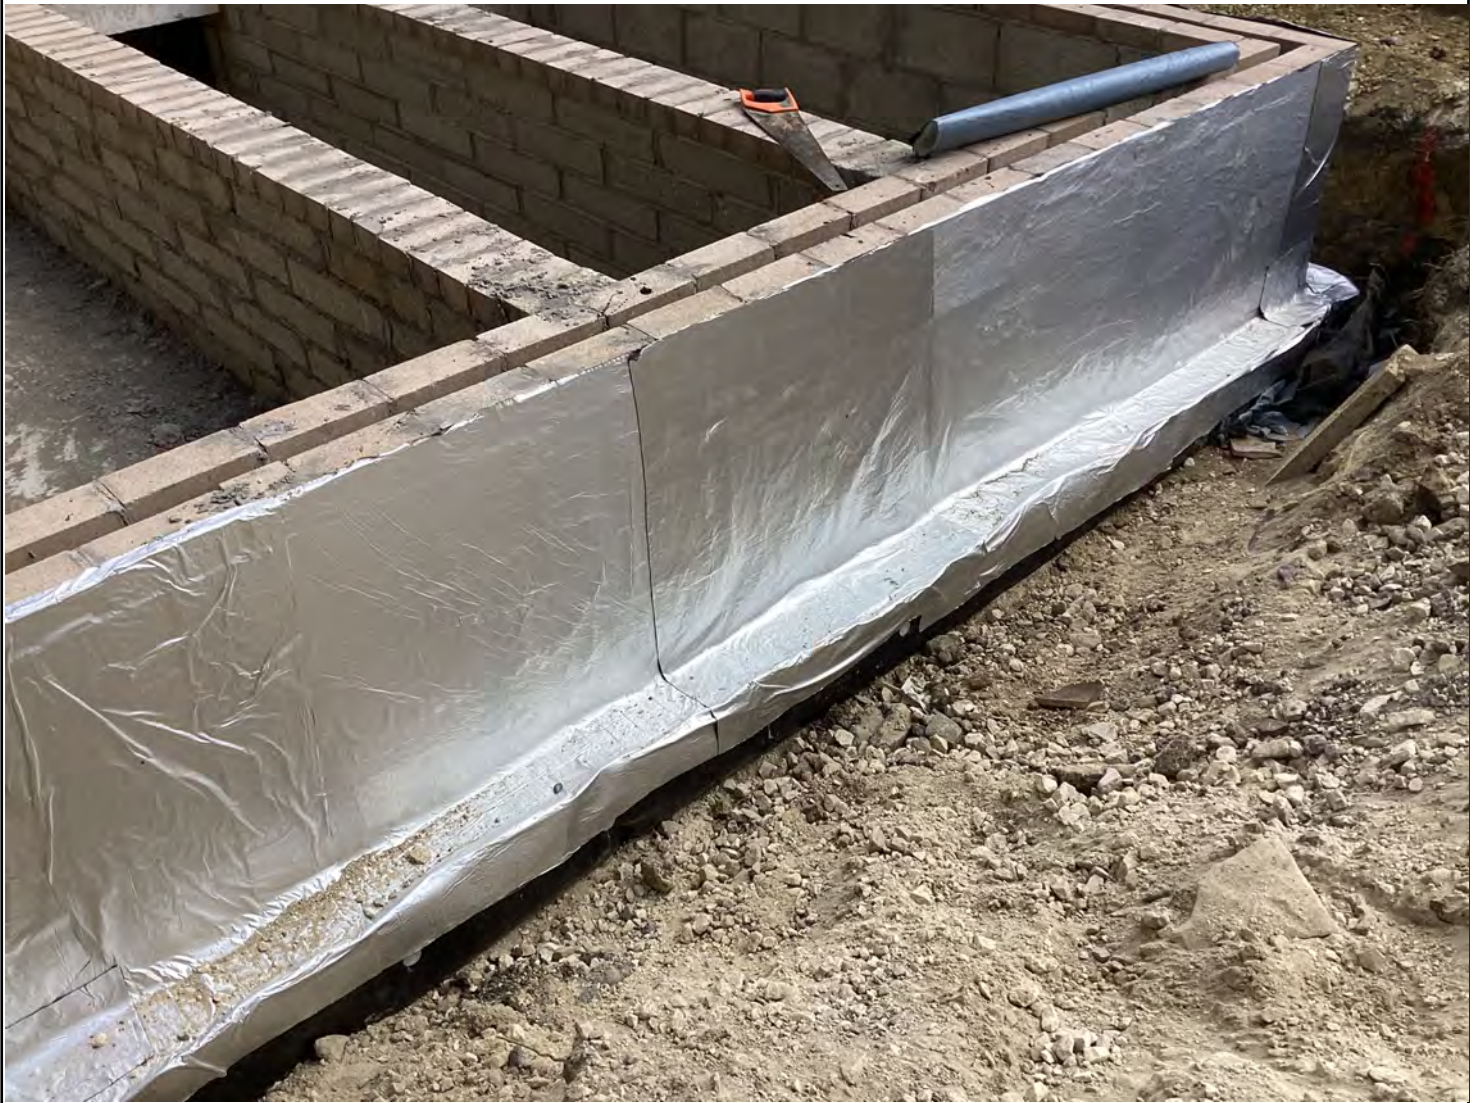
## VERIFICATION ITEM ONE

Overview of an elevation showing the typical completed installation of the Visqueen

Gas Resistant Self Adhesive Membrane to the walls. In addition, the GRSAM also

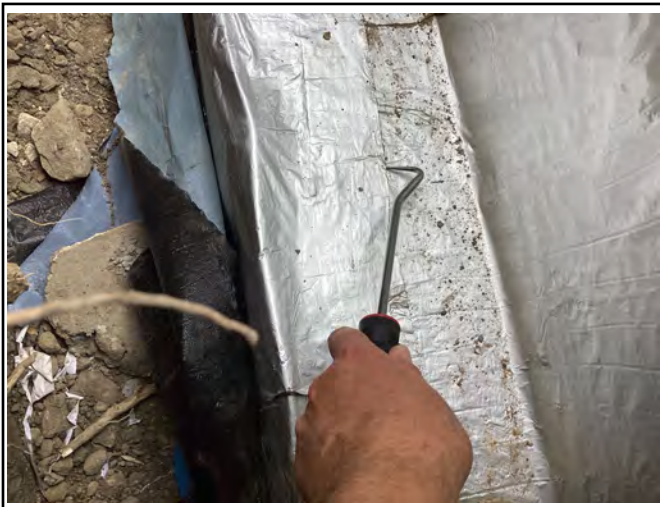
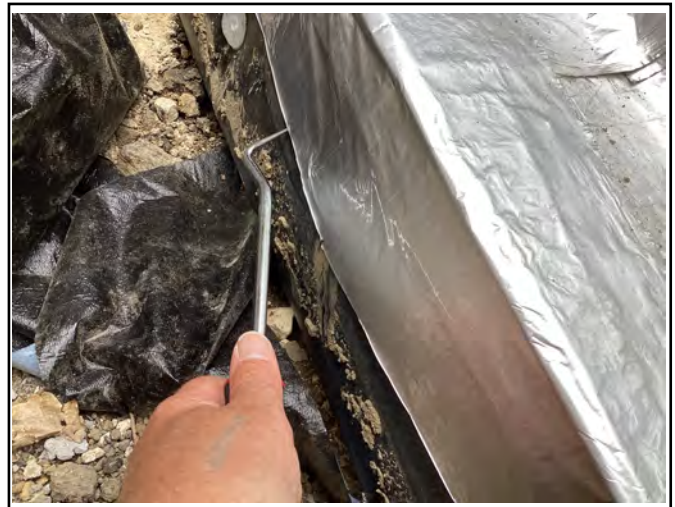
The Visqueen Gas Resistant Self Adhesive Membrane had been profiled to the concrete toe. The previously installed Visqueen Ultimate Geoseal beneath the concrete slab had been lapped, pinned into position before the Visqueen Gas Resistant

Self Adhesive Membrane was lapped providing a continuous seal against any ground gasses. Photos showing the Mechanical Point Stress Test being undertaken along the lap edges. No faults were identified during the verification process.

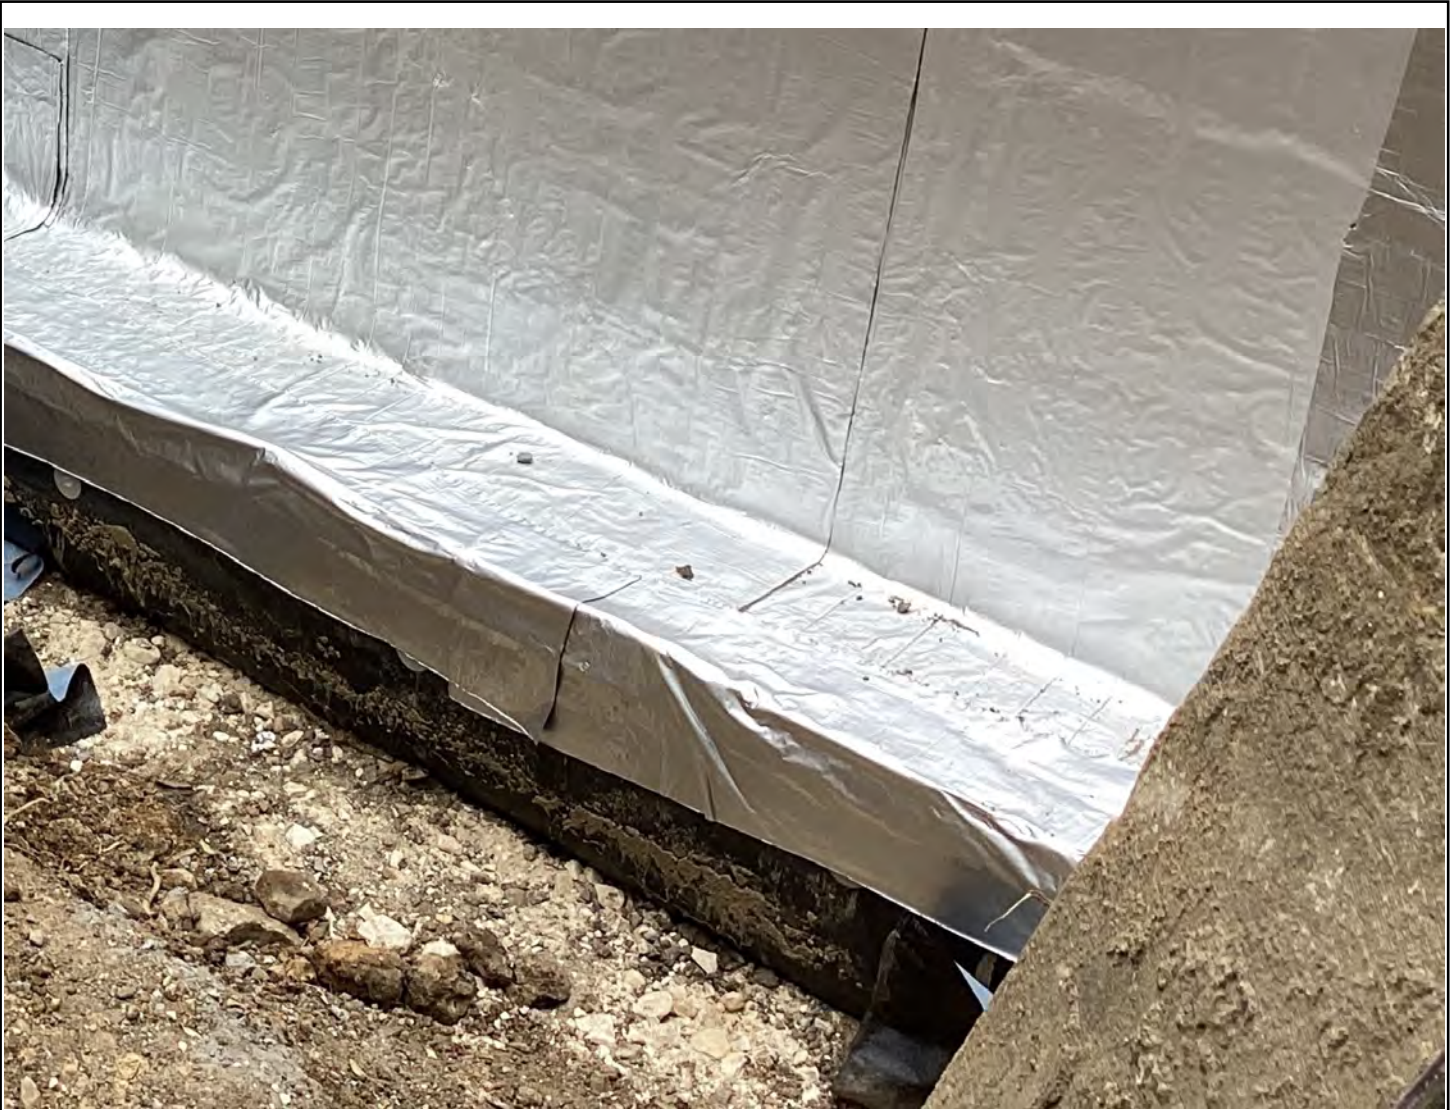
## VERIFICATION ITEM TWO

Overview of the Visqueen Gas Resistant Self Adhesive Membrane following it's  
installation to the substation toe.

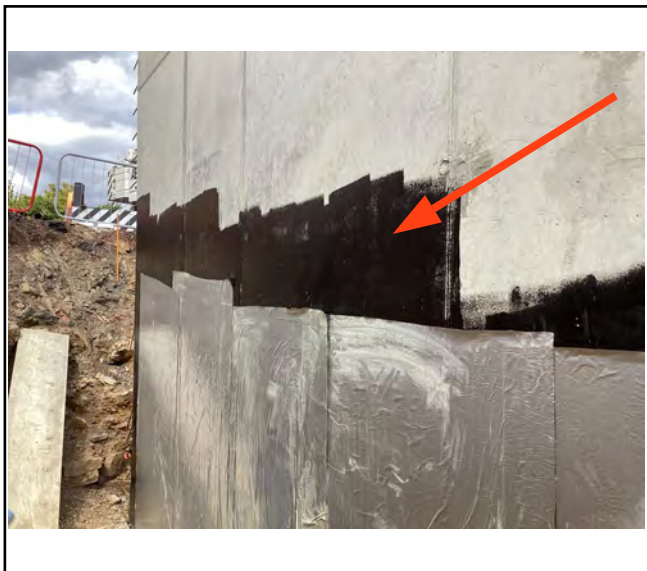
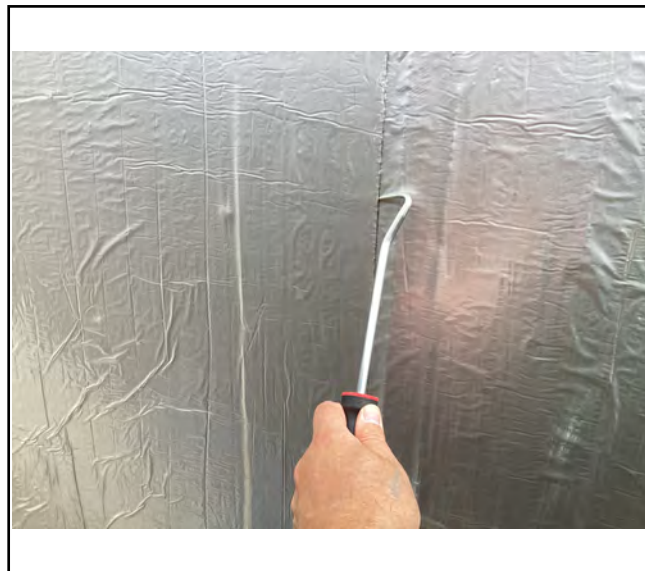
The Visqueen Gas Resistant Self Adhesive Membrane had been installed along the retaining wall which had been previously primed using bitumen primer identified with a red arrow on photo 1.

Photo 2 showing the Mechanical Point Stress Test being undertaken along the edge of the vertical lap joints. The purpose being to ensure there were capillary leak risk and no issues were identified during the verification.

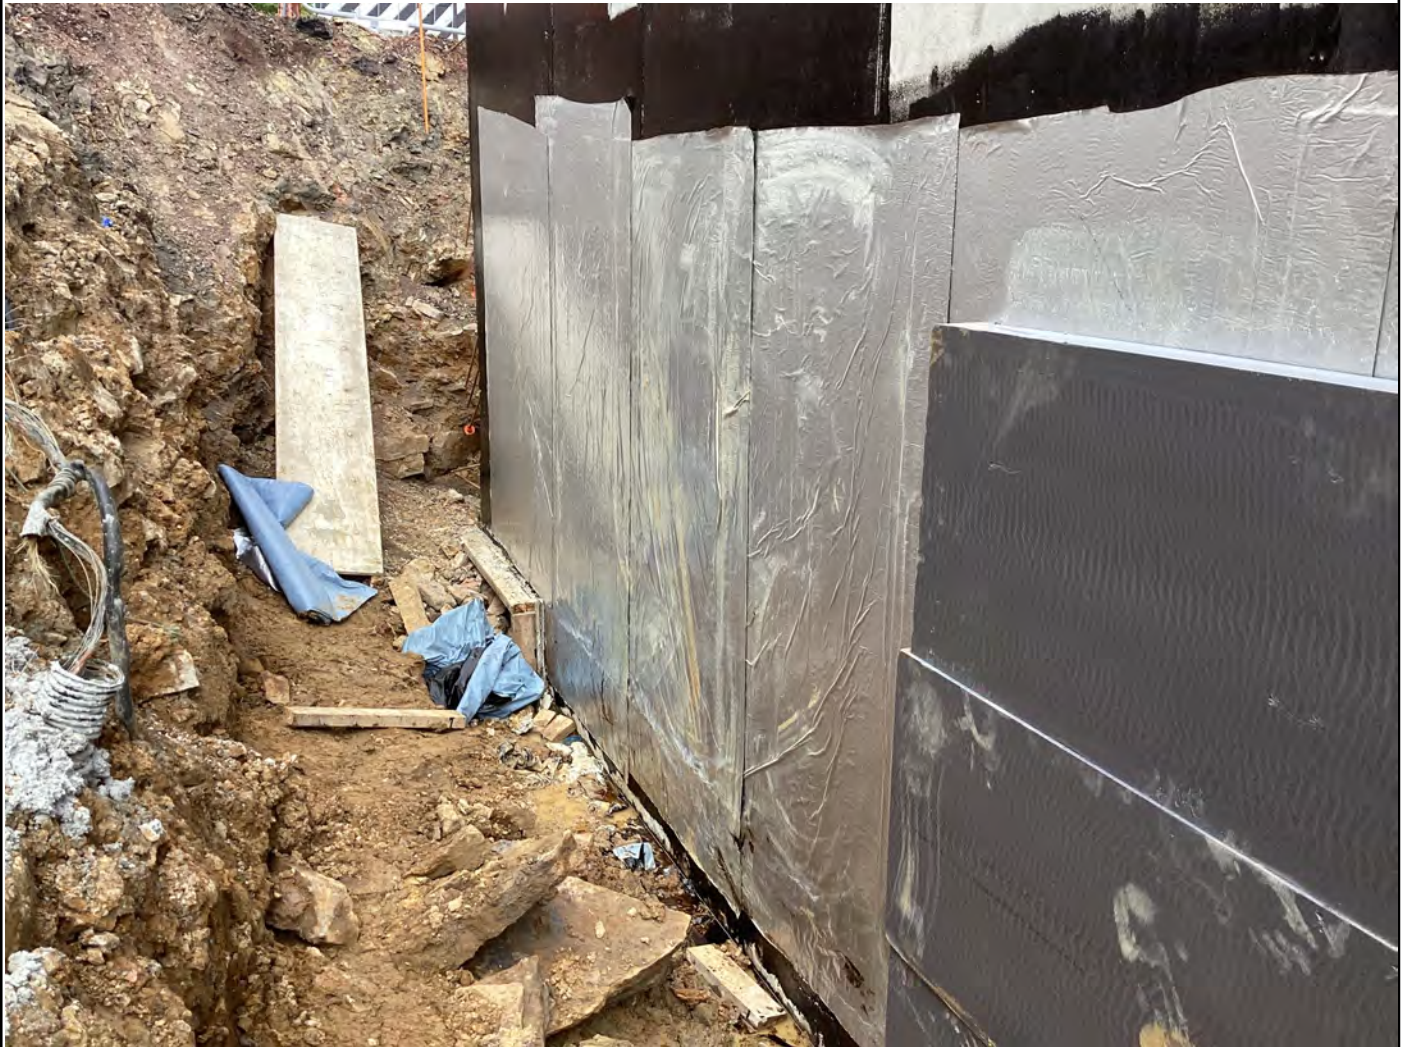
## VERIFICATION ITEM THREE

Overview of the completed small section of retaining wall where the Visqueen

Gas Resistant Self Adhesive Membrane had been applied. Note also the bitumen pr

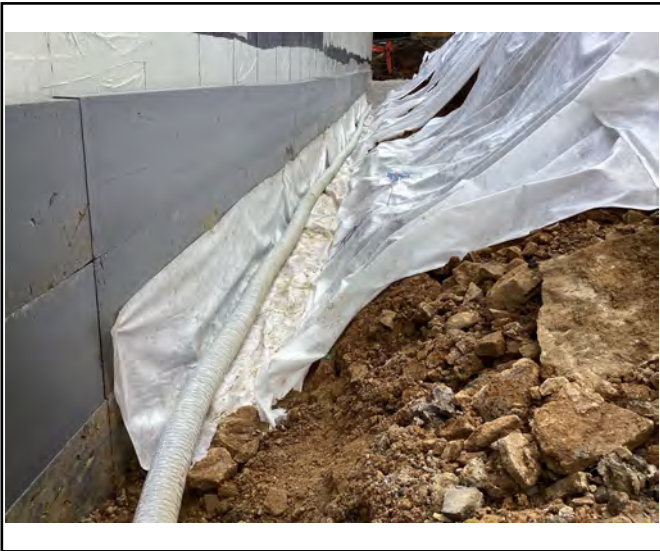
View of a land drain at the base of  
the retaining wall.

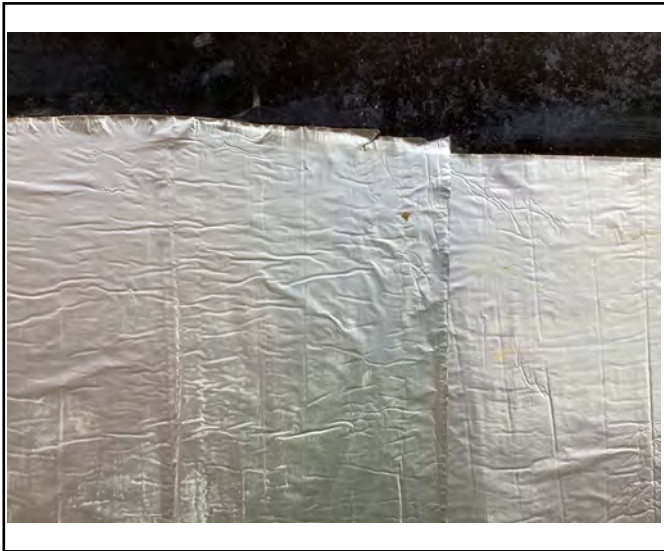
View showing both the bitumen primer  
and applied GRSAM

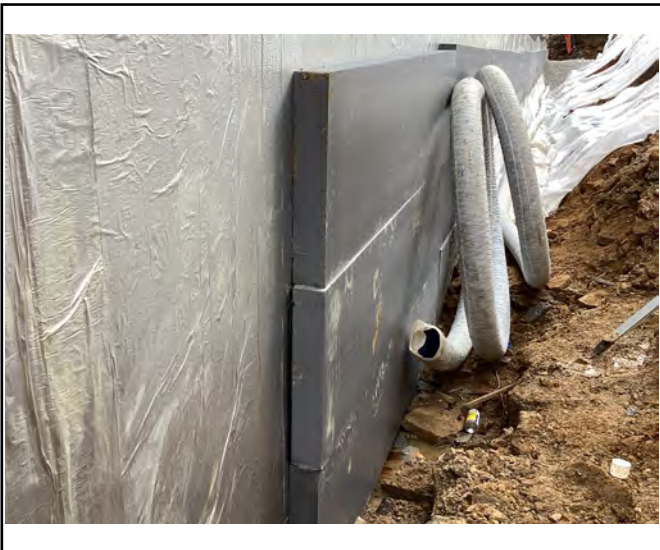
View showing both the land drain and  
insulation protecting the GRSAM

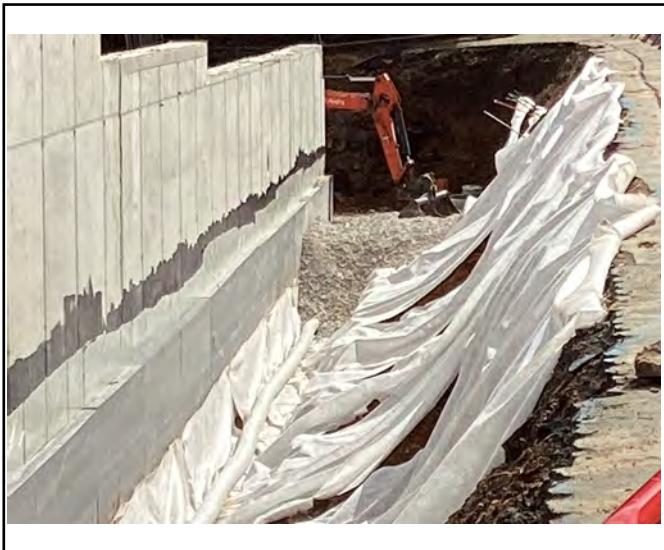
View of backfill against the insulation

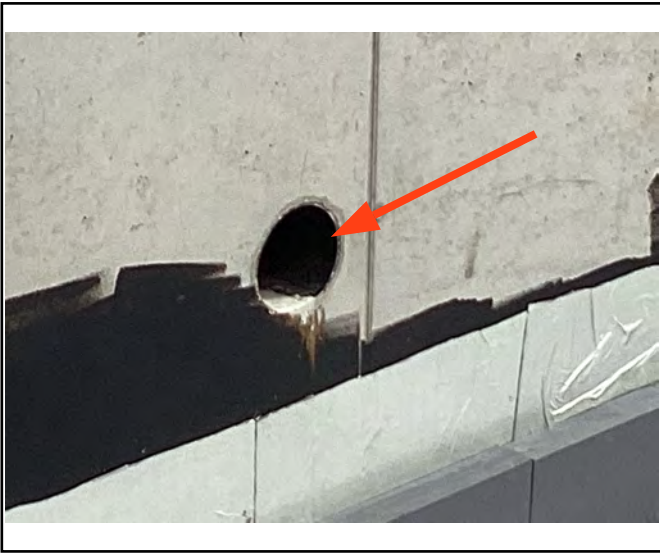
View of a duct through the retaining wall - this will be sealed in the future.

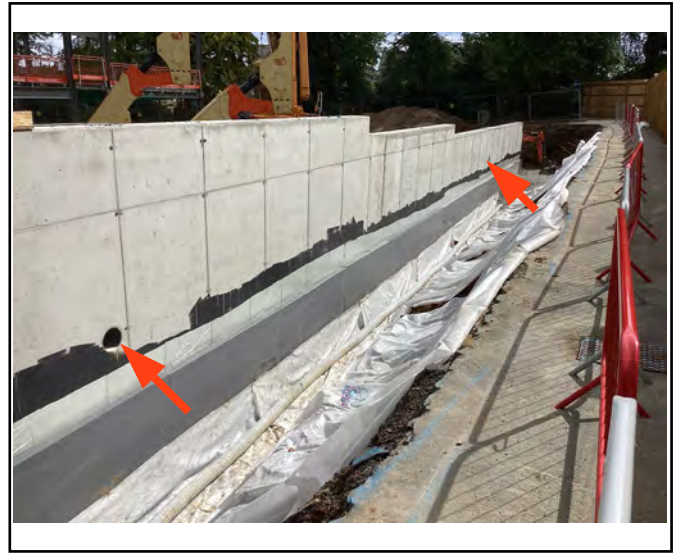
View showing the positions of the ducts requiring sealing

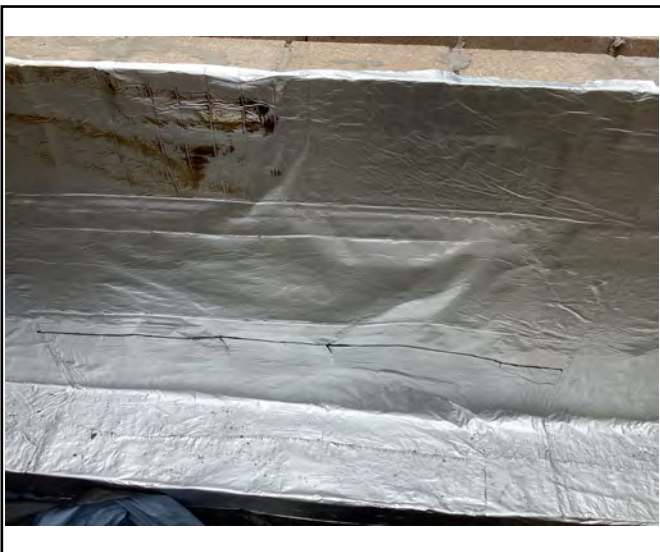
View of one of two areas of GRSAM where the substation wall incomplete

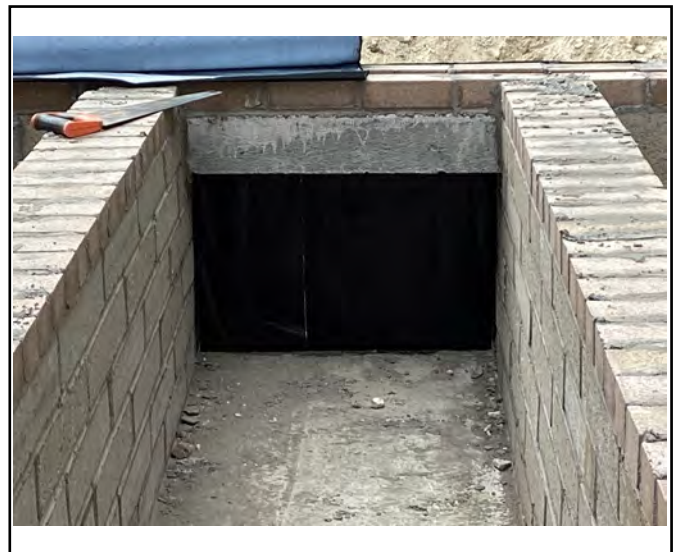
View of one of two sections of wall which will be completed later.

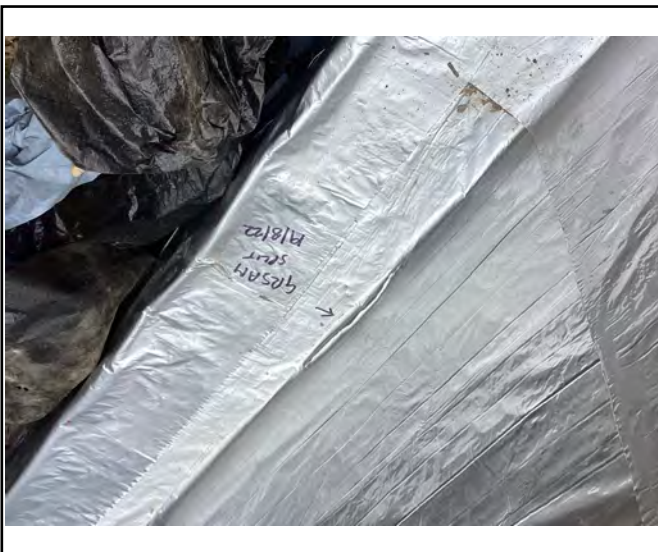
Detailing to toe using GRSAM being

checked for seal issues.

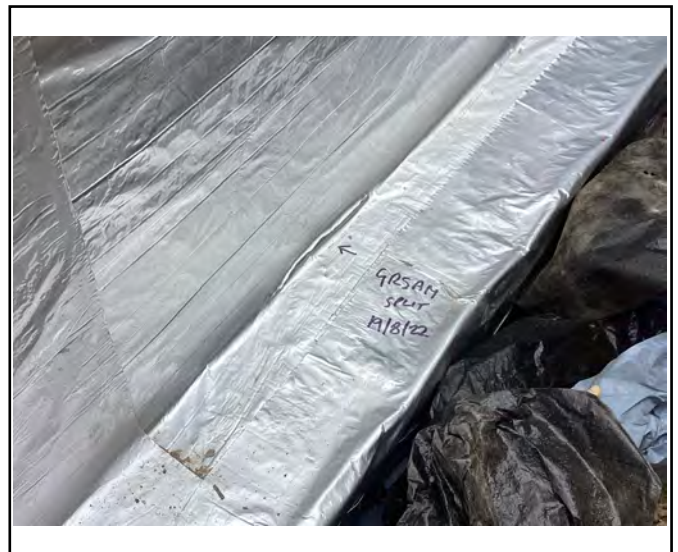
Butyl Tape being installed during

installation of Protect and Drain

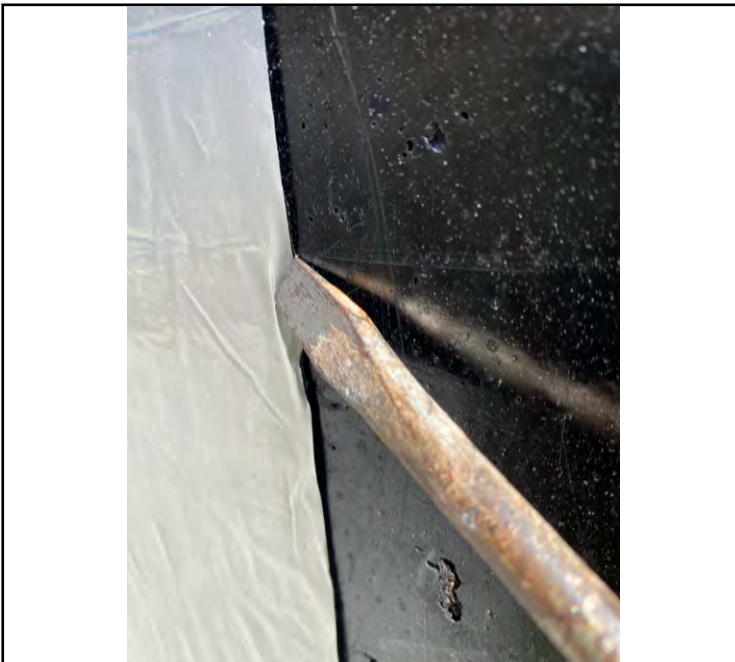
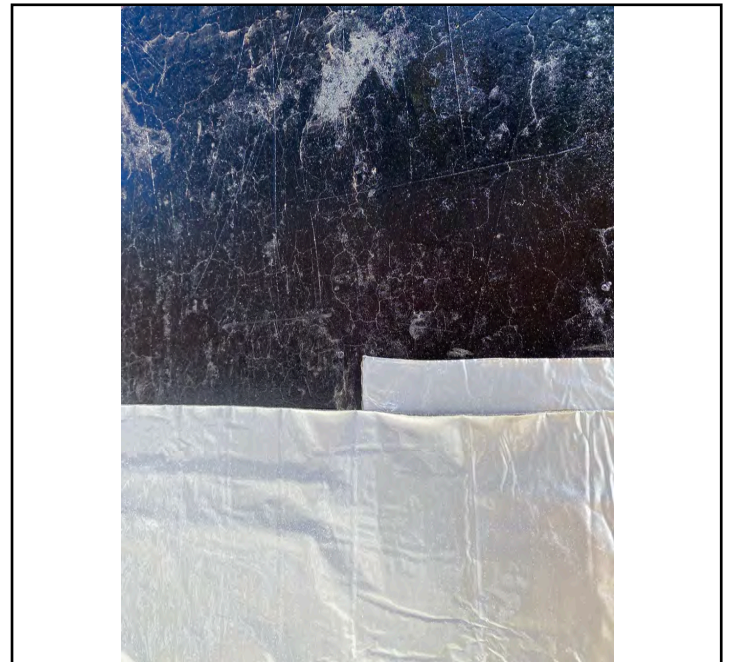
Photos showing the Mechanical Point Stress Test being undertaken along one of the

Edge joints to ensure there were no potential capillary leak issues. Verification confirmed

no issues were identified throughout the inspection.

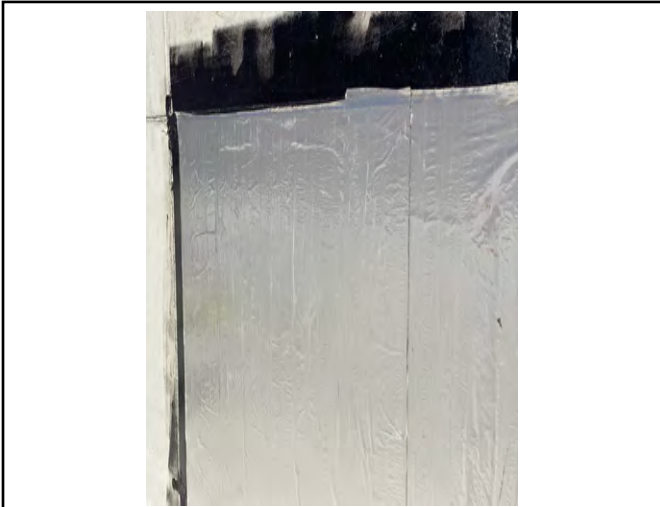
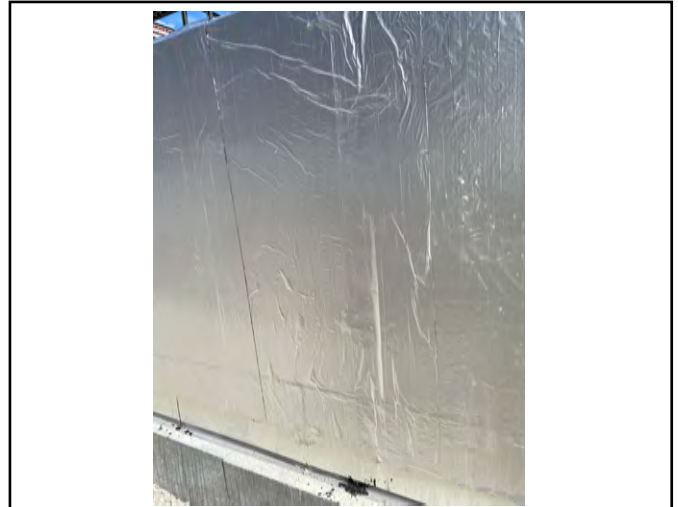
Made to the wall with the correct use of the primer. Generous laps had also been

Created ensuring a good install.

No faults were identified during the verification process.

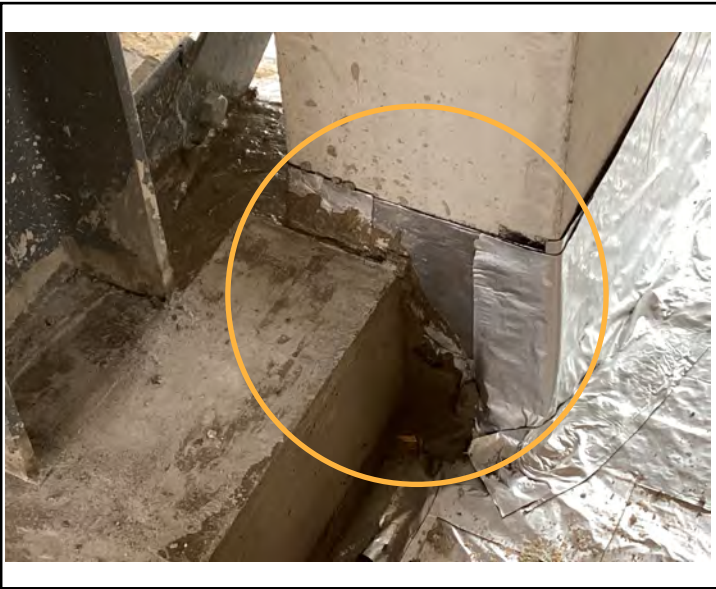
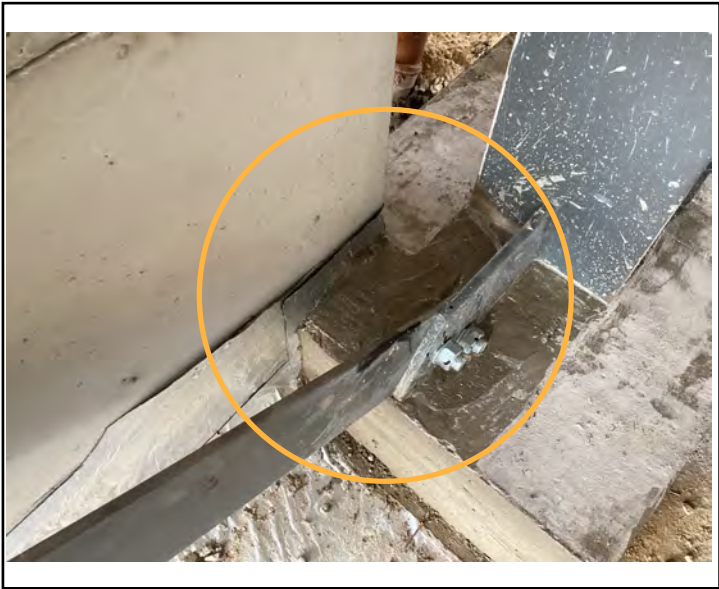
The installation of Visqueen Gas Resistant Self Adhesive Membrane had been completed to the base of 'Stairwell Number Four' as per Verification Item Two this report

Photos are showing two small areas (within the yellow circles) where concrete had been poured to the corners restricting verification.

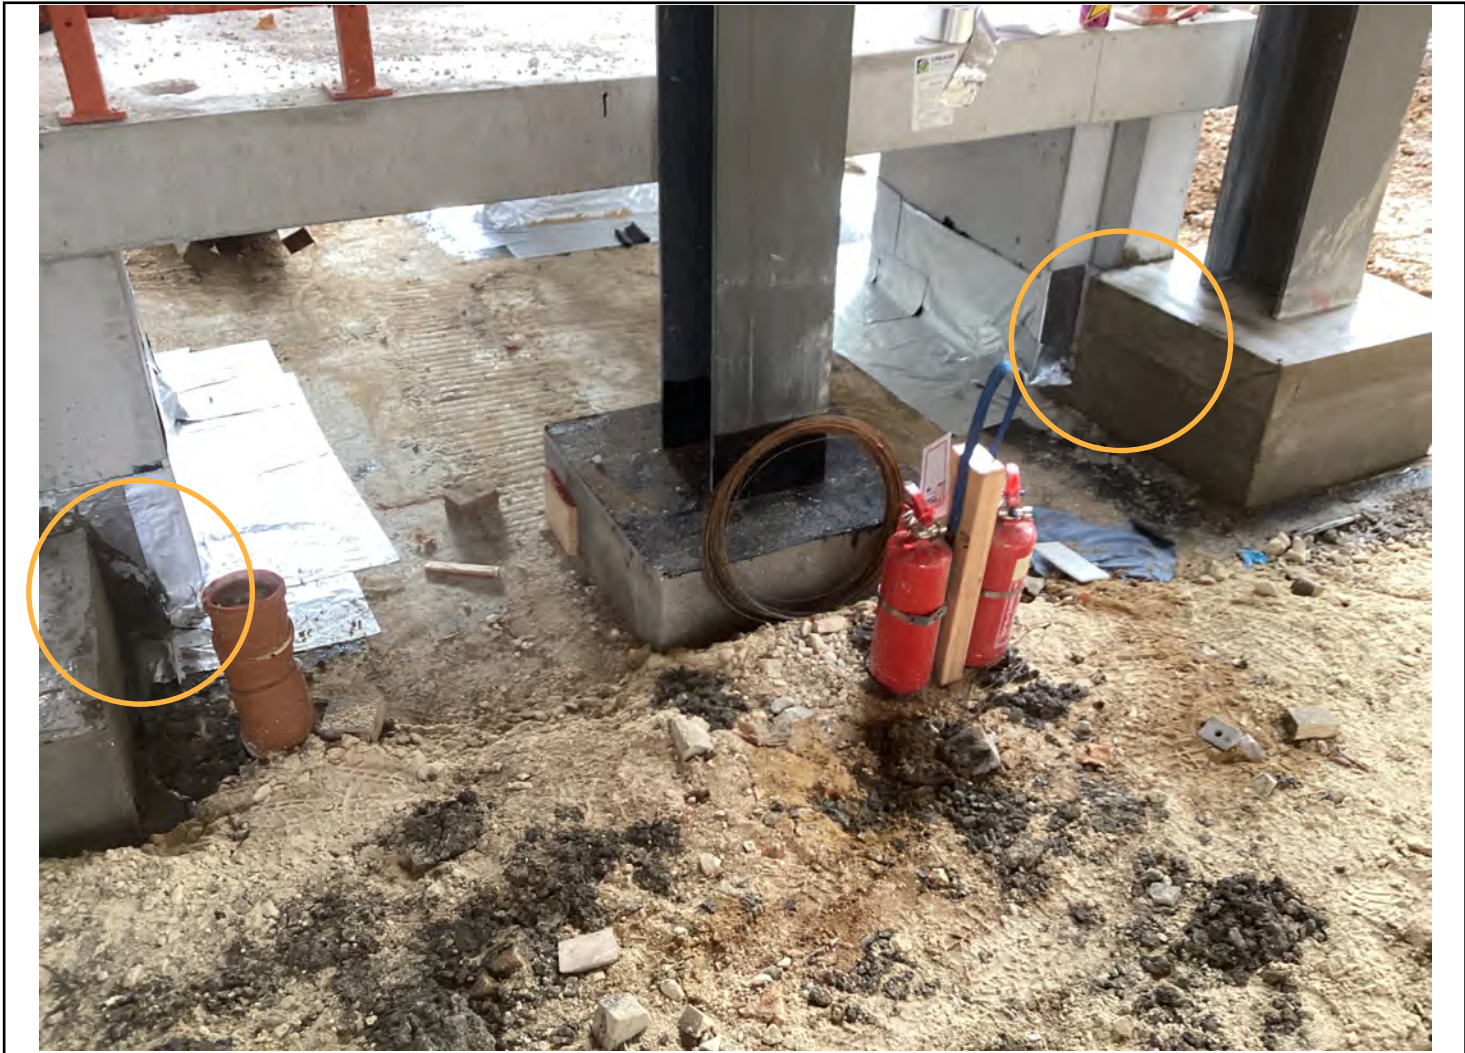
Overview showing the two areas identified with yellow circles where concrete had been poured against the corners of the Stairwell Number Four and restricted the verification of these areas.

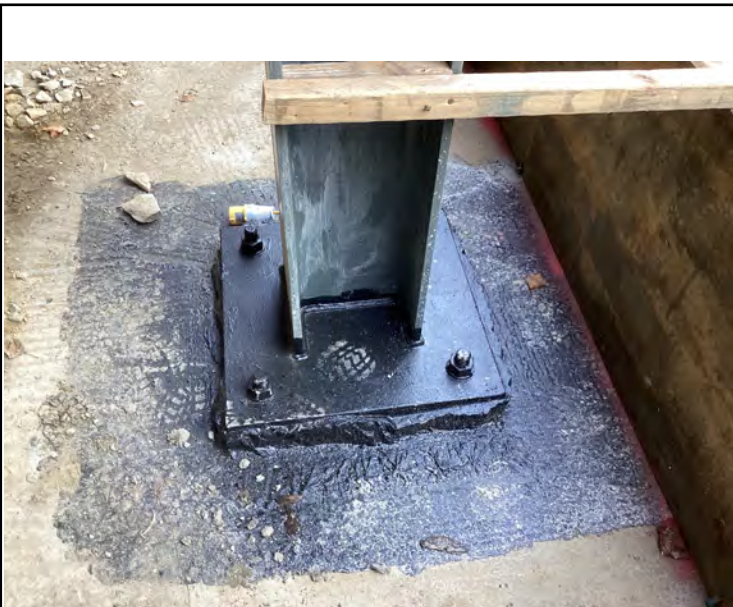
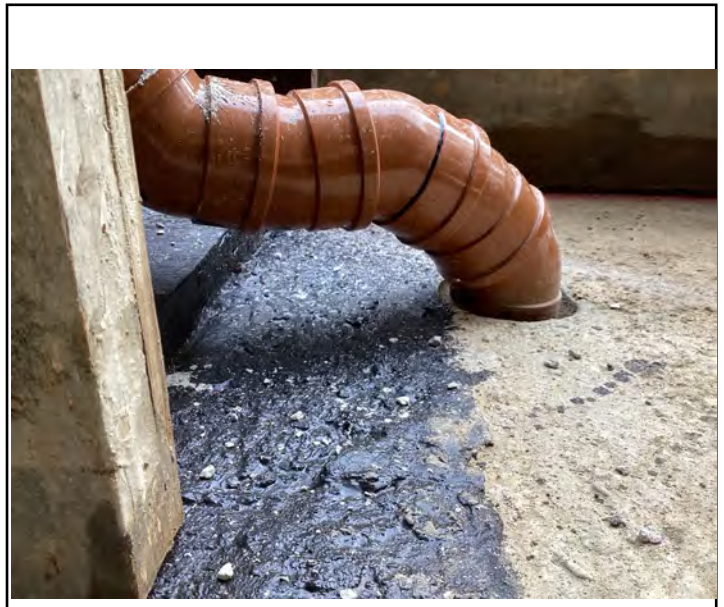
Photo 1 showing the extent of the typical application of a minimum of two coats of the Visqueen Liquid Gas Membrane to the whole of the Stanchion Base Plate and surrounding concrete pad foundation. Upon close inspection, it was evident that the

whole area was completely covered. Photo 2 showing the position of a pipe penetration which is positioned outside the proposed formwork and will be sealed with GRSAM later.
