# GEOSHIELD Verification Report

GEO102848

Galiford Try Building

Gas membrane to specification BS8485 2015

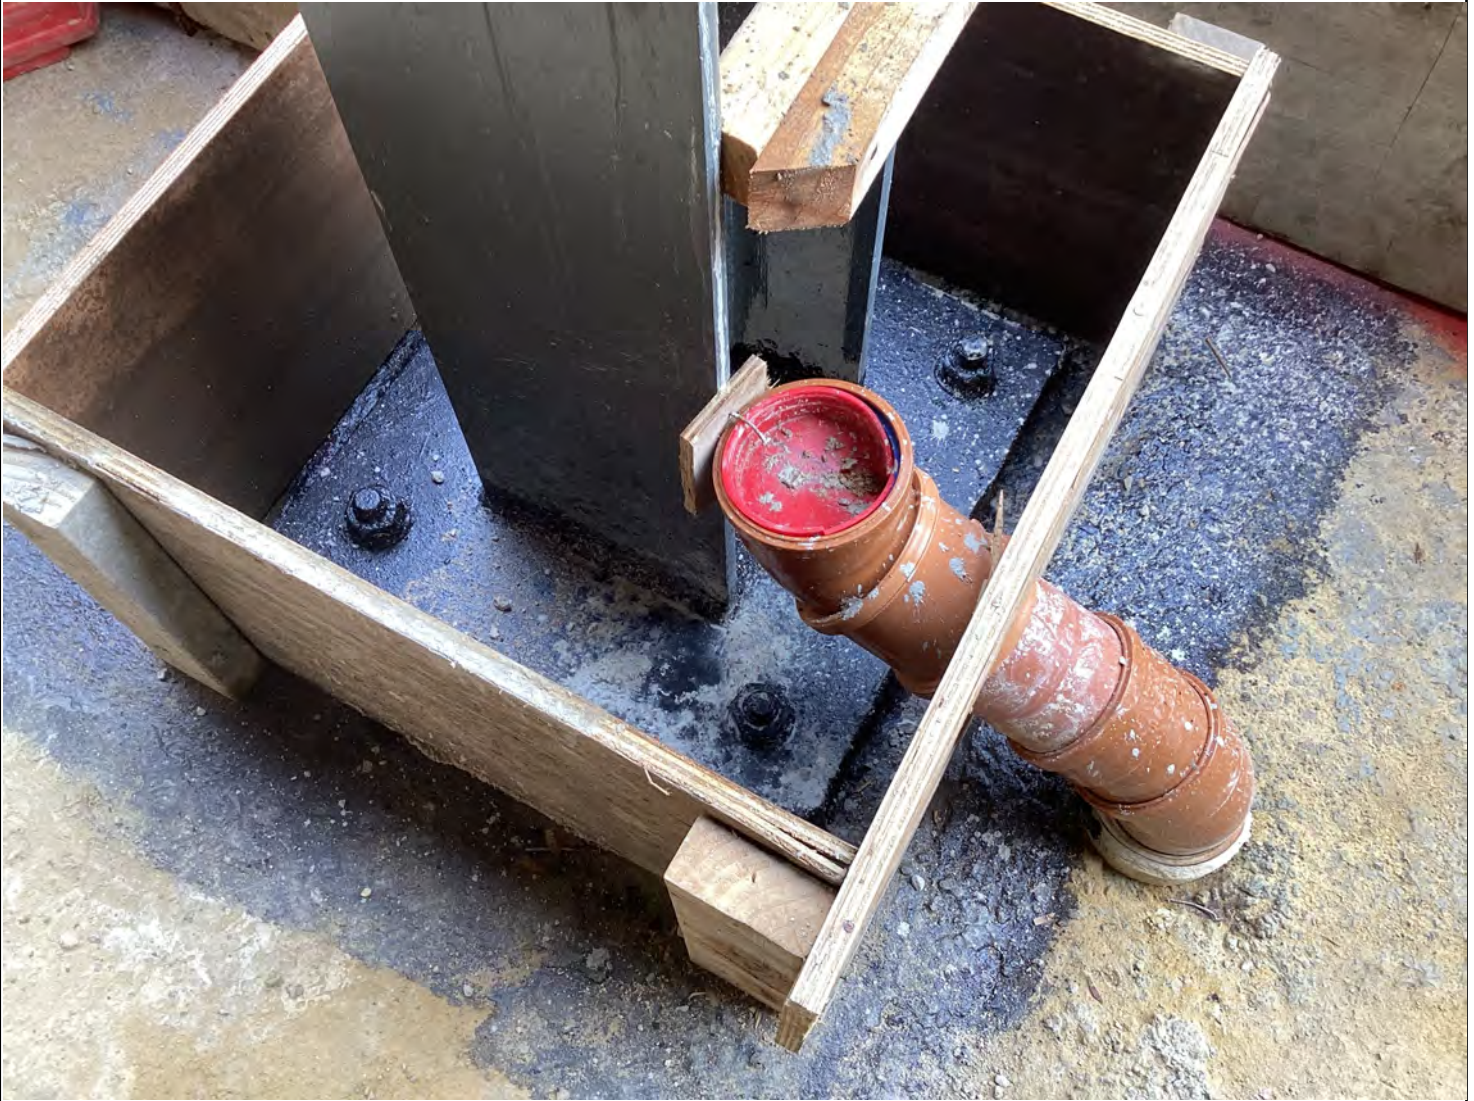
Overview showing the extent of the Visqueen Liquid Gas Membrane extending pass the formwork. The pipe penetration will be sealed during the installation of the Visqueen Gas Barrier using Visqueen Gas Resistant Self Adhesive Membrane.

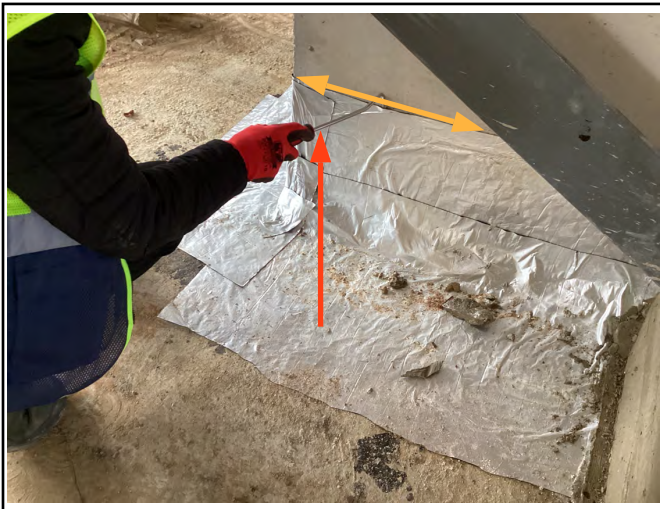
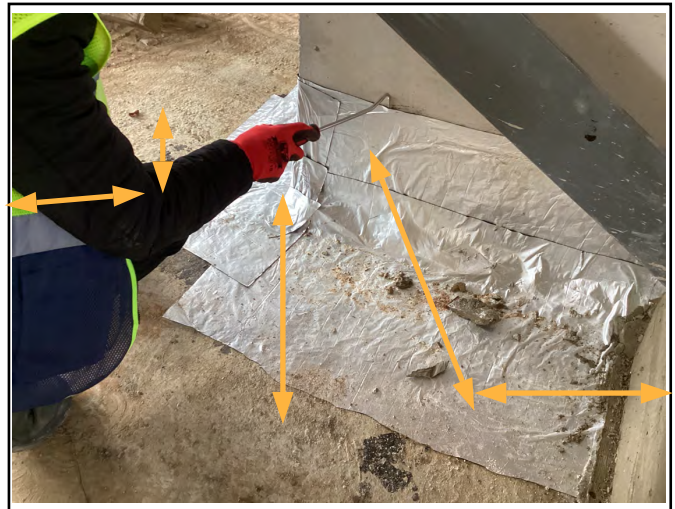
Photo 1 showing the Mechanical Point Stress Test was undertaken along the edges of the installed Visqueen Gas Resistant Self Adhesive Membrane (see yellow arrows).

Upon inspection, there were no signs of any potential capillary leaks during the verification.

The Visqueen Gas Resistant Self Adhesive Membrane was well adhered to both the previously applied Visqueen Liquid Membrane and the base of the concrete stairwell.

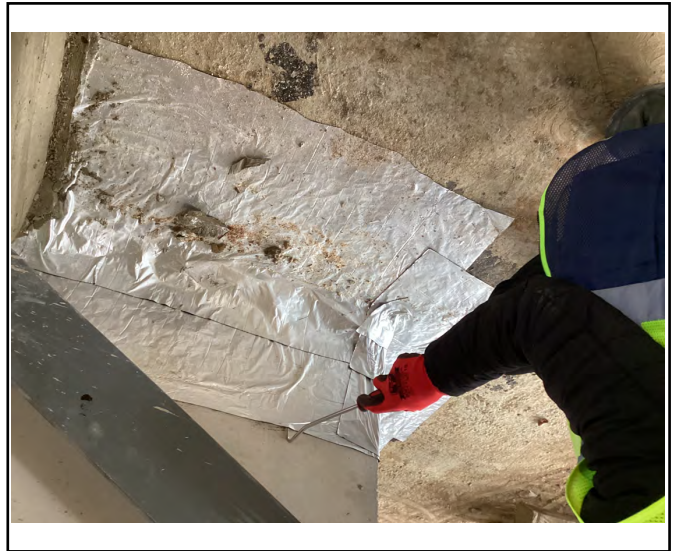
View of a concrete base requiring  
priming prior to sealing with GRSAM

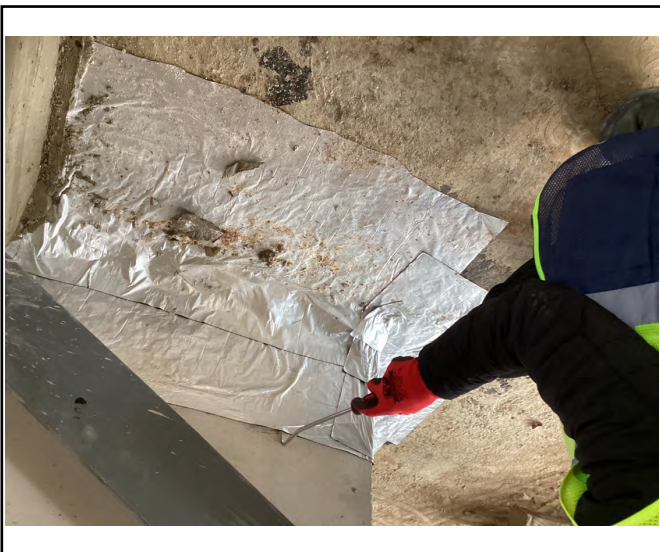
View of incomplete substrate

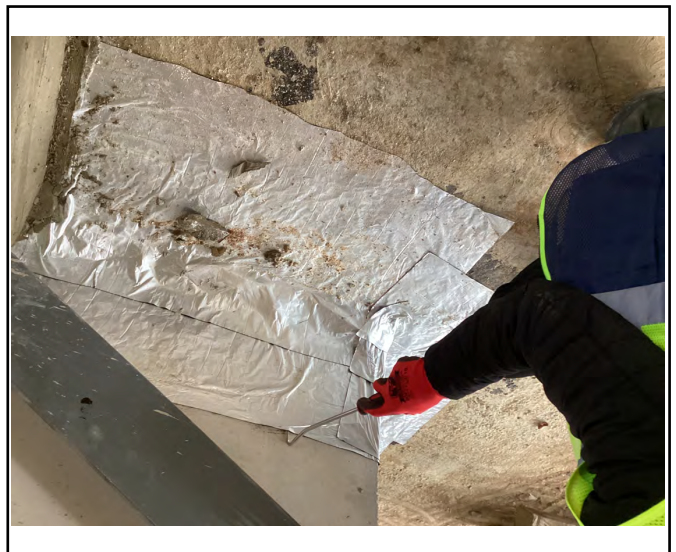
View showing pipe penetration  
which may prove difficult to seal.

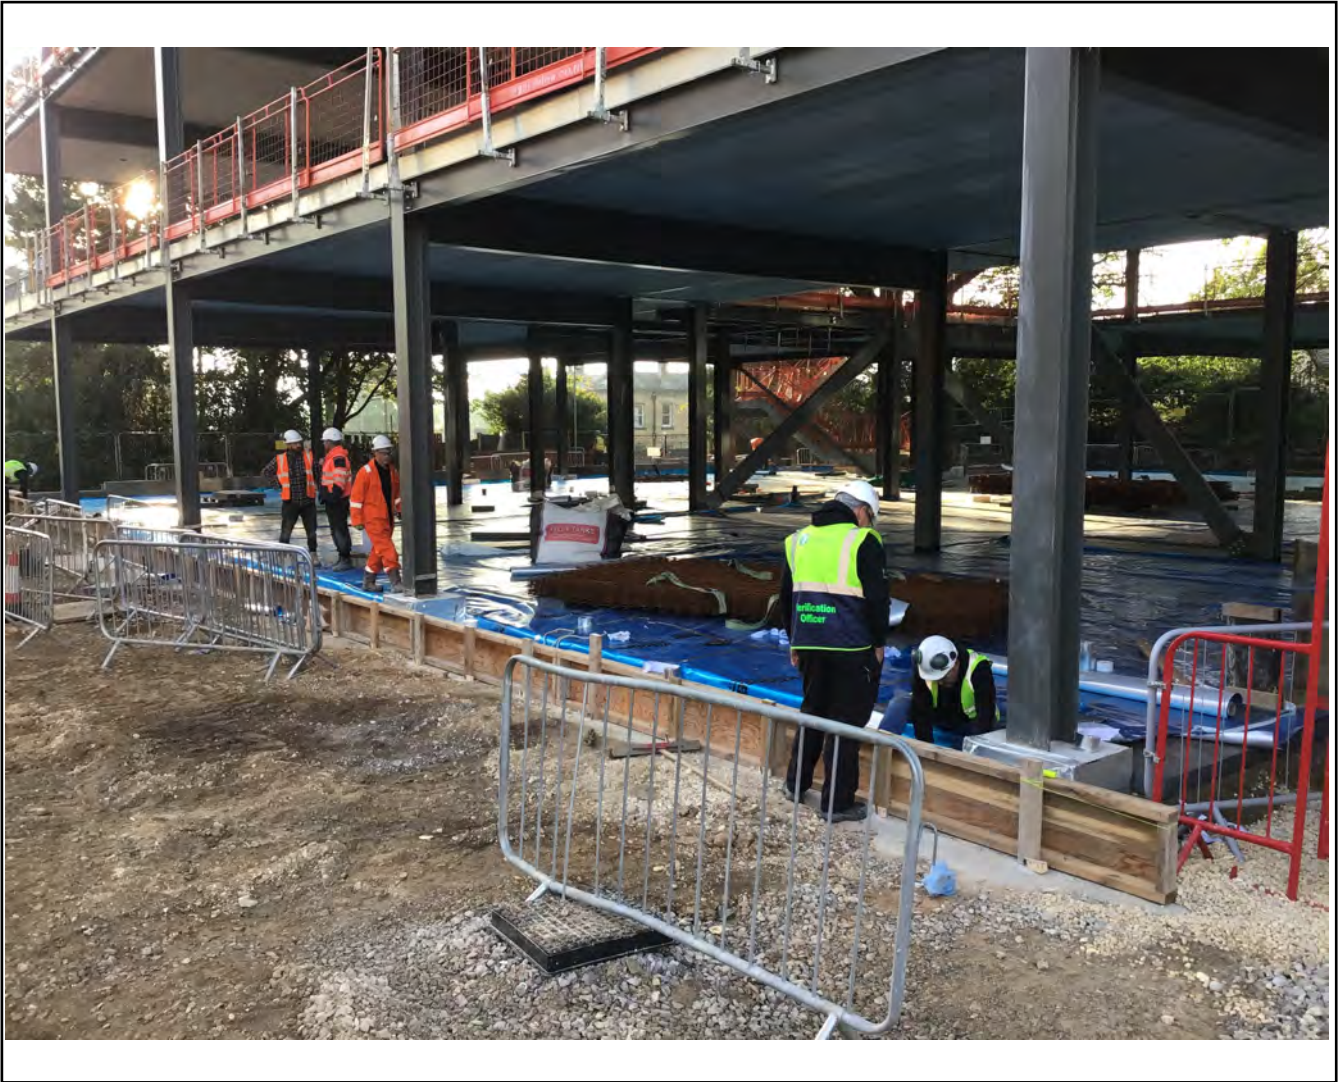
Overview of site

The image shows the external shuttering and membrane on site

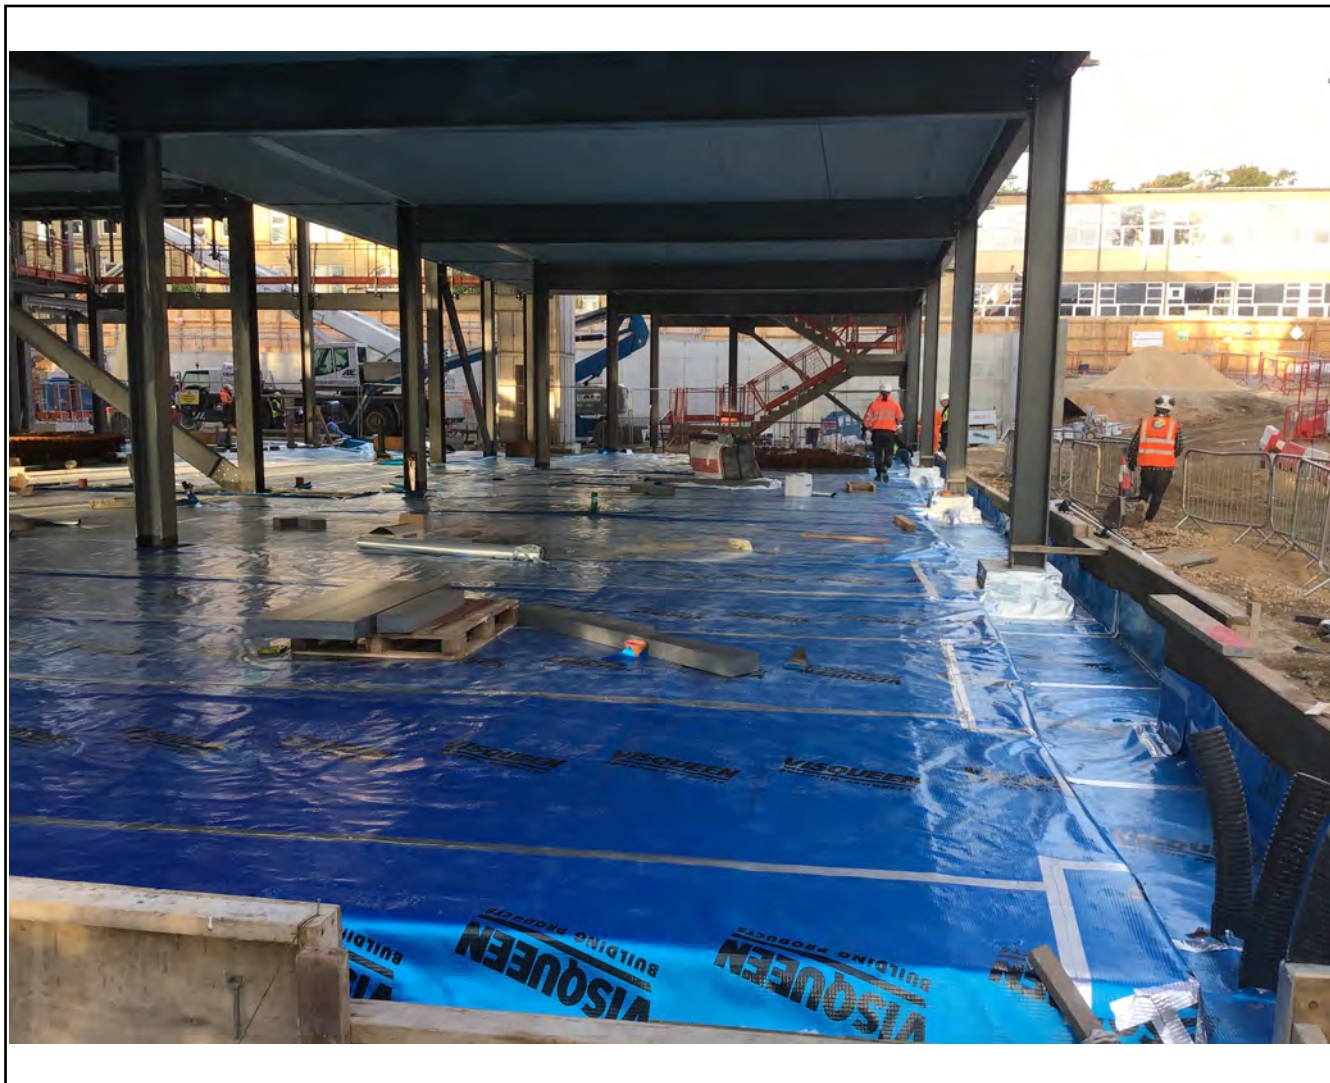
Overview of site

Image shows the taped seams on the Visqueen Gas Barrier (GB) membrane

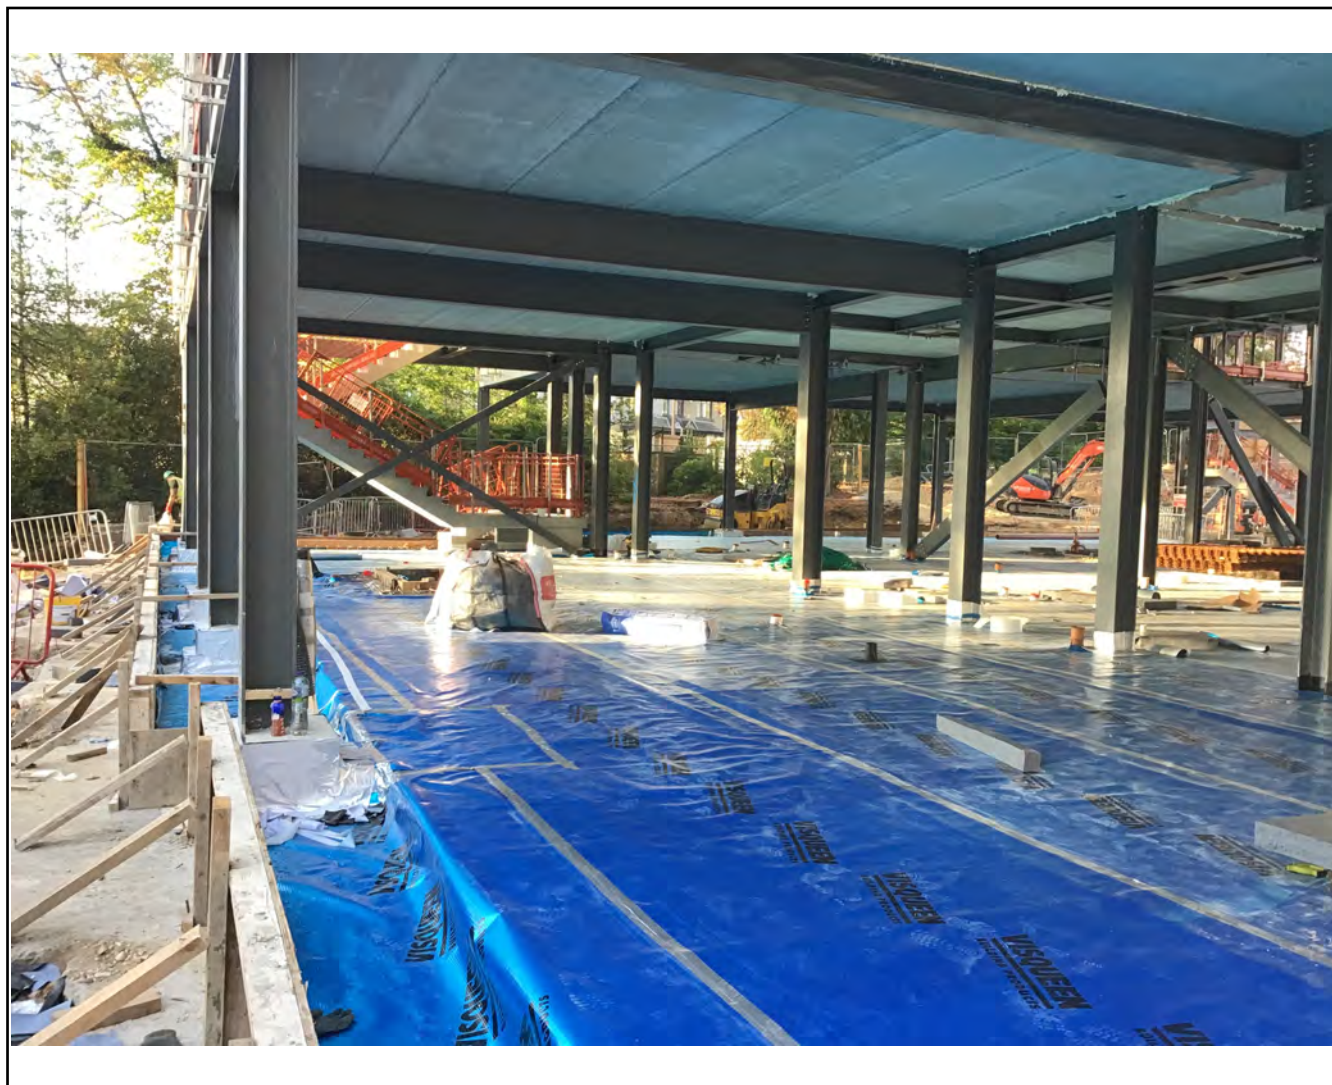
Overview of site

Image shows visqueen GB and Stanchion penetrations
