**Moss View, Holmfirth**  
**Bat Survey Report, including nocturnal survey**  
**23<sup>rd</sup> May 2024**

| Document ref: MBE/BAT/2023/110/02 | | | | |

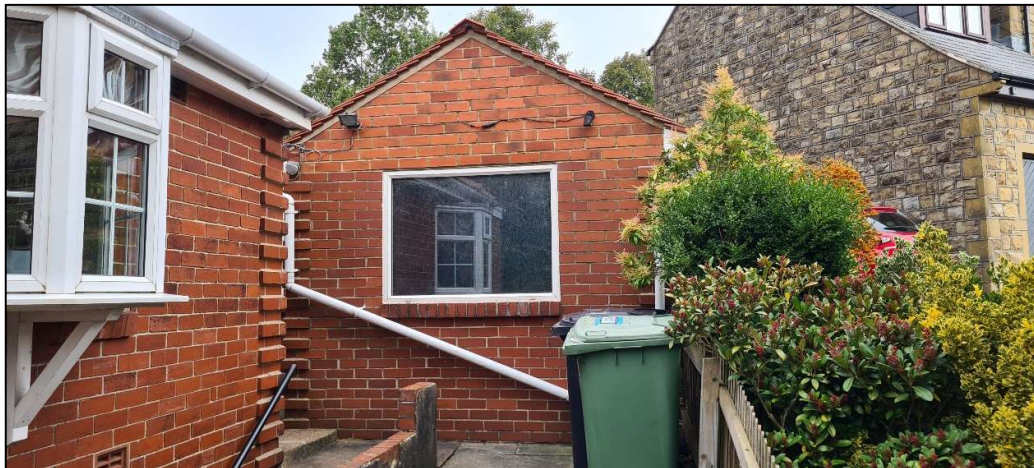
**Plate 5. The southern elevation of the garage and part of the eastern elevation of the dwelling**

- 5.2.9 The brick-built garage had a two-pitched roof covered with rosemary tiles. The north and southern gables had mortared verges. The eaves of the building were enclosed by tight-fitting uPVC soffit boxes. The single-storey building was accessed via a metal roller door (Plate 1). A window, framed with uPVC, was present on the southern elevation (Plate 5).

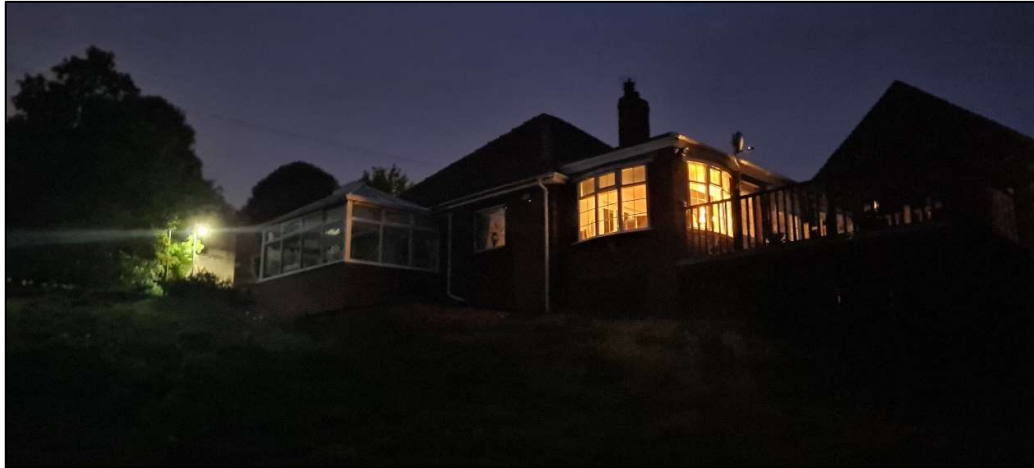
5.2.12 The temperature at the beginning of monitoring was 15°C, with no wind (Beaufort Scale 0) and full cloud cover (eight oktas cloud cover). The temperature remained at 15°C and the cloud cover remained full but the wind increased slightly to a light air (Beaufort Scale 1) and at 22:30 spots of rain were observed, progressing to light rain at 22:40 (two minutes before the end of the survey). The light levels in the area around the building were considered to be relatively low during the survey, although some light

spill occurred from the buildings windows and streetlighting was present along the road to the north of the site (Plate 7).

**Plate 7. View of the building and surrounding area photographed from approximately Surveyor Position 2 at 22:16 on 21<sup>st</sup> May 2024 (one hour and four minutes after sunset)<sup>1</sup>**
