Arboricultural Consultancy for AXA Insurance

Insured	Mr Robert Benyon joint PH Mrs Janet Benyon	Address	Greentrees, Prospect Lane, Birkenshaw, Bradford, BD11 2EL		
Client	Subsidence Management Services	Contact	Stephen Rutherford	Claim No.	IFS-AXA-SUB-22-0104686
ES Ref	SA-252157	Consultant	Nigel Chopping	Contact No.	0330 380 1036
Report Date	29/03/2023

Scope of Report: To survey the property and determine significant vegetation contributing to subsidence damage, make recommendation for remedial action and assess initial mitigation and recovery prospects. The survey does not make an assessment for decay or hazard evaluation.

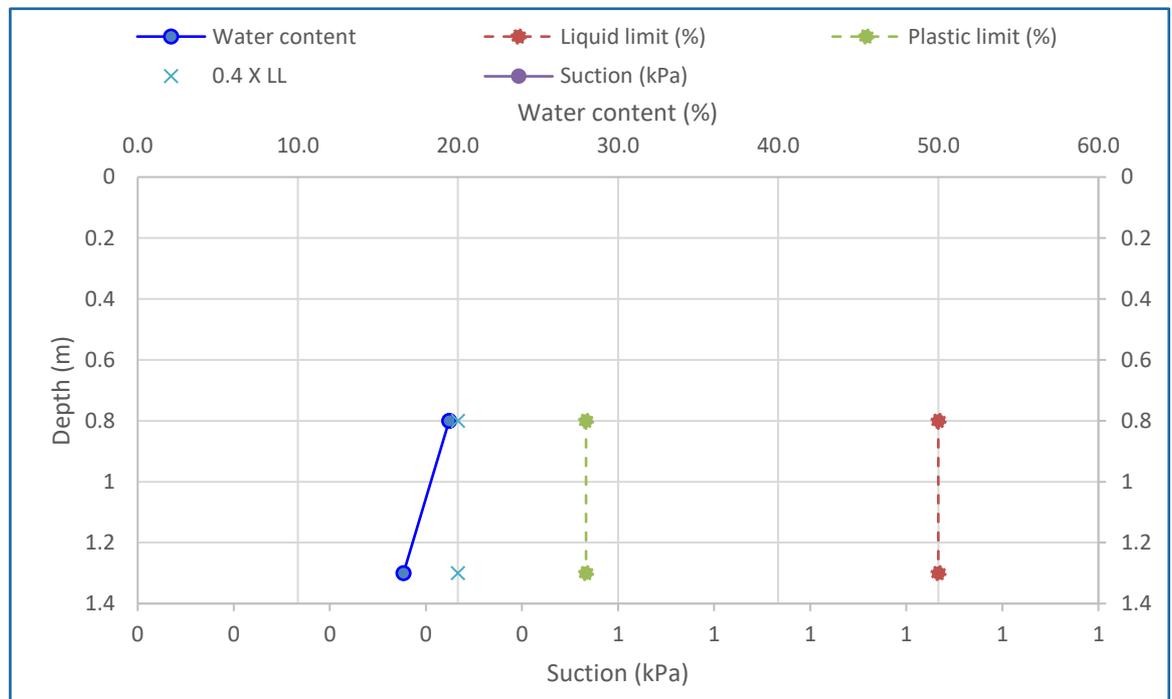
Samples from BH1

Lab Ref	Depth (m)	WC (%)	LL (%)	PL (%)	PI (%)	.425 mm(%)	mod. PI (%)	Av. Suc. (kPa)	Description
1	0.8	19.4	50	28	22	100	22		Firm orange-brown/light grey mottled CLAY/SILT with rare gravel and sand. Gravel is fine
2	1.3	16.6	50	28	22	100	22		Soft orange-brown/light grey mottled CLAY/SILT with rare gravel and sand. Gravel is fine and medium.
