**Project Name:** HAIGH HUDDLESTON & ASSOCIATES - Manchester Road  
Slaithwaite

**Project Description:** Investigation

**Project Date:** 15/02/2024

**Inspection Standard:** MSCC5 Sewers & Drainage GB (SRM5 Scoring)

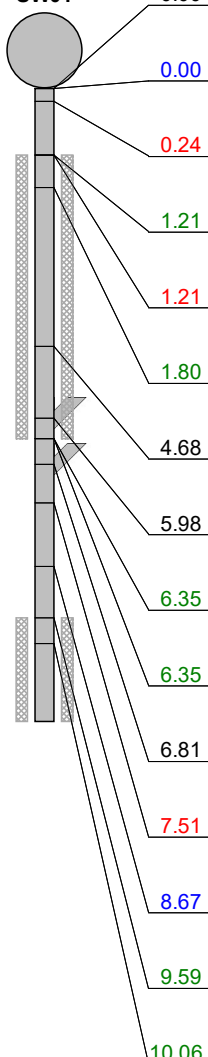
| Scale: 1:137 | Position [m] | Code | Observation | MPEG | Photo | Grade |
|---|---|---|---|---|---|---|
| | 0.24 | FL | Fracture, longitudinal at 12 o'clock | 00:00:15 | 002.jpg | 3 / 2 |
| | 1.21 | FL | Fracture, longitudinal at 1 o'clock | 00:00:20 | 004.jpg | 3 / 2 |
| | 7.51 | FC | Fracture, circumferential from 2 o'clock to 6 o'clock | 00:01:38 | 008.jpg | 3 / 2 |

| Scale: | 1:137 | Position [m] | Code | Observation | MPEG | Photo | Grade |
|---|---|---|---|---|---|---|---|
| | | 12.88 | FCJ | Fracture, circumferential at joint from 11 o'clock to 2 o'clock | 00:02:07 | 010.jpg | 3 / 2 |
| | | 22.34 | CCJ | Crack, circumferential at joint from 10 o'clock to 1 o'clock | 00:04:54 | 014.jpg | 2 / 2 |
| | | 27.44 | BJ | Broken pipe at joint from 11 o'clock to 12 o'clock | 00:05:16 | 013.jpg | 4 |
| | | 35.89 | CL | Crack, longitudinal at 12 o'clock | 00:05:52 | | 2 / 2 |

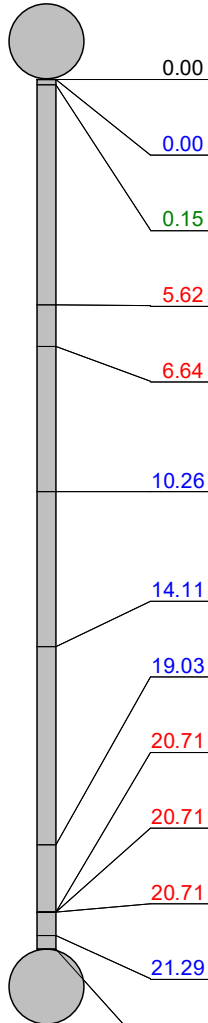
| No. | m+ | Code | Observation |
|---|---|---|---|
| 4 | 5.62 | CLJ | Crack, longitudinal at joint at 12 o'clock |
| 9 | 20.71 | FL | Fracture, longitudinal at 9 o'clock |
| 10 | 20.71 | FL | Fracture, longitudinal at 12 o'clock |
| 11 | 20.71 | B | Broken pipe from 11 o'clock to 1 o'clock |
