Kirklees Cultural Heart, Huddersfield

Huddersfield Library - Conservation of Artwork  
- Articulation in Motion Ceramic Panel 09-10

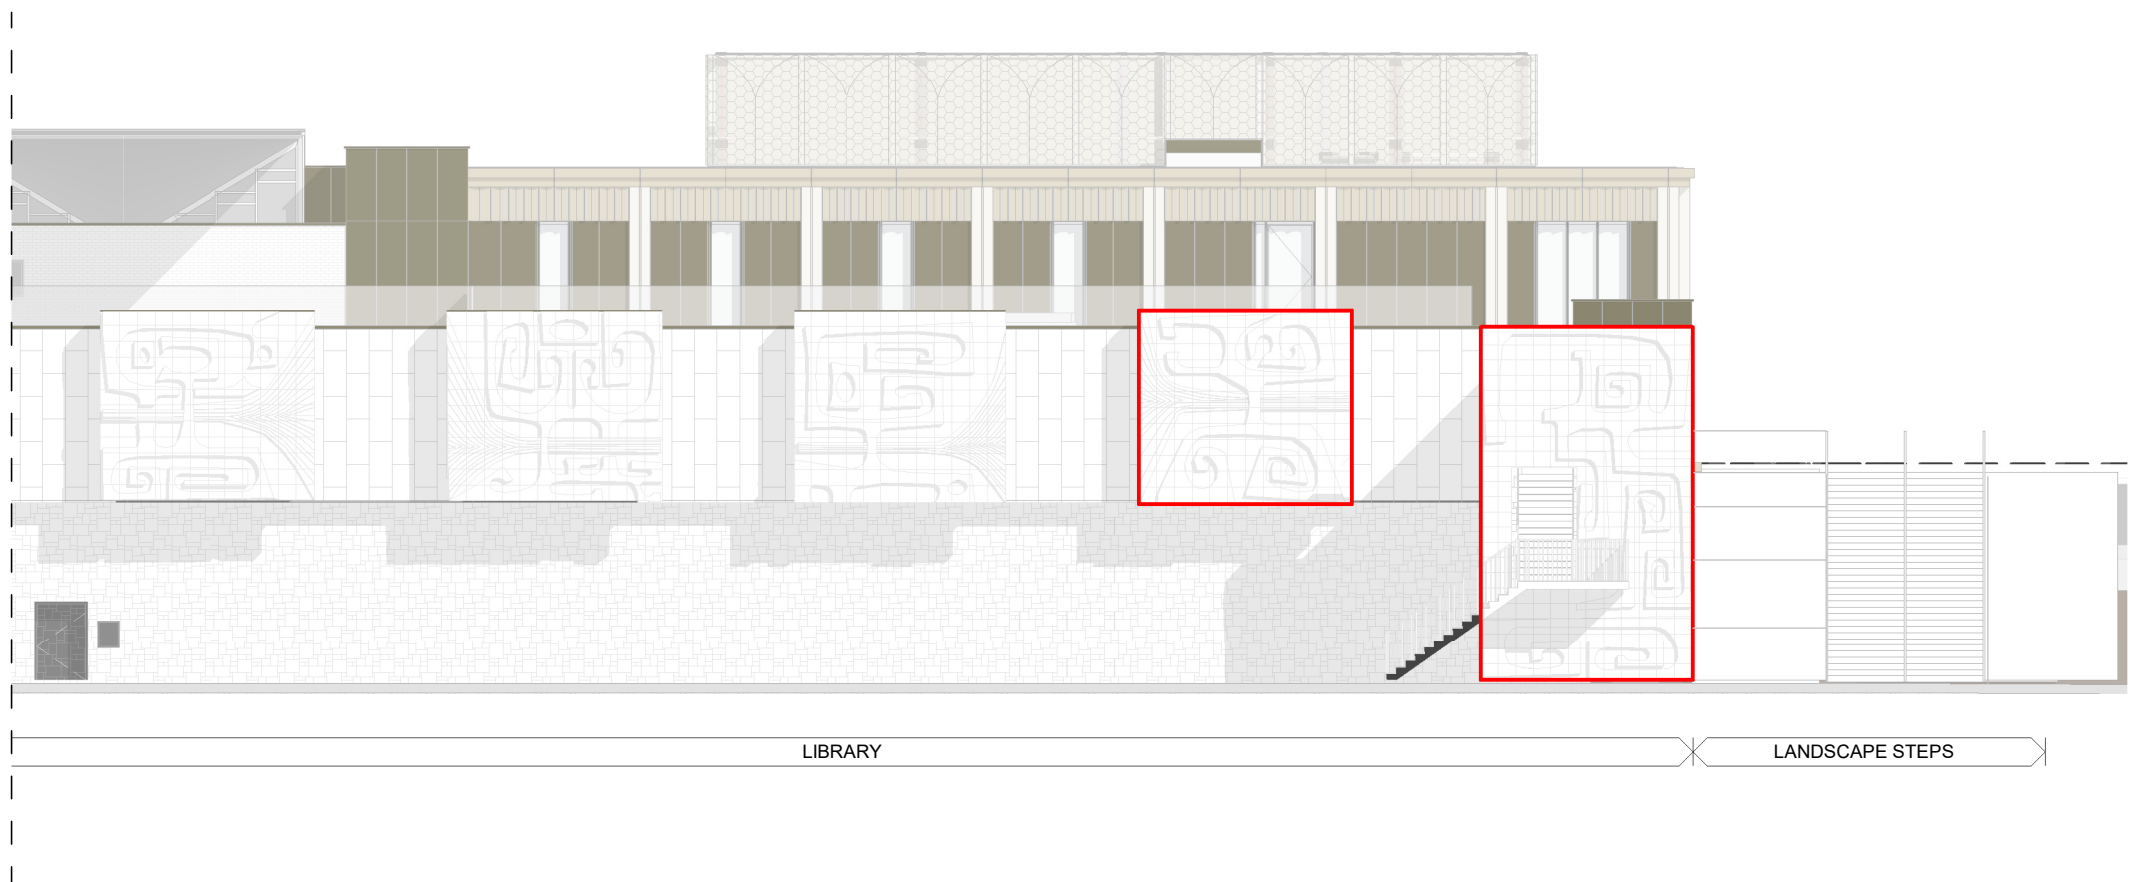
1 Main Elevation (East) - Ceramic Panel 09  
1 : 20

Visual inspection has confirmed that the ceramic panels are largely in good repair with damage present but in limited volumes. There are a variety of cracks with areas of repair from different times since 1969. Many areas of cracking appear to have occurred in firing. Other cracks or broken units have been reassembled with a dark mortar like that used to bed the units. These may be units that failed in the firing or later and have been reassembled for use. A few units appear to have been mortar repaired with the mortar mixed in an attempt to match the tone of the ceramic. Some degradation in panel 10 is indicative of changes in the mix of the clay and possible lower firing temperatures. The later fabrication of this panel could offer some explanation for the difference in its condition as it is thought the original kiln had been dismantled by the time panel 10 was sculpted.

- Removal of non-original fixtures and fittings applied onto the panels
- Panels to be cleaned
- Failed and loose pointing to be renewed
- Damaged units to be mortar renewed
- Damaged unit to be mortar repaired (mix to match)
- Missing elements to be investigated and where appropriate reinstated
- New lead / hard metal weathering capping to be fitted at the head

- 50% repointing
- 100% doff / thermotech cleaning
- Localised mortar repairs
- 12 no. specialist replacement panels approx 480mm square
- Remediation of corroding fixings where damage has been caused to the ceramics
