PROJECT
 Kirklees Cultural Heart, Huddersfield

DRAWING TITLE
 Huddersfield Library - Conservation of Artwork - Articulation in Motion Ceramic Panel 03-04

IR430301 CTA ZZ XX DR A 074202 P02

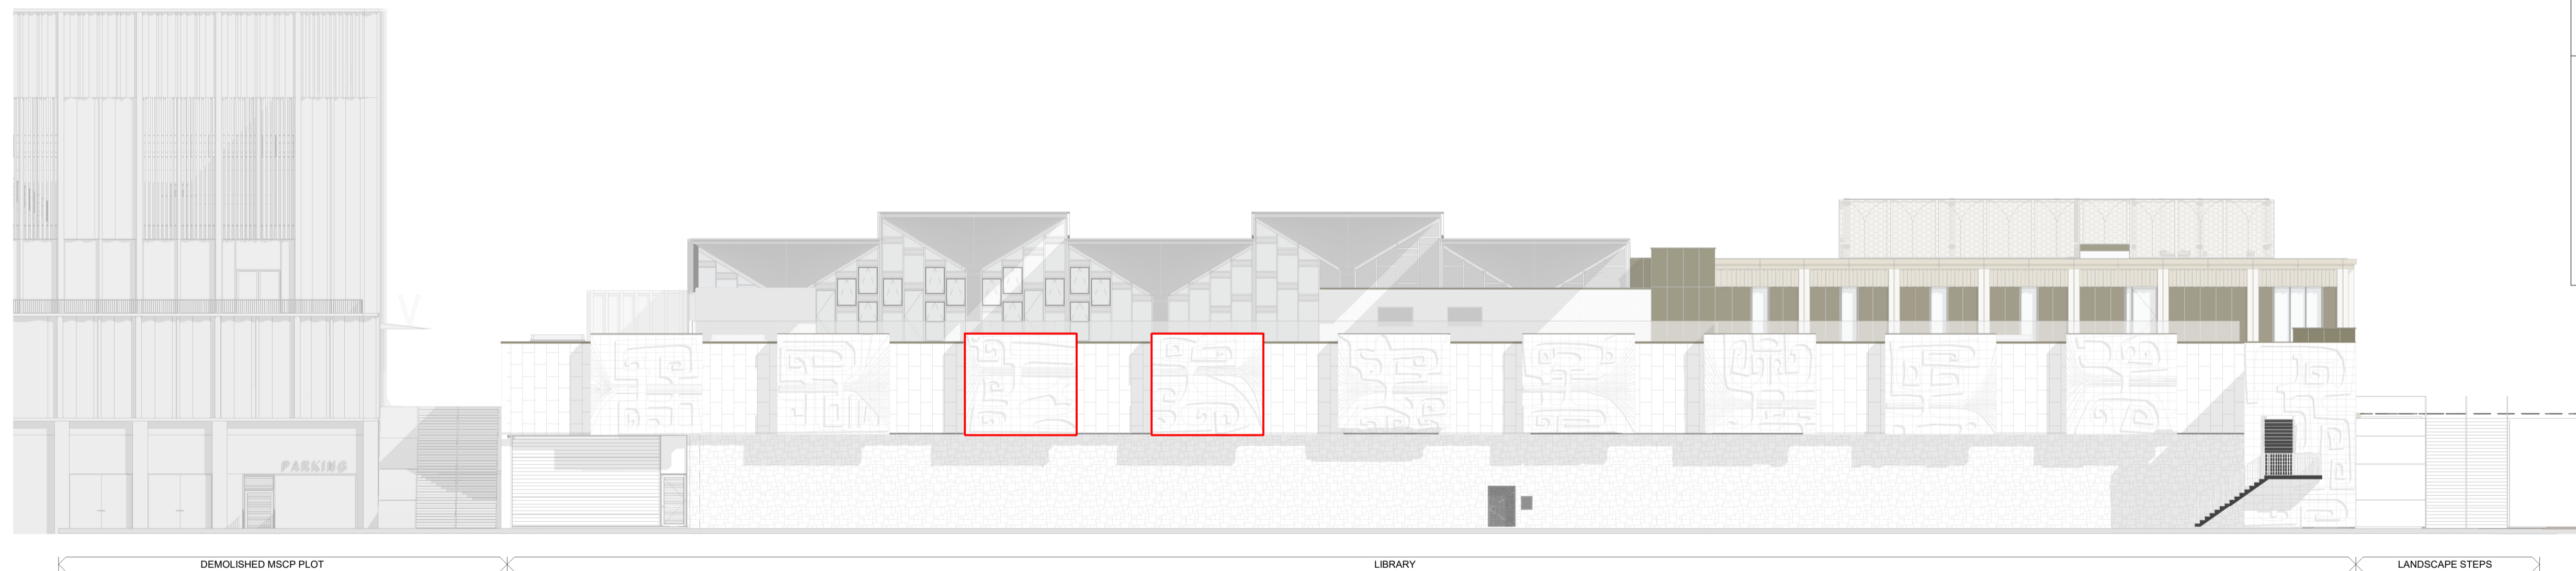
Key Elevation (East)
1 : 200

Condition
 Visual inspection has confirmed that the ceramic panels are largely in good repair with damage present but in limited volumes. There are a variety of cracks with areas of repair from different times since 1969. Many areas of cracking appear to have occurred in firing. Other cracks or broken units have been reassembled with a dark mortar like that used to bed the units. These may be units that failed in the firing or later and have been reassembled for use. A few units appear to have been mortar repaired with the mortar mixed in an attempt to match the tone of the ceramic. Some degradation in panel 10 is indicative of changes in the mix of the clay and possible lower firing temperatures. The later fabrication of this panel could offer some explanation for the difference in its condition as it is thought the original kiln had been dismantled by the time panel 10 was sculpted.

Conservation and Repair
 The intention is for a further detailed survey of the sculpture to be undertaken so that consolidation and repair designs can be resolved. The intention is:
 - Panels to be cleaned
 - Failed and loose pointing to be renewed
 - Damaged units to be mortar renewed
 - Damaged unit to be mortar repaired (mix to match)
 - Missing elements to be investigated and where appropriate reinstated
 - New lead / hard metal weathering capping to be fitted at the head

Proposed Repairs
 - 50% repointing
 - 100% eff / thermotech cleaning
 - Localised mortar repairs
 - 12 no. specialist replacement panels approx 480mm square
 - Remediation of corroding fixings where damage has been caused to the ceramics
