## OUR CULTURAL HEART

# Existing Precast RC Plank/Slab Investigation Report

**Curtins Ref: 081801-CUR-00-XX-PR-S-00006**

Site Address: Queensgate Market, Princess St, Huddersfield HD1 2RS

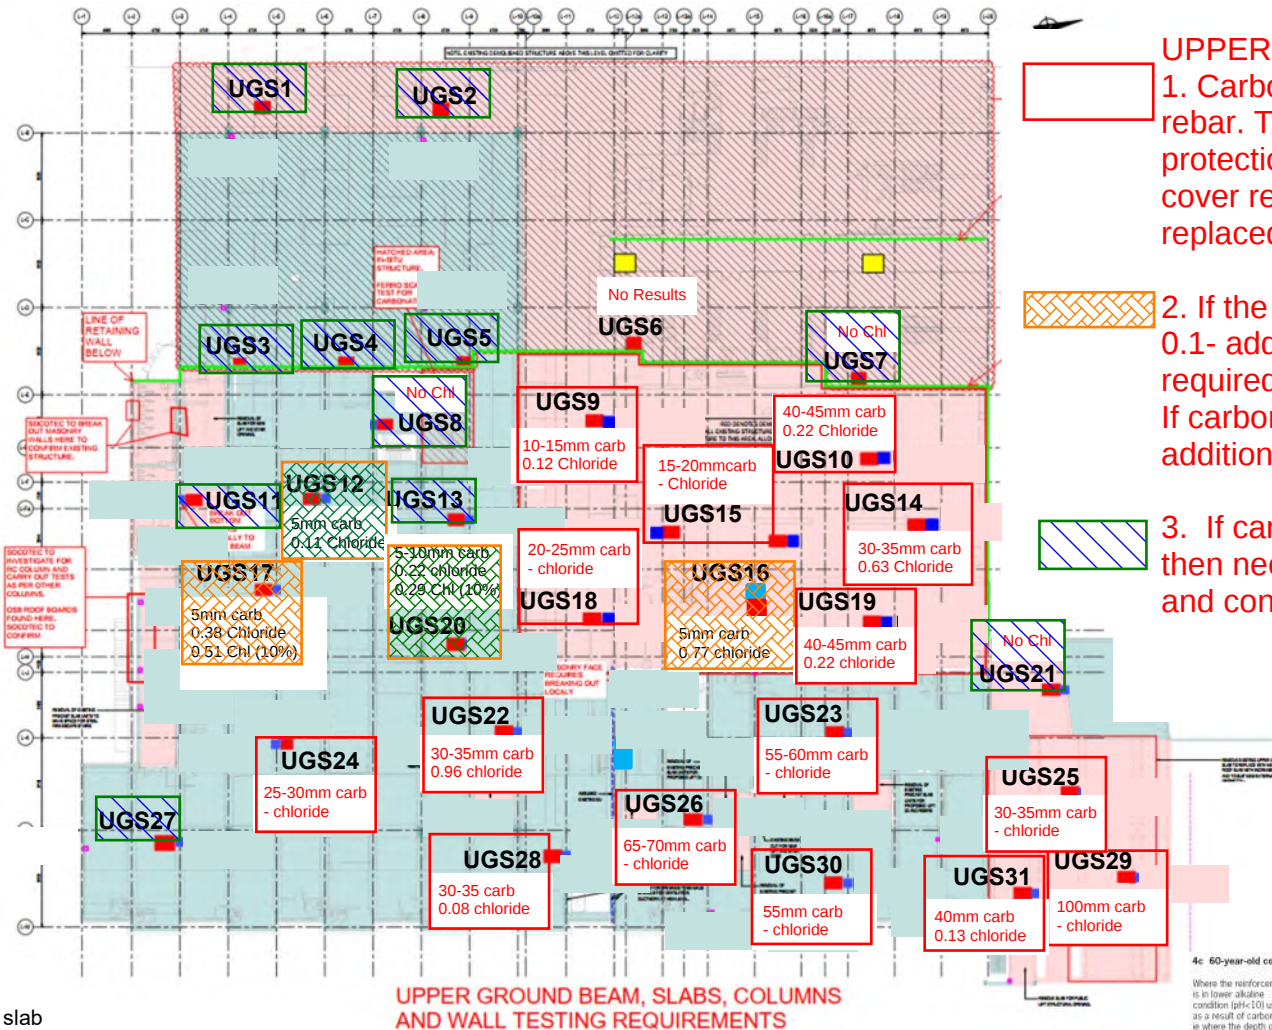
## Indicative intrusive locations

The chloride content results for the Upper Ground Floor and Level One indicate that several locations have chloride levels exceeding the 0.4% limit. These high levels of chloride do not show any clear pattern or correlation with the existing layout or exposure conditions, suggesting that the issue is widespread.

UGS# = Upper ground slab  
UGB# = Upper ground floor beam  
UGC# = Upper ground floor column/wall

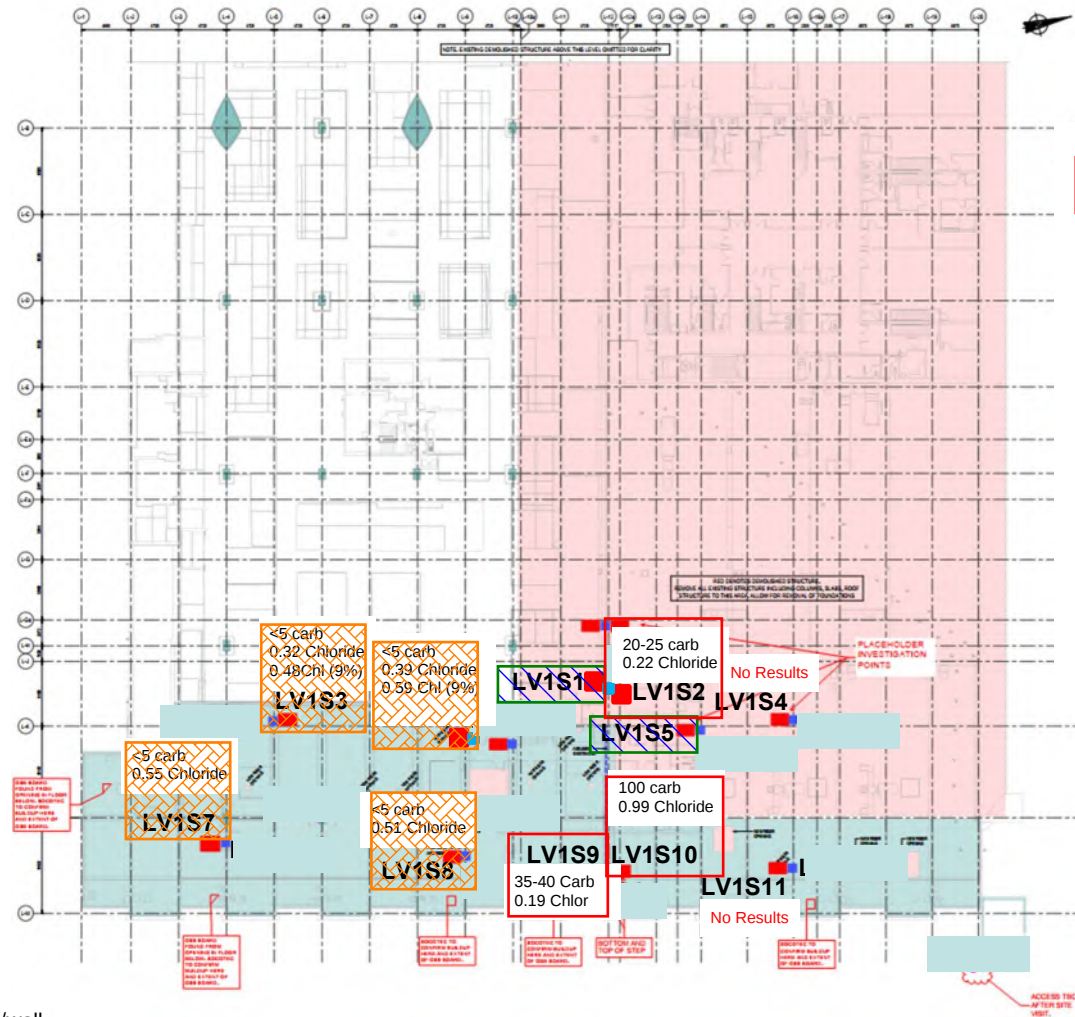
### Indicative intrusive locations

LV1S# = Level 1 slab  
LV1B# = Level 1 beam  
LV1C# = Level 1 column/wall

1. Carbonation front is at the rebar. Therefore the rebar has no protection and requires the to be cover replaced or the plank replaced.

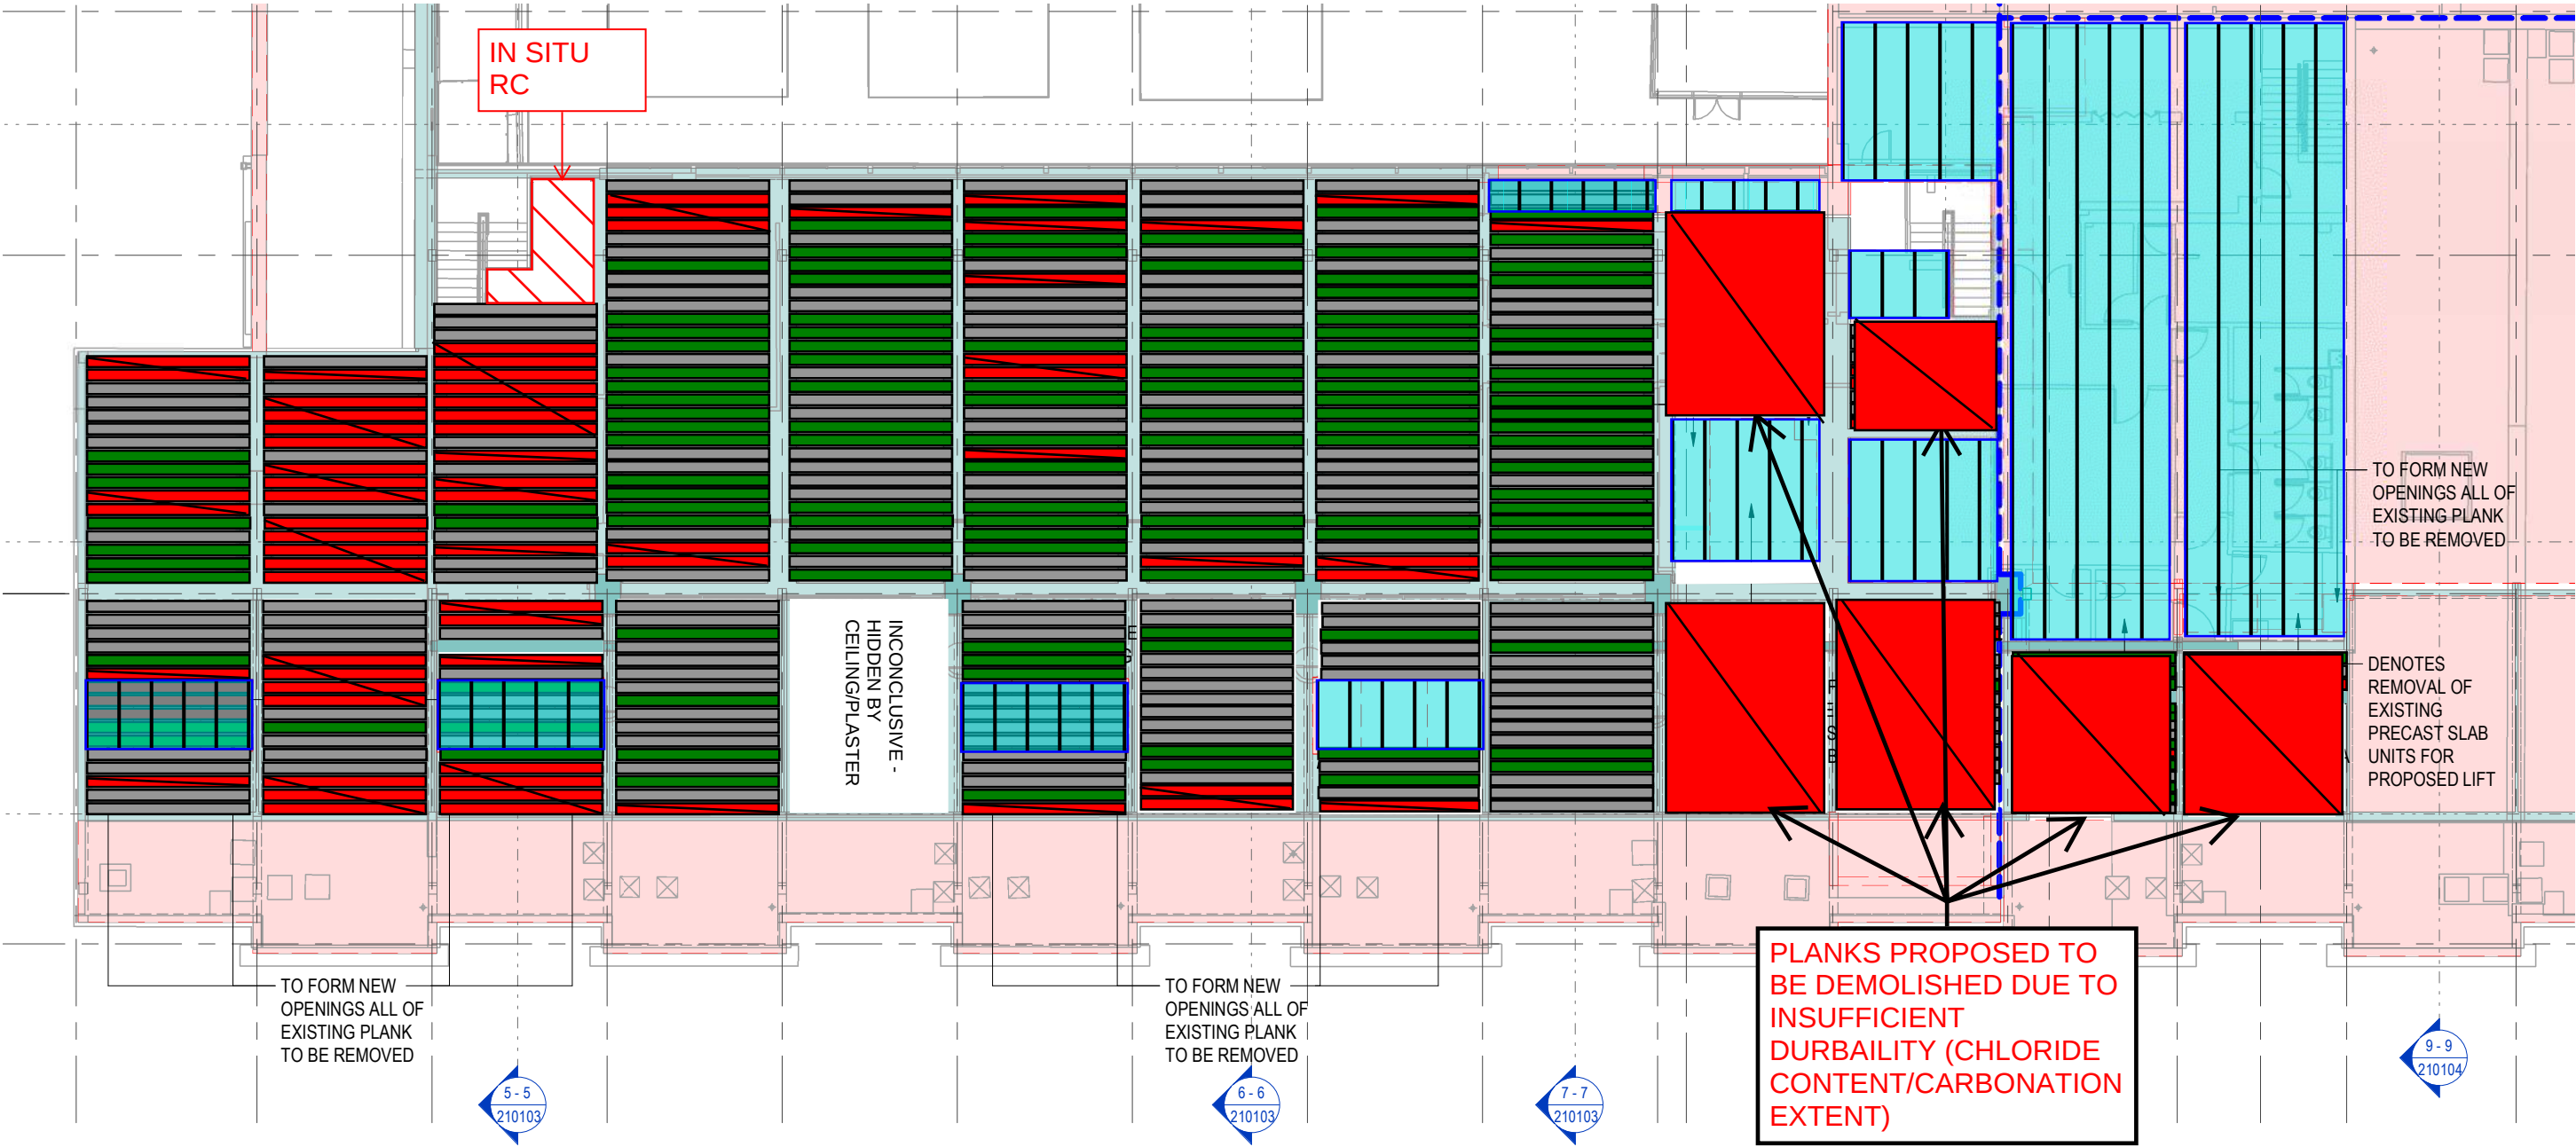
Appendix D - Condition Survey Results of precast RC planks & Typical Sections

- **Type 1:** Transverse cracks with no water ingress– No substantial reinforcement corrosion.
- **Type 2:** Transverse cracks with water ingress with– Corrosion present.
- **Type 3:** Significant transverse cracks with water ingress or longitudinal cracks – Corrosion present.
