82 Manchester Road, Slaithwaite

Bat Survey Report

7th May 2024

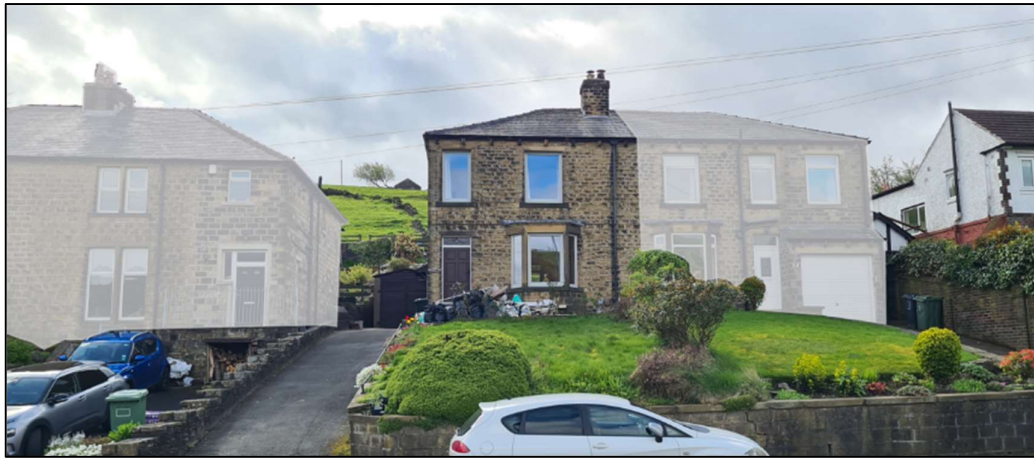
- 5.2.2 The two-storey dwelling had a hipped two-pitched roof covered with Welsh slate (Plate 1 and 2). The walls were constructed from stone and the metal guttering was suspended on stone supports. No fascias or soffit box was present.
- 5.2.3 The windows and doors were predominantly framed with uPVC although a transom window above the front door and a ground-floor window on the east side of the house were framed with wood. A small single-storey open porch was present on the eastern edge of the building (Plate 3). The porch had a wooden frame and lean to-roof which was covered with a bituminous roofing felt.

Plate 1. The dwelling viewed from the north (adjacent properties greyed out)

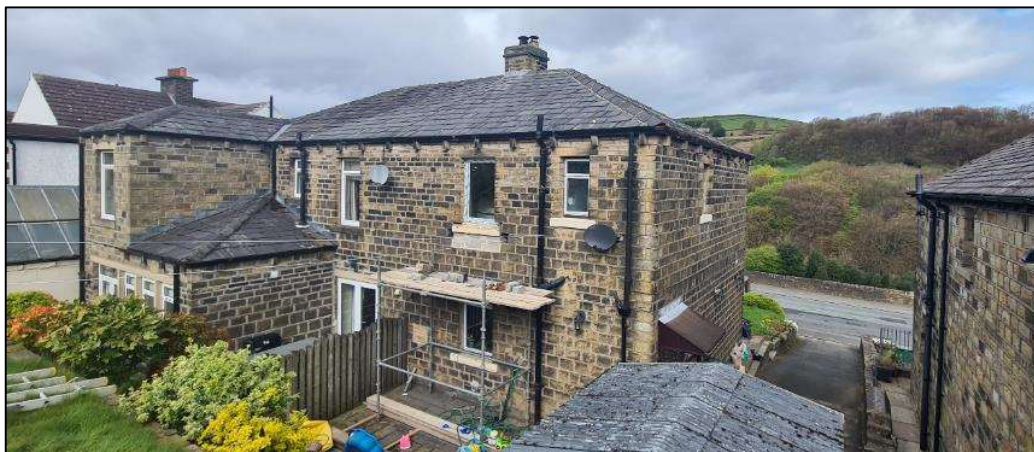
Plate 2. The dwelling viewed from the southeast

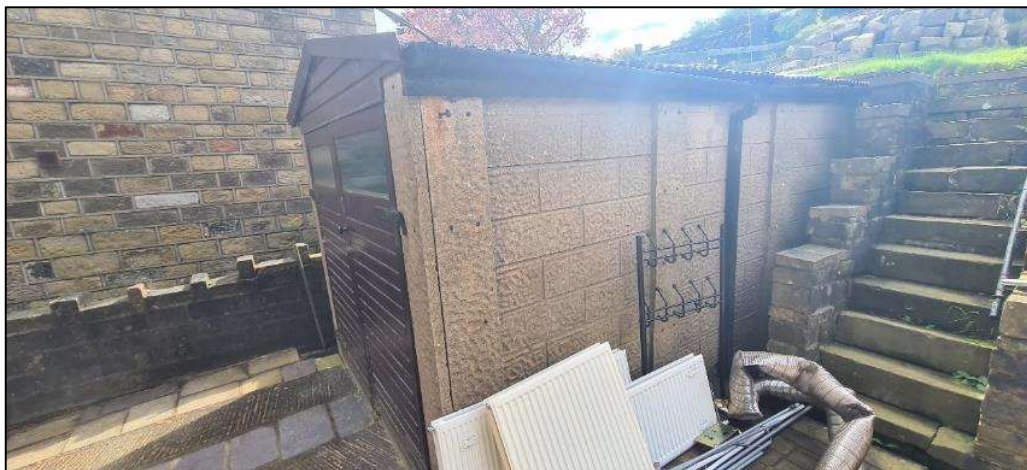
5.2.11 The single-storey garage was constructed from prefabricated concrete panels and posts (Plate 5). The building had a shallow two-pitched roof covered with corrugated cement boards (Plate 6). Wooden cladding was present on the gables and a wooden fascia supported the guttering on the western aspect. No fascia or guttering was present on the eastern side of the building.

Plate 5. The garage viewed from the northwest

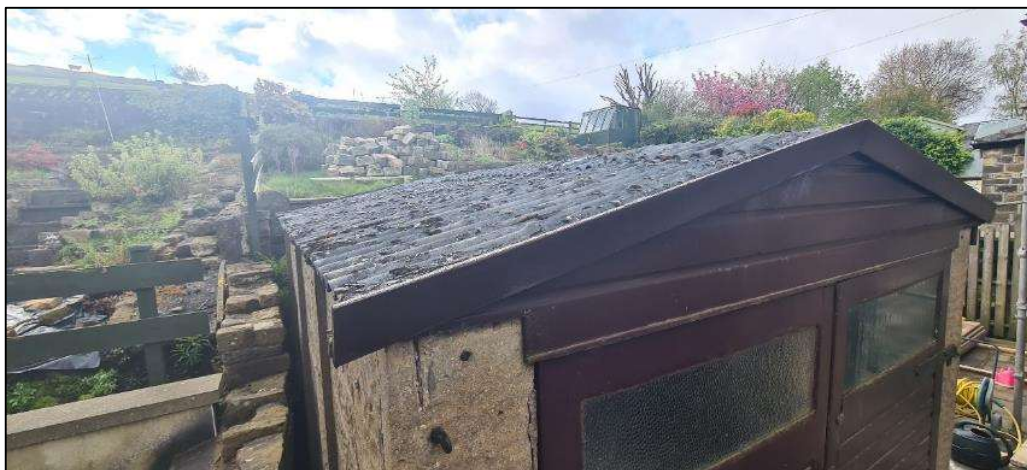
Plate 6. The garage roof viewed from the northeast
