Arboricultural Consultancy for AXA Insurance

Insured	Mr Stephen John Edwards	Address	20 Wellington Court, Bradford, BD11 2HY		
Client	Subsidence Management Services	Contact	Ian Domigan	Claim No.	IFS-AXA-SUB-22-0099767
ES Ref	SA-249643	Consultant	Keith Burgess	Contact No.	0330 380 1036
Report Date	05/04/2022

Scope of Report: To survey the property and determine significant vegetation contributing to subsidence damage, make recommendation for remedial action and assess initial mitigation and recovery prospects. The survey does not make an assessment for decay or hazard evaluation.

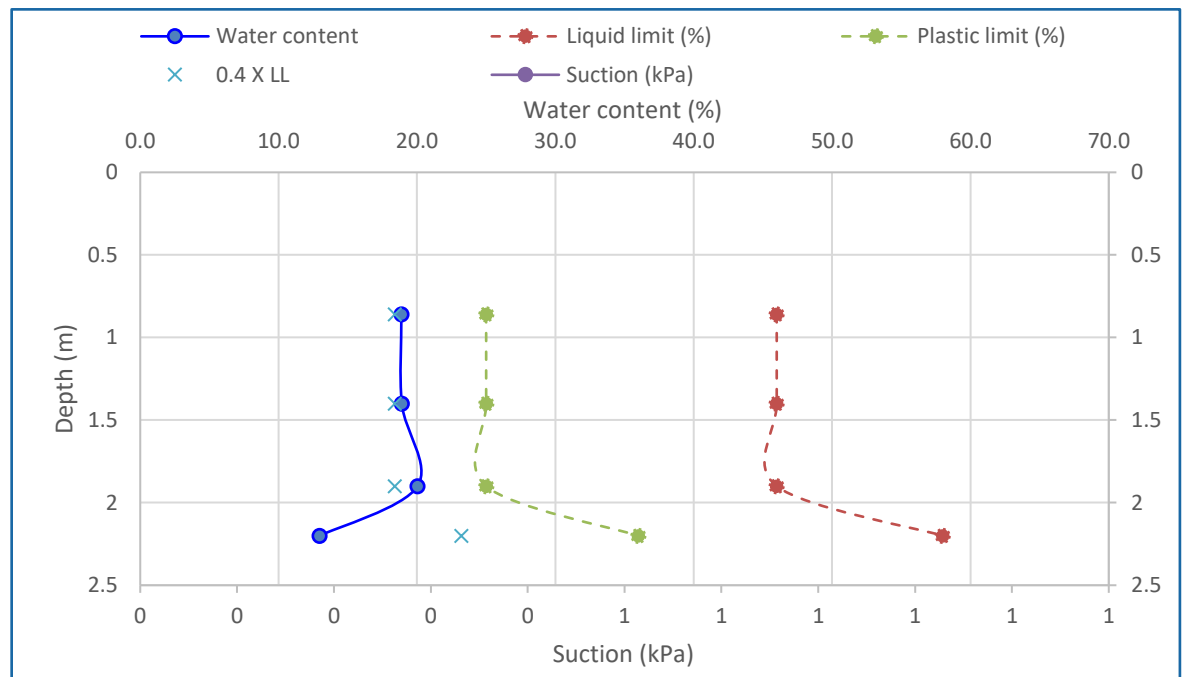
Plasticity Chart for Casagrande Classification

Lab Ref	Depth (m)	WC (%)	LL (%)	PL (%)	PI (%)	.425 mm(%)	mod. PI (%)	Av. Suc. (kPa)	Description
1	0.86	18.9	46	25	21	83	17		Firm brown/orange-brown/light grey silty CLAY with rare gravel and sand. Gravel is fine and medium.
2	1.4	18.9	46	25	21	83	17		Firm brown/orange-brown/light grey silty CLAY with rare gravel and sand. Gravel is fine and medium.
3	1.9	20.0	46	25	21	83	17		Firm brown/orange-brown/light grey silty CLAY with rare gravel and sand. Gravel is fine and medium.
4	2.2	13.0	58	36	22	43	9		Moist black gravelly COAL DUST. Gravel is fine to medium shale.

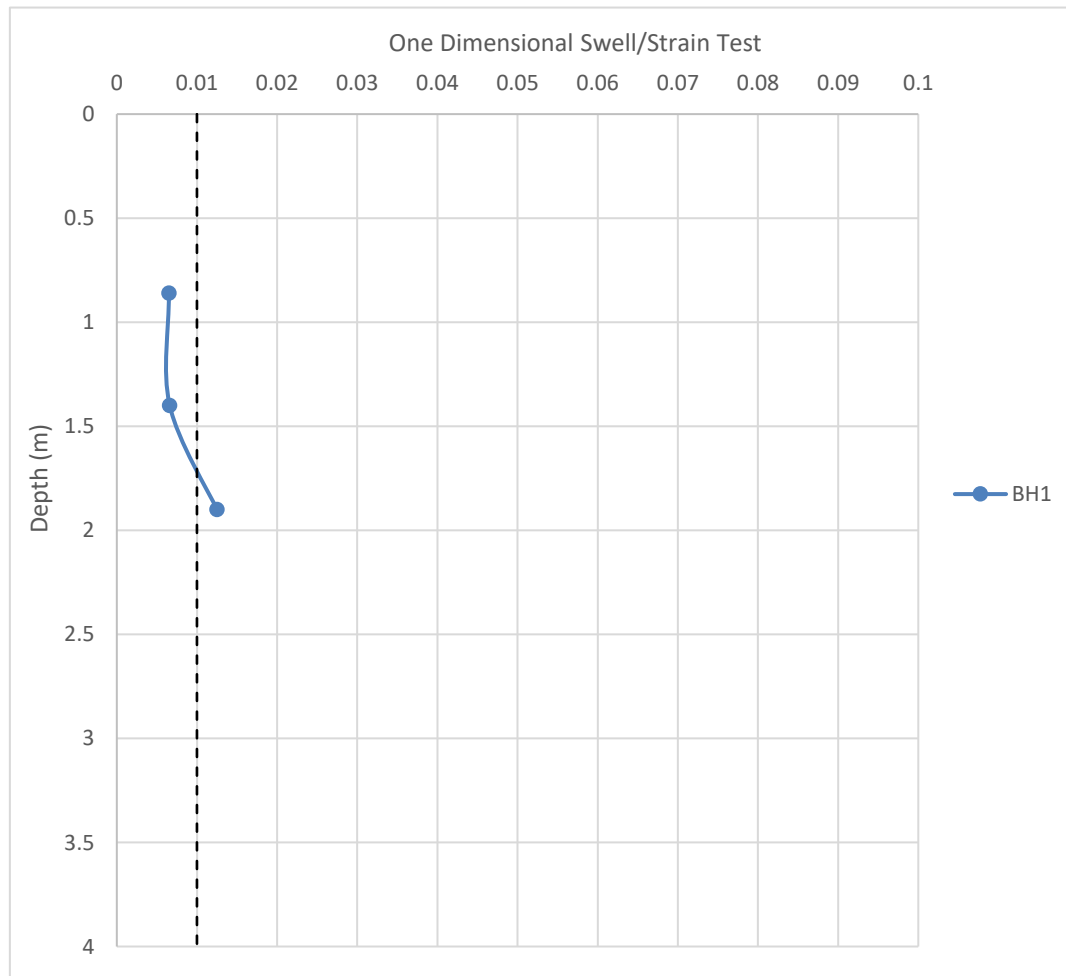
Summary of Oedometer Testing for BH1

Lab Ref	Depth (m)	Strain	Heave (mm)	Remarks
1	0.86	0.0065	0	
2	1.4	0.0066	0	
3	1.9	0.0125	3.1	
4	2.2

BH 1 estimate of heave	3mm
------------------------	-----
