Bat Survey to  
Kirkgate Surgery  
Kirkgate  
Birstall  
WF17 9HE

7<sup>th</sup> October 2021

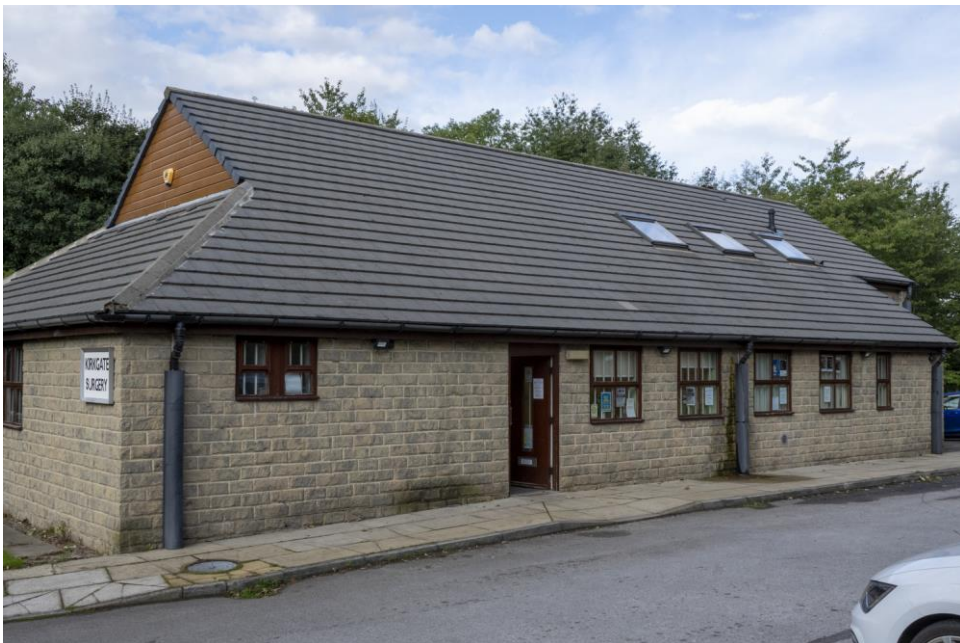
Plate 1 Location of bat roost

The north end of the building houses a fire escape stairway and forms a protruding tower of which the east and west elevations are cement rendered. The render on the west facing elevation is peppered with bat droppings which lead up to the very NW corner of the building where there is a gap where the stone and the render meet. This is almost not visible from the ground, but the droppings lead straight to it and there is dark staining on the render at the entrance. This is a classic spot for common pipistrelle bats which is most likely the species roosting here, though potentially Daubenton's could be a candidate too given the proximity to the beck and the fishing ponds.

The daytime scoping survey established that bats are roosting in a gap in the stonework high up on the NW corner of the building. There are droppings adhered to the walls and dark staining around the entrance of a gap which is about 150mm x 50mm where the rendered west wall meets the facing stone of the north wall. This is a classic roost site favoured by common pipistrelle bats. There are plenty of droppings adhered to the walls which indicates that the roost was in use at some point during the current season. It is not possible to determine if this was a nursery roost or is used by a small number of non-breeders, though nursery roost is more likely. It is also not possible to determine the species of bat without DNA analysis of the droppings or by observing the emergence at the appropriate time of year when catching in a static net would also be possible. It is most likely to be common pipistrelle though two other species can't be ruled out.

The roost is not likely to be disturbed by the proposed alterations apart from indirect actions caused by drilling and hammering. There will be no direct impact on the roost and so the following method statement should ensure that no bats are harmed and no disturbance to the roost is caused
